# THERMAL ELECTRICAL INSPECTION

## SAMPLE REPORT

RETROFIT  
ELECTRIC

# Retrofit Electric - Thermal Electrical Inspection

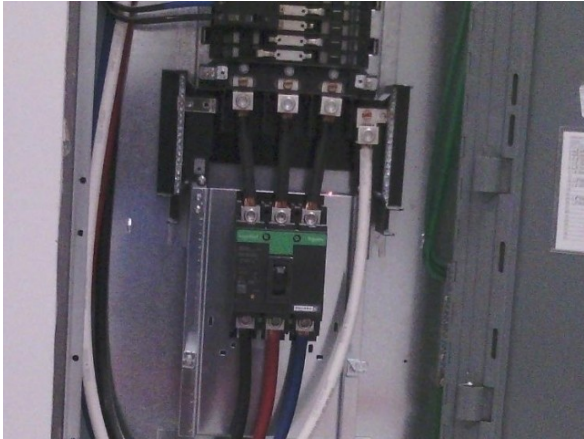
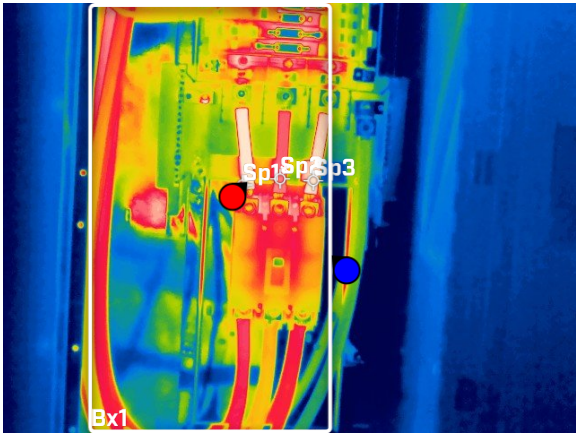
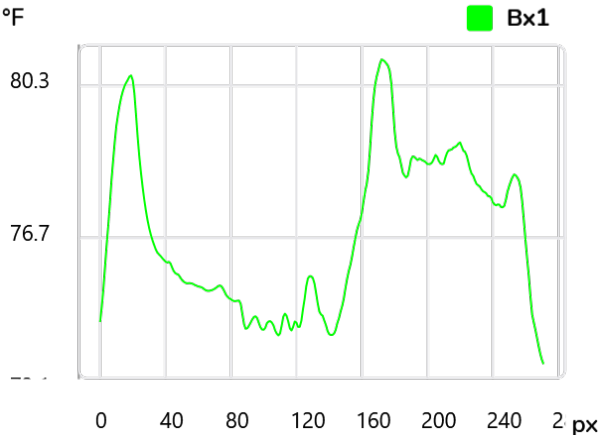
Thermogram 1 Created: 5/14/2026 9:55:13 AM

Equipment name : Production 204  
Device name : 1000  
Measurement Point : LZ-EV  
Status OK

Issue No Issue - Normal operation  
Recommended Action No action recommended at this time  
Comment No additional comments  
Priority None

| Location / Equipment | Status | Comments<br>(eg reason for no control) | Date |
|---|---|---|---|
| LZ-EV | OK | No issue, normal operation. No action recommended at this time. | 2026.06.18 |

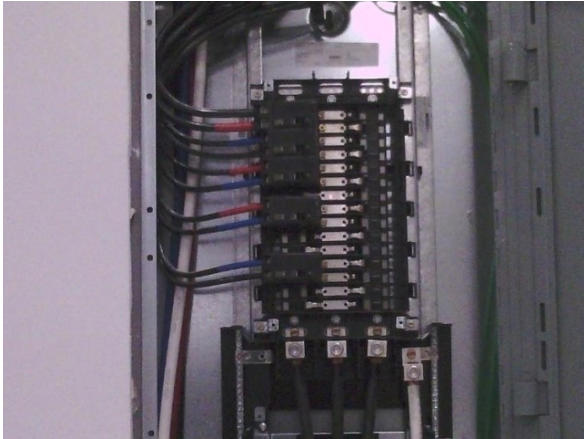
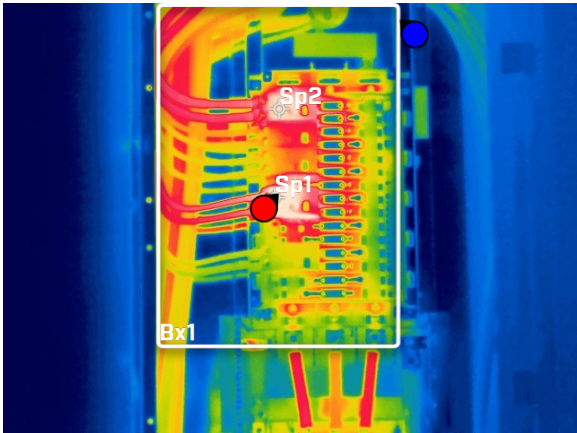
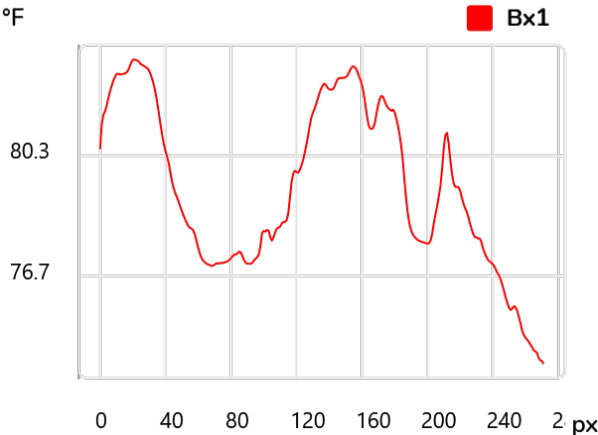
Thermogram 2 Created: 5/14/2026 9:56:18 AM

Equipment name : Production 204  
Device name : 1000  
Measurement Point : LZ-EV  
Status OK

**Issue** No Issue - Normal operation  
**Recommended Action** No action recommended at this time  
**Comment** No additional comments  
**Priority** None

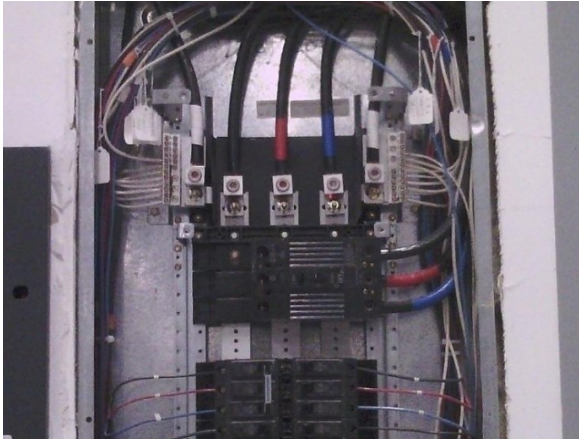
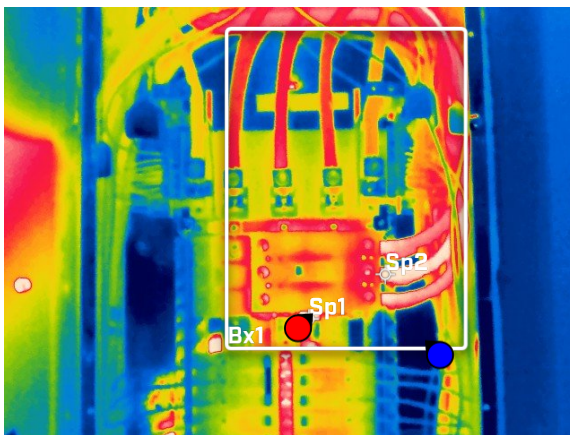
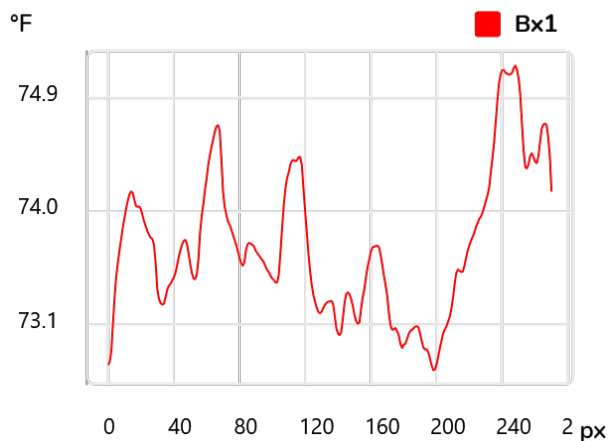
Thermogram 3 Created: 5/14/2026 10:11:44 AM

Equipment name : Production 204  
Device name : 1000  
Measurement Point : LZ-EV  
Status OK

**Recommended Action** No action recommended at this time

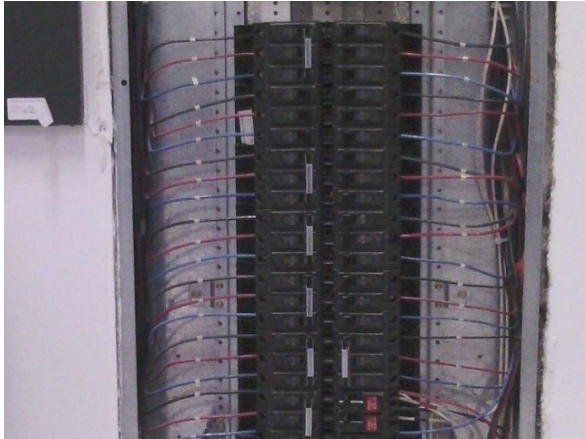
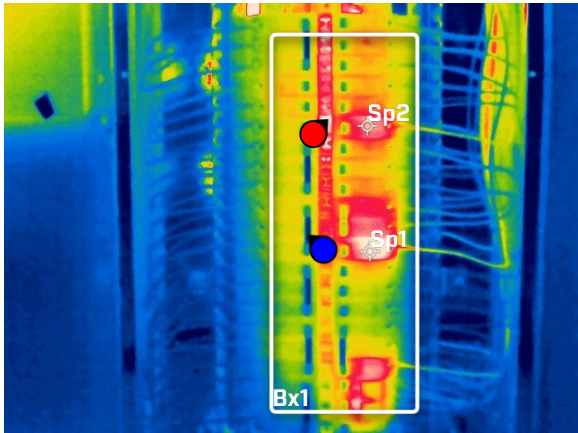
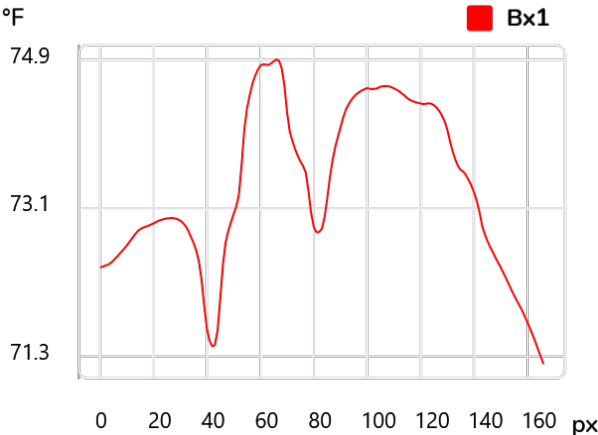
Thermogram 4 Created: 5/14/2026 10:14:37 AM

Equipment name : Production 204  
Device name : 1000  
Measurement Point : LZ-EV  
Status OK

Issue No Issue - Normal operation  
Recommended Action No action recommended at this time  
Comment No additional comments  
Priority None

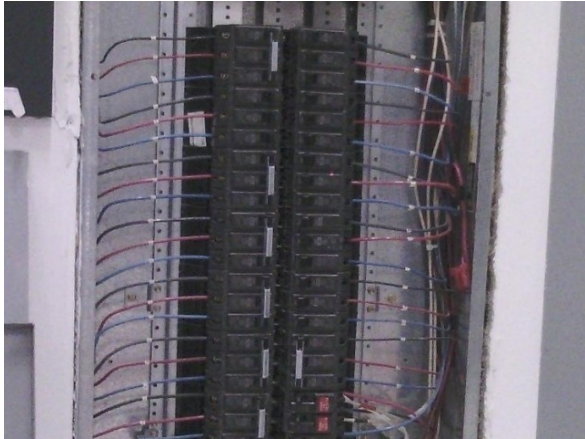
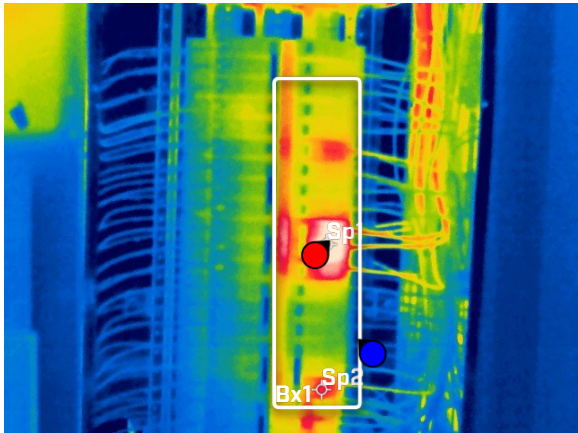
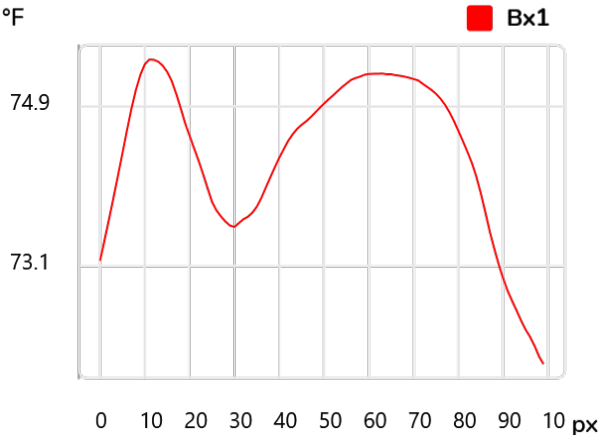
Thermogram 5 Created: 5/14/2026 1:02:22 PM

Equipment name : Production 204  
Device name : 1001  
Measurement Point : LZ-2A  
Status OK

**Issue** No Issue - Normal operation  
**Recommended Action** No action recommended at this time  
**Comment** No additional comments  
**Priority** None

| Location / Equipment | Status | Comments<br>(eg reason for no control) | Date |
|---|---|---|---|
| LZ-2A | OK | No issue, normal operation. No action recommended at this time. | 2026.06.18 |

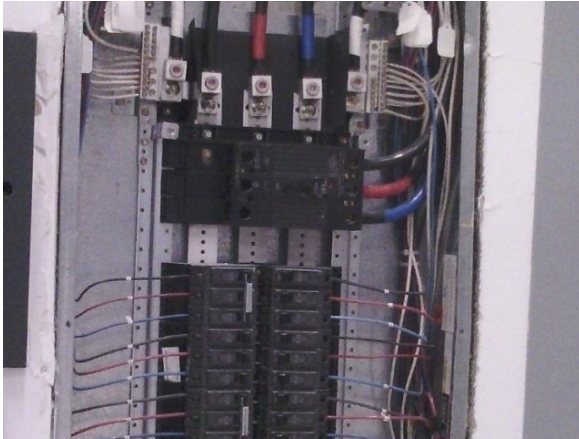
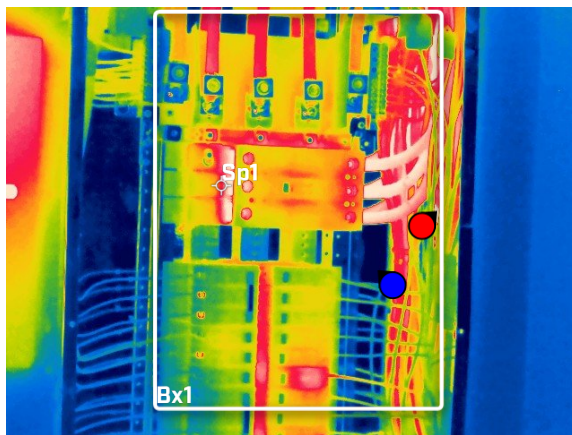
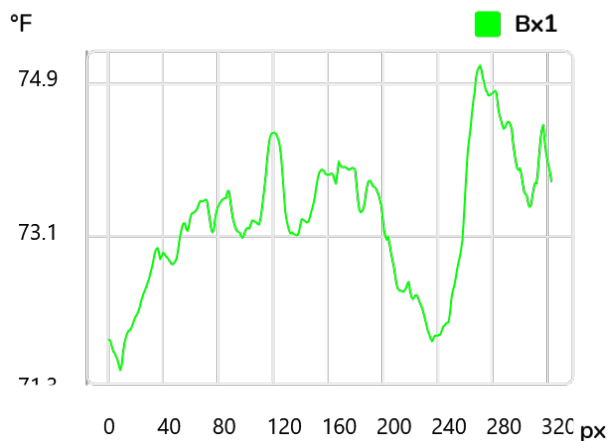
Thermogram 6 Created: 5/14/2026 1:03:12 PM

Equipment name : Production 204  
Device name : 1001  
Measurement Point : LZ-2A  
Status OK

**Recommended Action** No action recommended at this time

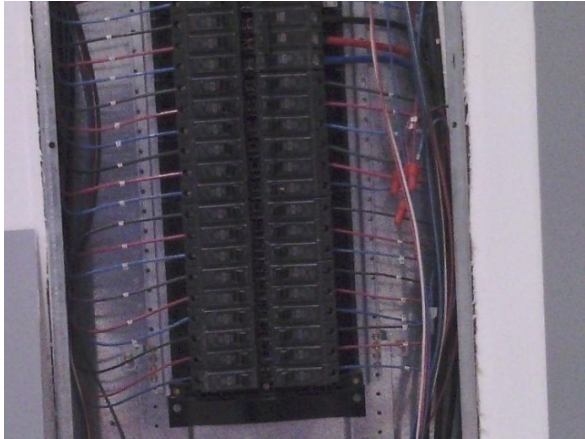
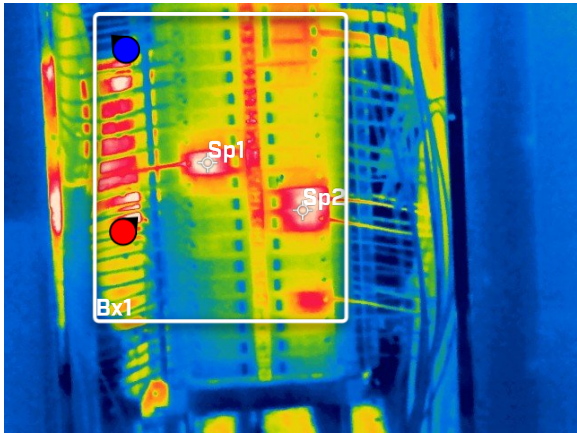
Thermogram 7 Created: 5/14/2026 10:26:02 AM

Equipment name : Production 204  
Device name : 1002  
Measurement Point : LZ-2B  
Status Note

Issue Loose connection(s)  
Recommended Action Inspect connections  
Comment Verify connections on lower 3-pole breakers.  
Priority 2-Intermediate/Investigate

| Location / Equipment | Status | Comments<br>(eg reason for no control) | Date |
|---|---|---|---|
| LZ-2B | Note | Verify connections on lower 3-pole breakers. Possibly dirty or loose. | 2026.06.18 |

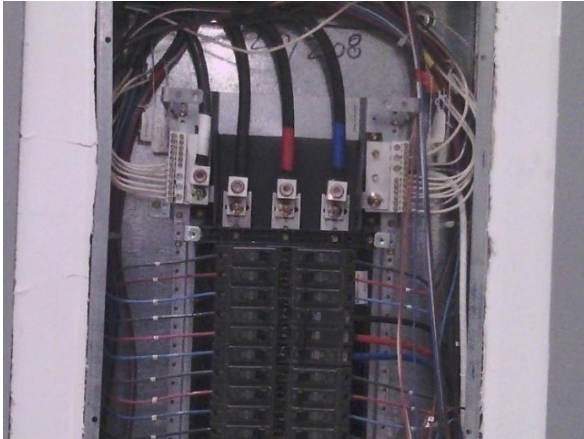
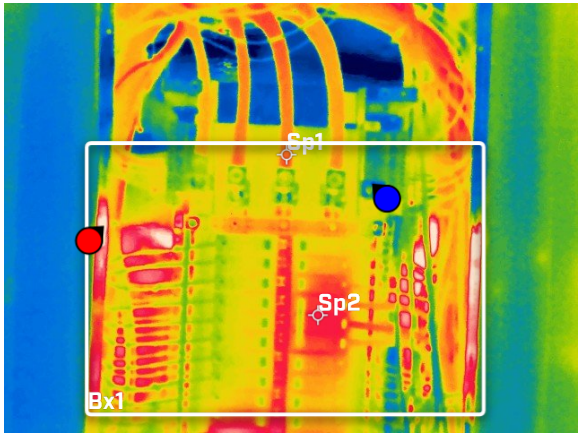
Thermogram 8 Created: 5/14/2026 10:29:34 AM

Equipment name : Production 204  
Device name : 1002  
Measurement Point : LZ-2B  
Status Note

**Issue** Loose connection(s)  
**Recommended Action** Inspect connections  
**Comment** Verify connections on lower 3-pole breakers.  
**Priority** 2-Intermediate/Investigate

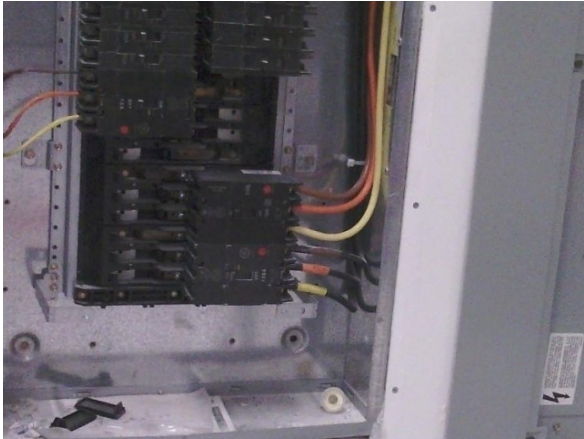
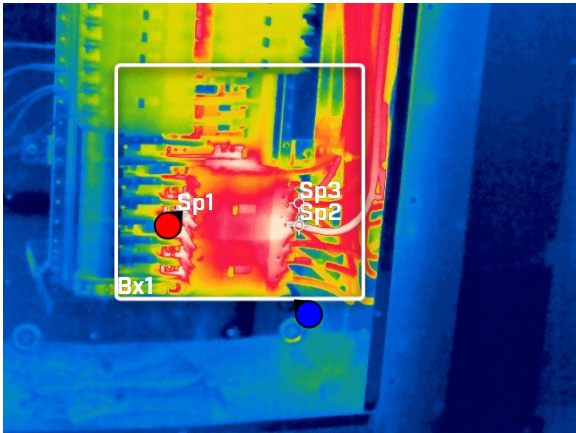
Thermogram 9 Created: 5/14/2026 10:43:03 AM

Equipment name : Production 204  
Device name : 1002  
Measurement Point : LZ-2B  
Status Note

Issue Loose connection(s)  
Recommended Action Inspect connections  
Comment Verify connections on lower 3-pole breakers.  
Priority 2-Intermediate/Investigate

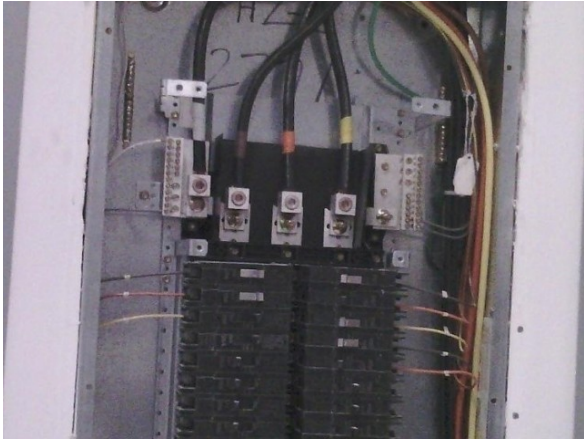
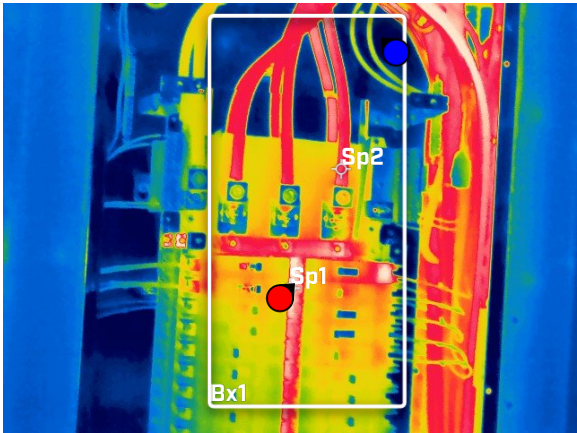
Thermogram 10 Created: 5/14/2026 10:49:53 AM

Equipment name : Production 204  
Device name : 1002  
Measurement Point : LZ-2B  
Status Note

Issue Loose connection(s)  
Recommended Action Inspect connections  
Comment Verify connections on lower 3-pole breakers.  
Priority 2-Intermediate/Investigate

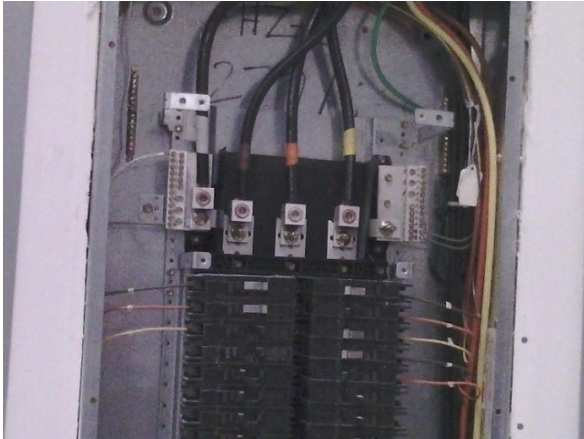
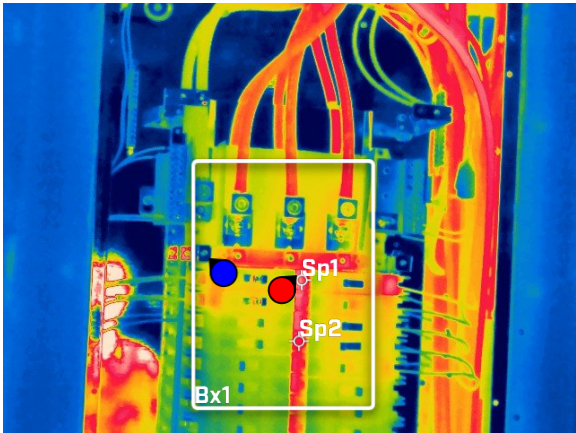
Thermogram 11 Created: 5/14/2026 10:50:19 AM

Equipment name : Production 204  
Device name : 1002  
Measurement Point : LZ-2B  
Status Note

Issue Loose connection(s)  
Recommended Action Inspect connections  
Comment Verify connections on lower 3-pole breakers.  
Priority 2-Intermediate/Investigate

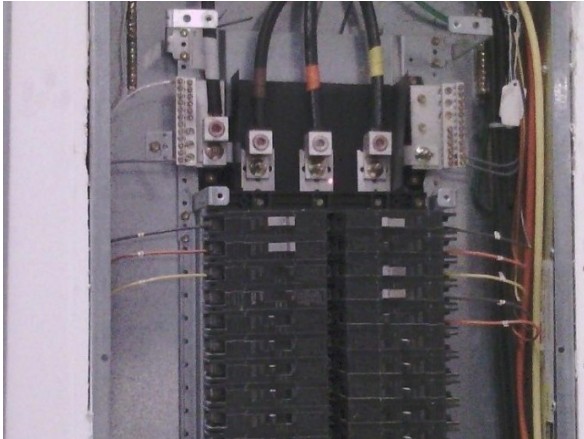
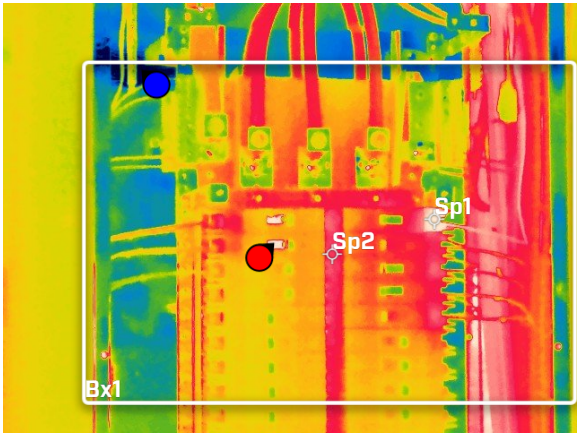
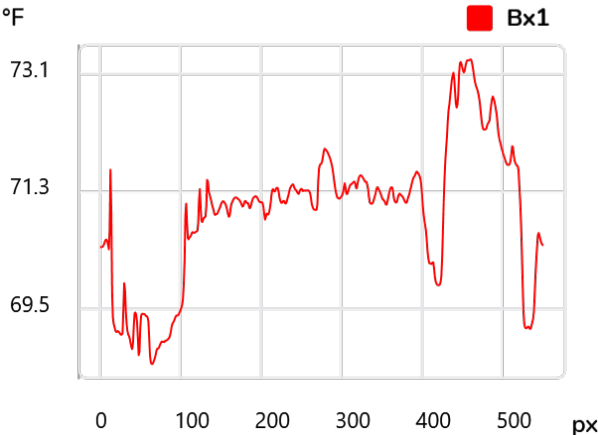
Thermogram 12 Created: 5/15/2026 8:30:40 AM

Equipment name : Production 204  
Device name : 1003  
Measurement Point : HZ-2  
Status OK

**Issue** No Issue - Normal operation  
**Recommended Action** No action recommended at this time  
**Comment** No additional comments  
**Priority** None

| Location / Equipment | Status | Comments<br>(eg reason for no control) | Date |
|---|---|---|---|
| HZ-2 | OK | No issue, normal operation. No action recommended at this time. | 2026.06.18 |

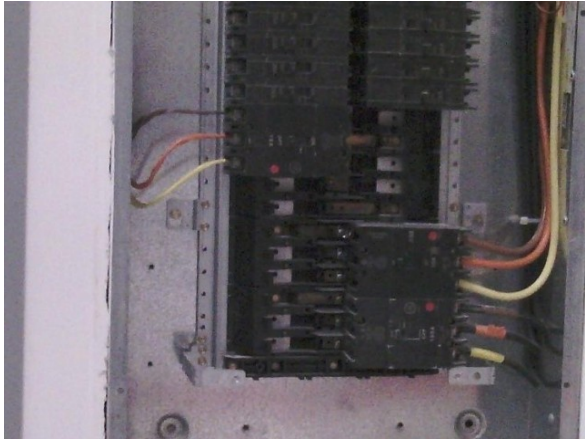
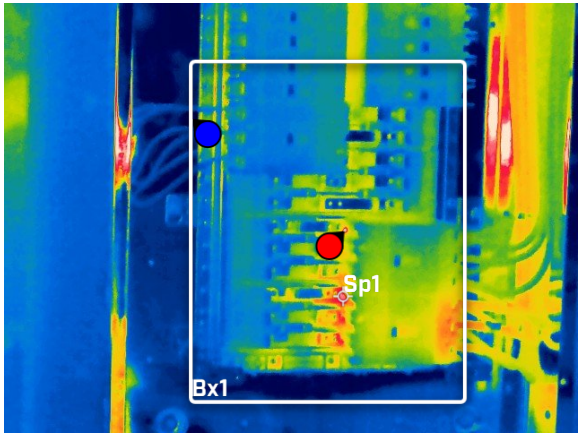
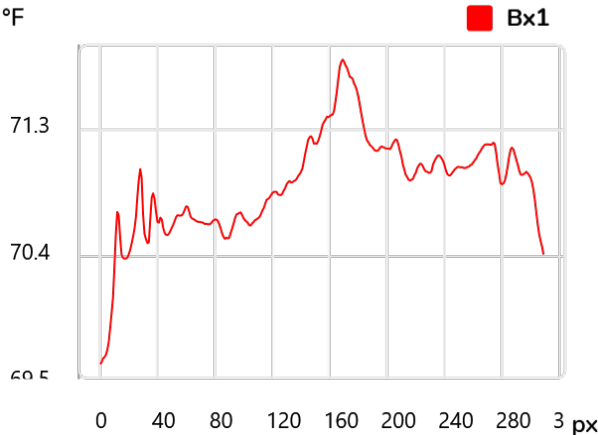
Thermogram 13 Created: 5/15/2026 8:31:44 AM

Equipment name : Production 204  
Device name : 1003  
Measurement Point : HZ-2  
Status OK

**Issue** No Issue - Normal operation  
**Recommended Action** No action recommended at this time  
**Comment** No additional comments  
**Priority** None

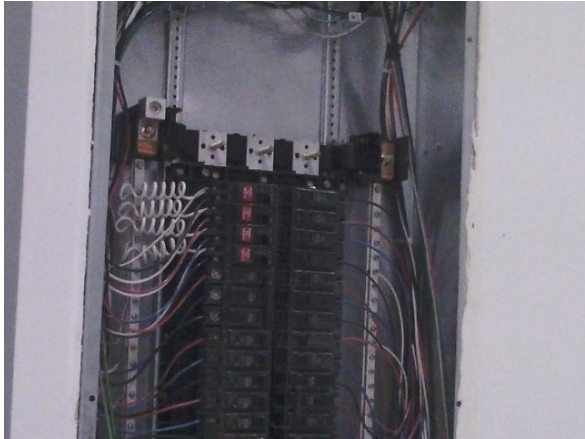
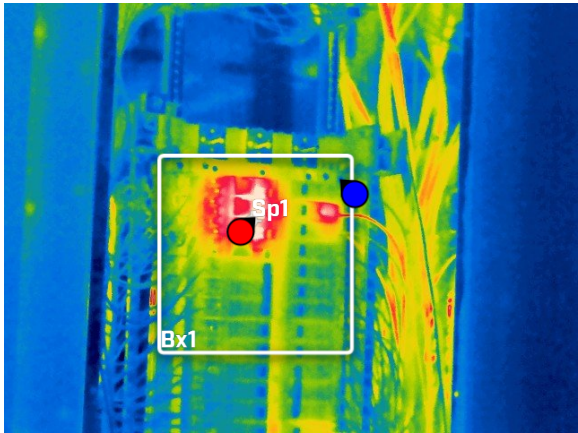
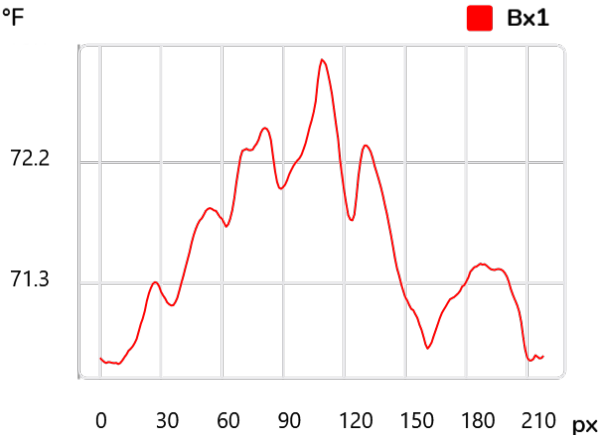
Thermogram 14 Created: 5/14/2026 11:05:49 AM

Equipment name : Production 204  
Device name : 1004  
Measurement Point : LZ-2C  
Status OK

**Issue** No Issue - Normal operation  
**Recommended Action** No action recommended at this time  
**Comment** No additional comments  
**Priority** None

| Location / Equipment | Status | Comments<br>(eg reason for no control) | Date |
|---|---|---|---|
| LZ-2C | OK | No issue, normal operation. No action recommended at this time. | 2026.06.18 |

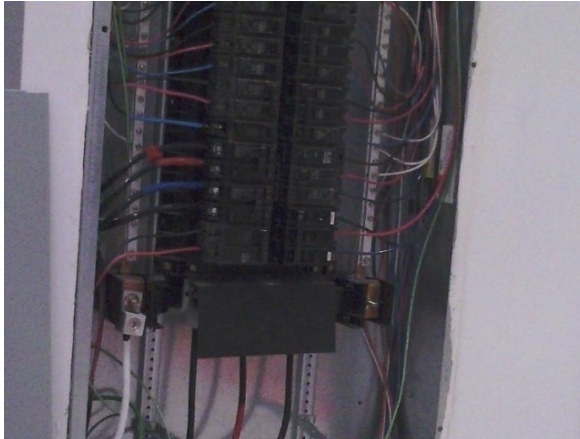
Equipment name : Production 204  
Device name : 1004  
Measurement Point : LZ-2C  
Status OK

Recommended Action No action recommended at this time

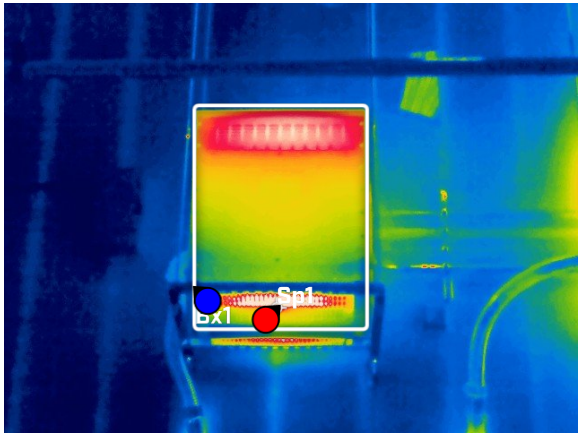
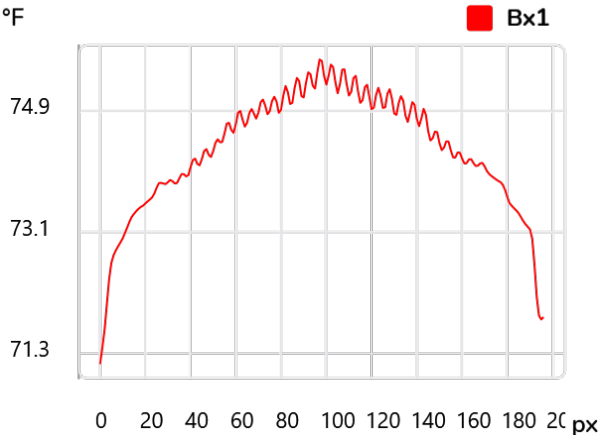
Thermogram 17 Created: 5/14/2026 12:51:25 PM

**Issue** No Issue - Normal operation  
**Recommended Action** Monitor changes  
**Comment** Continue to monitor, use photo as benchmark  
**Priority** 3 - Minor/Monitor

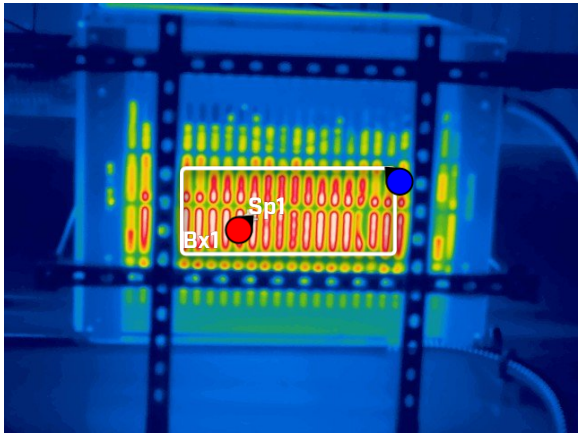
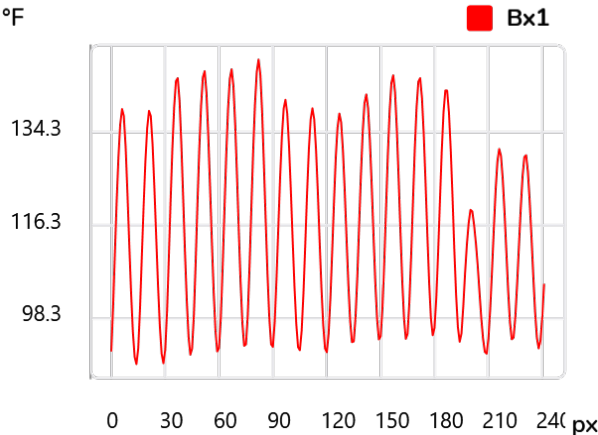
Thermogram 18 Created: 5/14/2026 12:49:02 PM

Issue No Issue - Normal operation  
Recommended Action Monitor changes  
Comment Continue to monitor, use photo as benchmark  
Priority 3 - Minor/Monitor

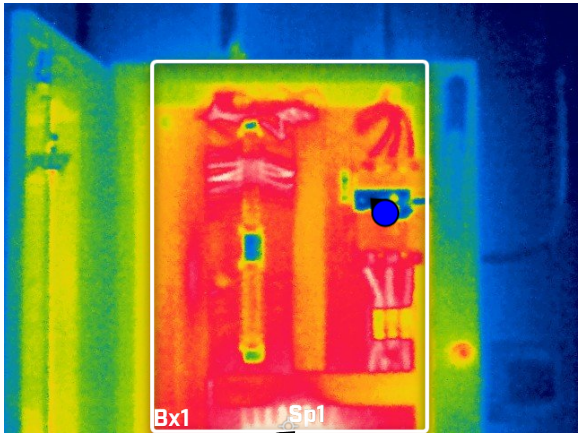
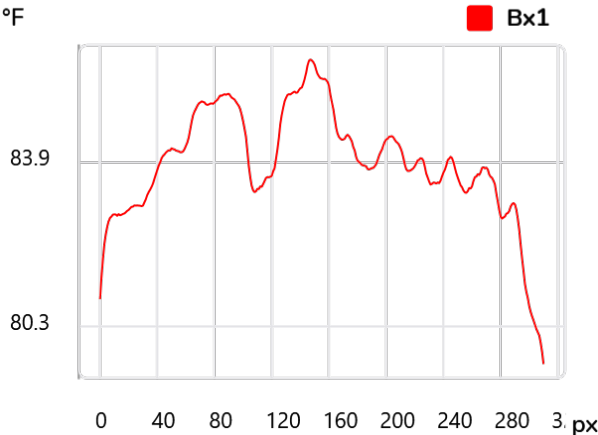
Thermogram 20 Created: 5/19/2026 8:54:40 AM

**Issue** No Issue - Normal operation  
**Recommended Action** No action recommended at this time  
**Comment** No additional comments  
**Priority** None

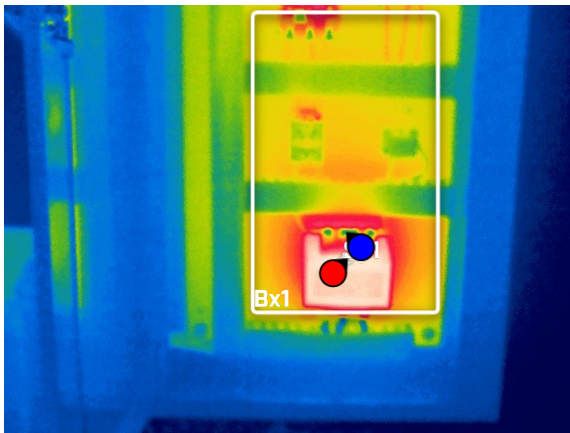
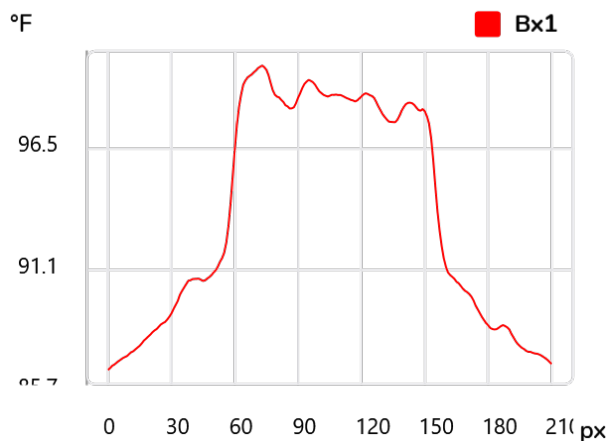
## Thermogram 21

Issue No Issue - Normal operation

Recommended Action No action recommended at this time

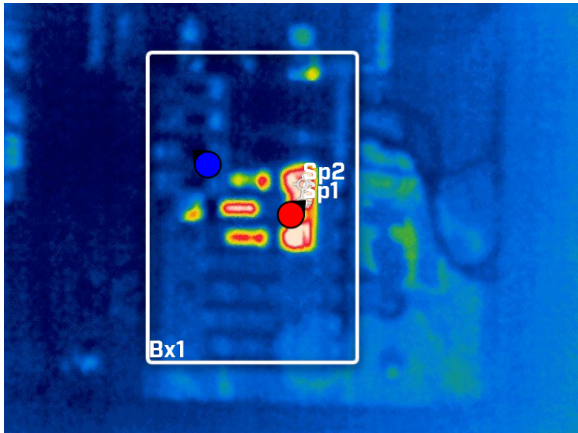
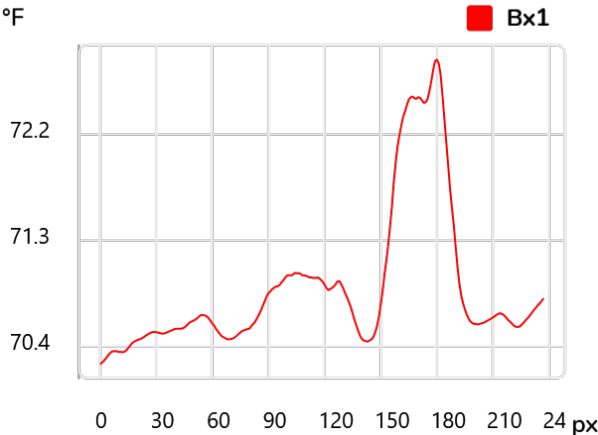
Thermogram 22 Created: 5/14/2026 1:31:58 PM

**Issue** No Issue - Normal operation  
**Recommended Action** No action recommended at this time  
**Comment** No additional comments  
**Priority** None

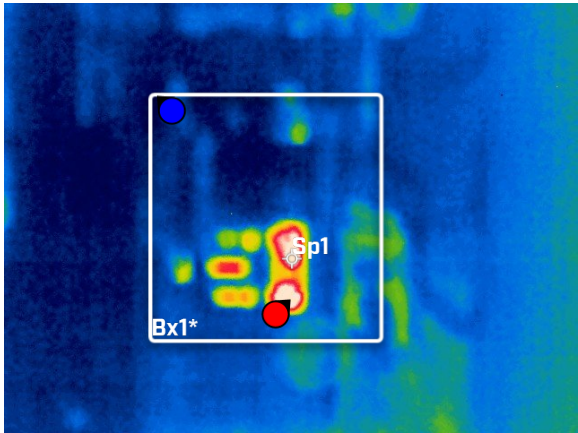
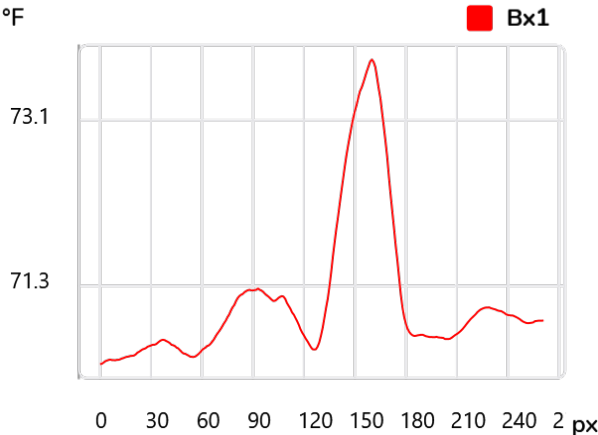
Thermogram 23 Created: 5/14/2026 1:32:29 PM

Issue No Issue - Normal operation  
Recommended Action No action recommended at this time  
Comment No additional comments  
Priority None

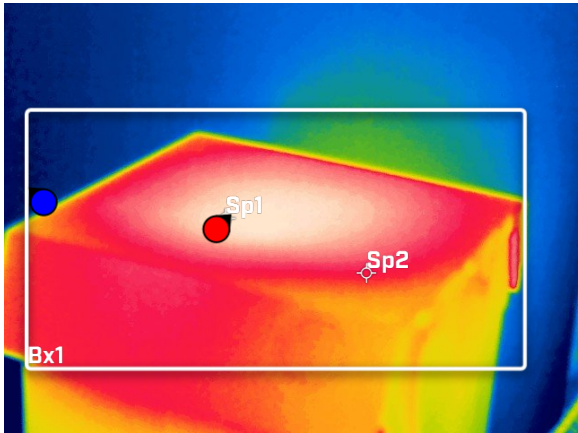
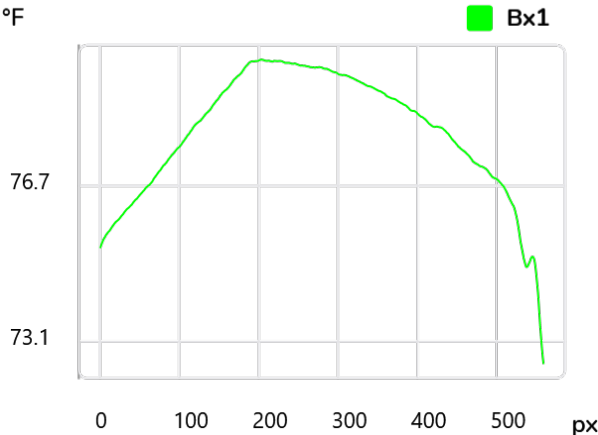
Thermogram 24 Created: 5/14/2026 1:39:30 PM

**Issue** No Issue - Normal operation  
**Recommended Action** No action recommended at this time  
**Comment** No additional comments.  
**Priority** None

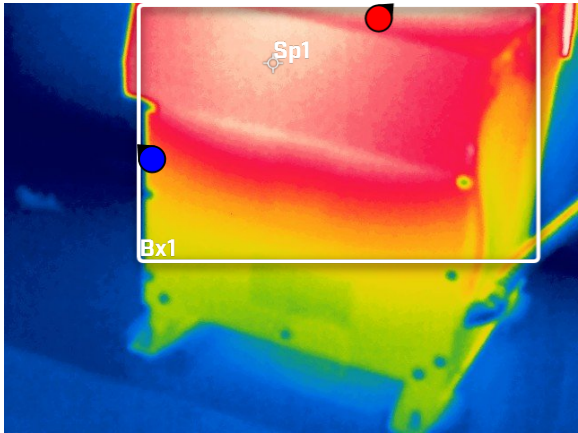
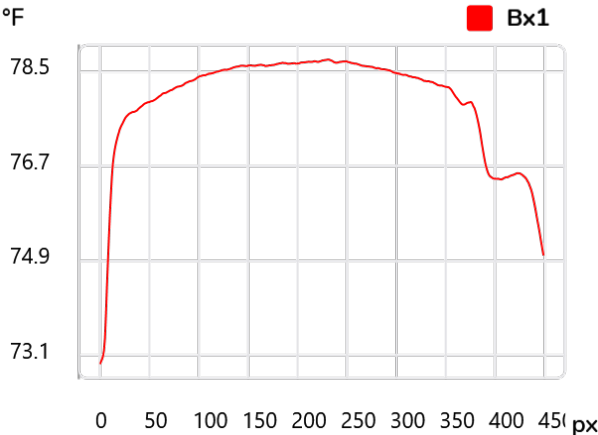
Thermogram 25 Created: 5/14/2026 1:39:55 PM

Issue No Issue - Normal operation  
Recommended Action No action recommended at this time  
Comment No additional comments.  
Priority None

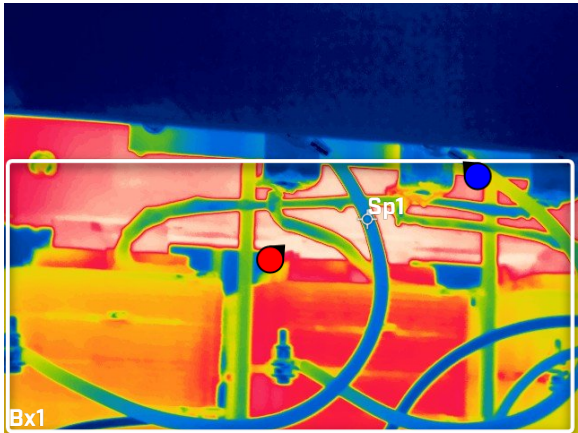
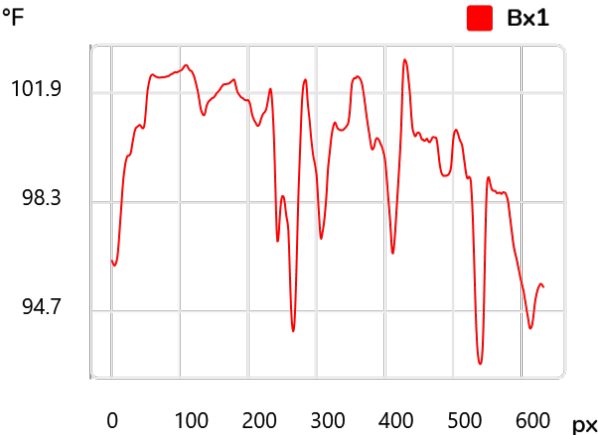
Thermogram 26 Created: 5/14/2026 1:50:40 PM

**Issue** No Issue - Normal operation  
**Recommended Action** No action recommended at this time  
**Comment** No additional comments.  
**Priority** None

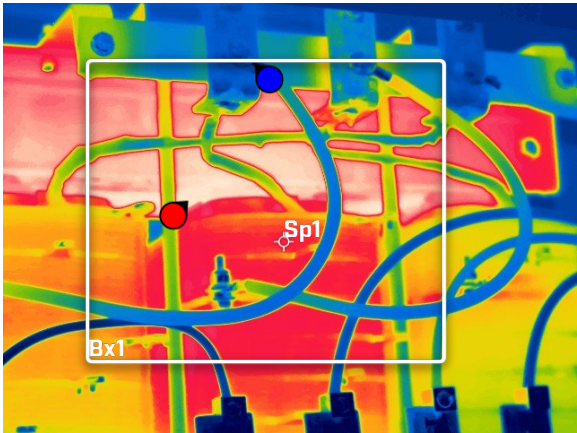
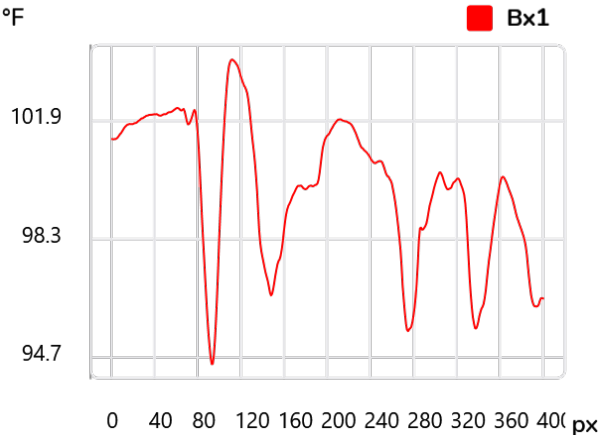
Thermogram 28 Created: 5/14/2026 1:51:51 PM

**Issue** No Issue - Normal operation  
**Recommended Action** No action recommended at this time  
**Comment** No additional comments.  
**Priority** None

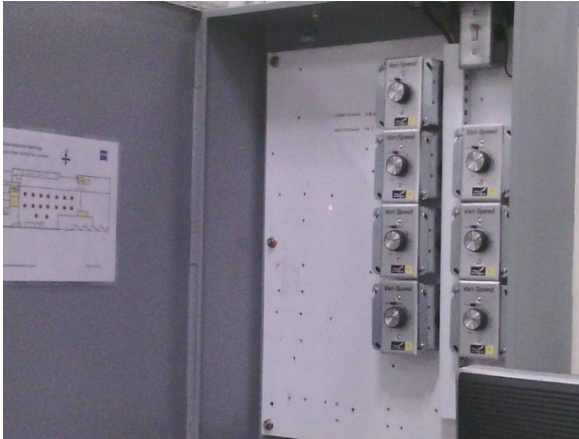
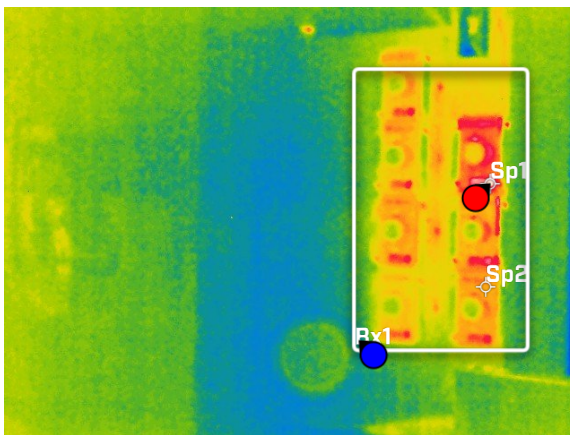
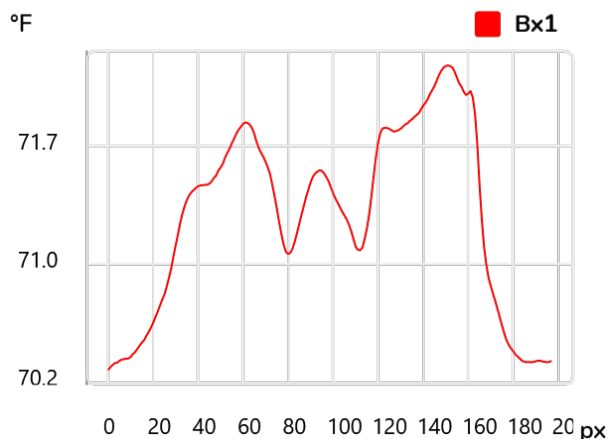
Thermogram 30 Created: 5/20/2026 1:43:30 PM

Equipment name : Production 204  
Device name : 1010  
Measurement Point : Fan Control A  
Status OK

**Recommended Action** No action recommended at this time

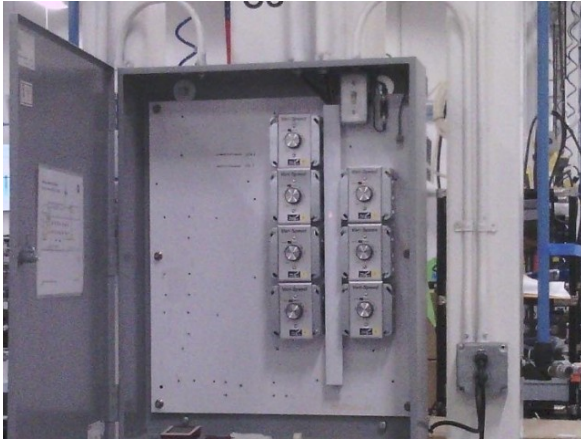
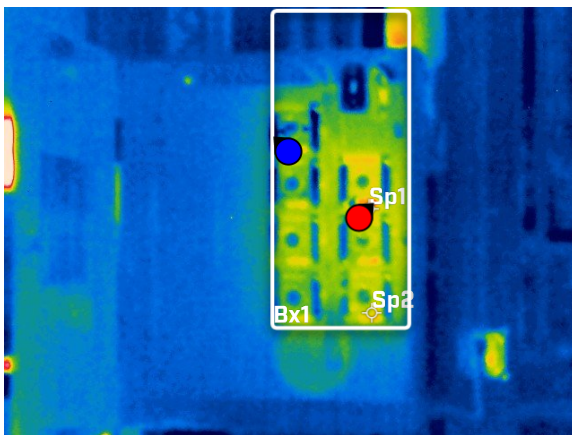
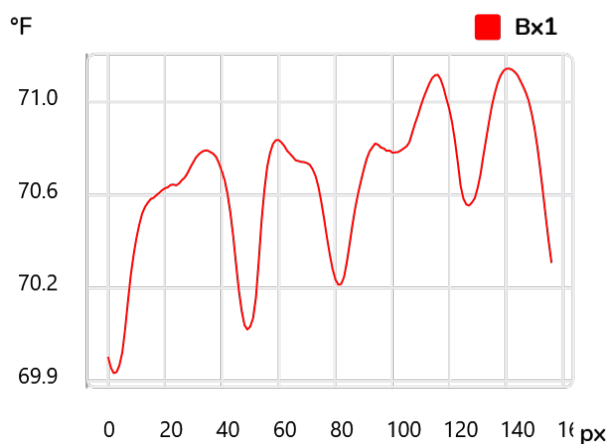
Thermogram 31 Created: 5/20/2026 1:48:17 PM

Equipment name : Production 204  
Device name : 1010  
Measurement Point : Fan Control A  
Status OK

**Recommended Action** No action recommended at this time

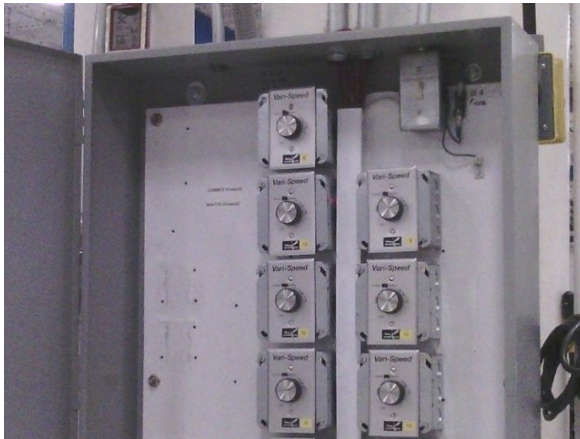
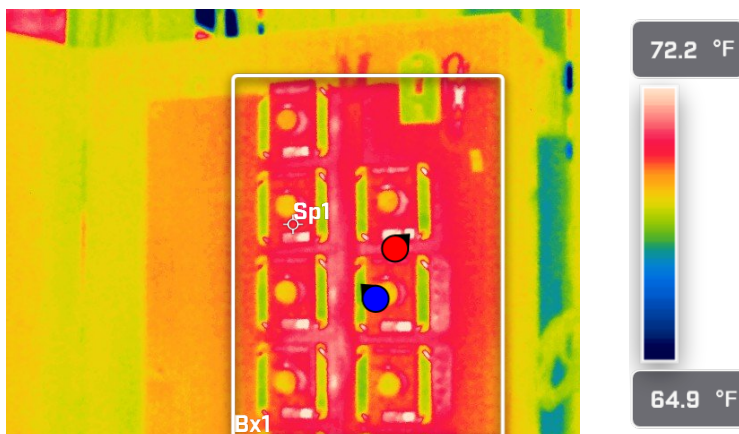
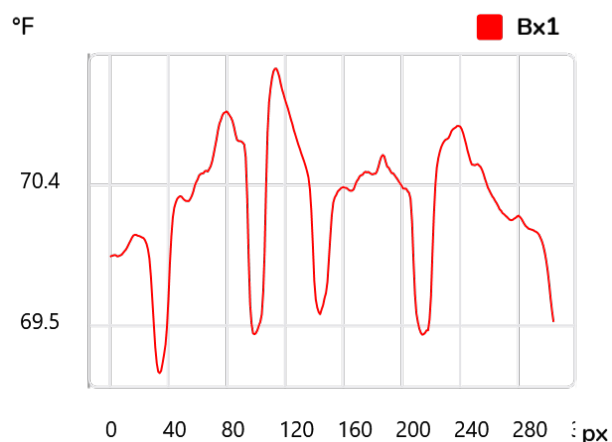
Thermogram 32 Created: 5/20/2026 1:51:48 PM

Equipment name : Production 204  
Device name : 1011  
Measurement Point : Fan Control B  
Status OK

**Issue** No Issue - Normal operation  
**Recommended Action** No action recommended at this time  
**Comment** No additional comments.  
**Priority** None

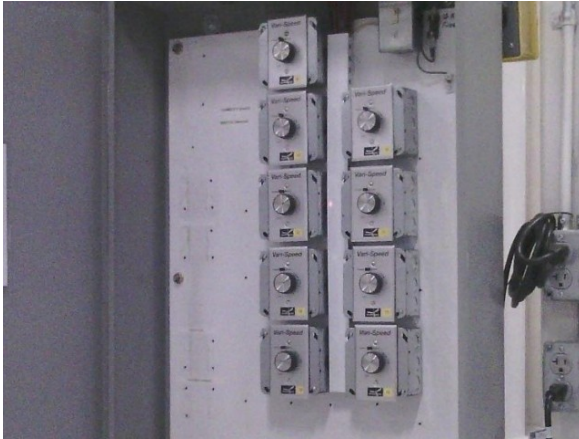
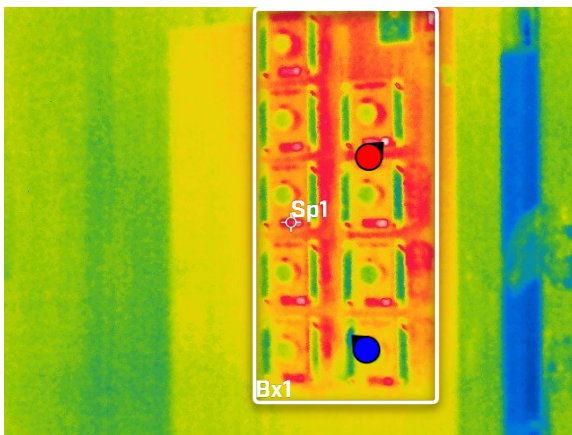
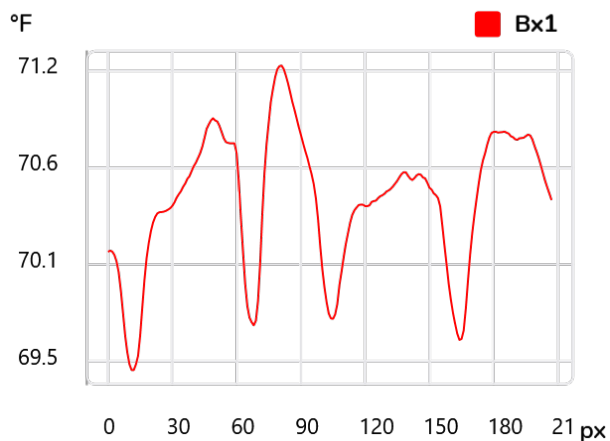
Thermogram 33 Created: 5/20/2026 1:52:18 PM

Equipment name : Production 204  
Device name : 1011  
Measurement Point : Fan Control B  
Status OK

**Recommended Action** No action recommended at this time

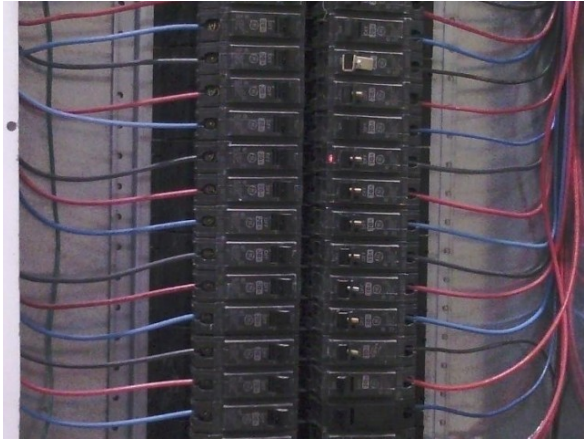
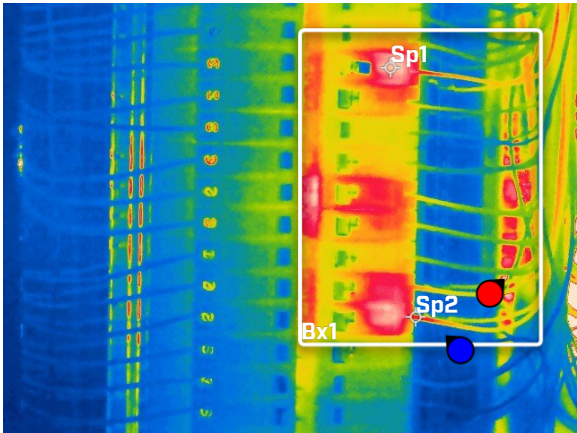
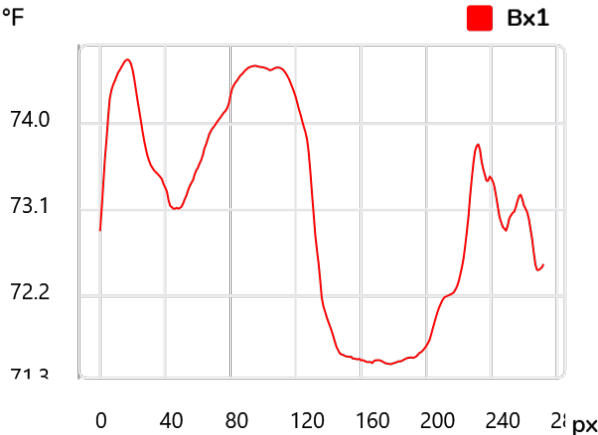
Thermogram 34 Created: 5/14/2026 2:36:10 PM

Equipment name : Production 204  
Device name : 1012  
Measurement Point : LZ-4A  
Status OK

**Issue** No Issue - Normal operation  
**Recommended Action** No action recommended at this time  
**Comment** No additional comments.  
**Priority** None

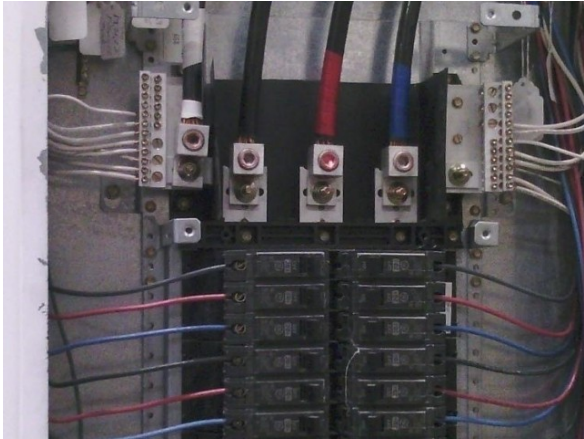
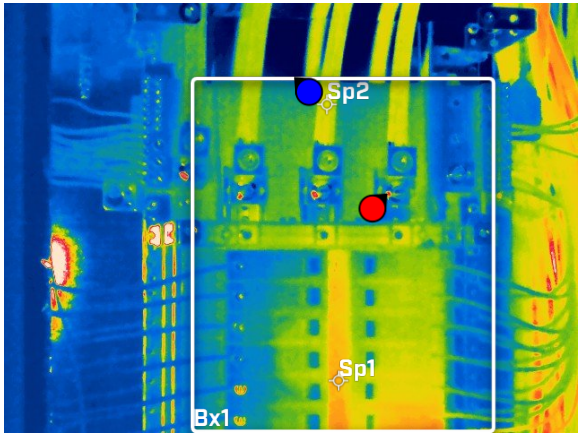
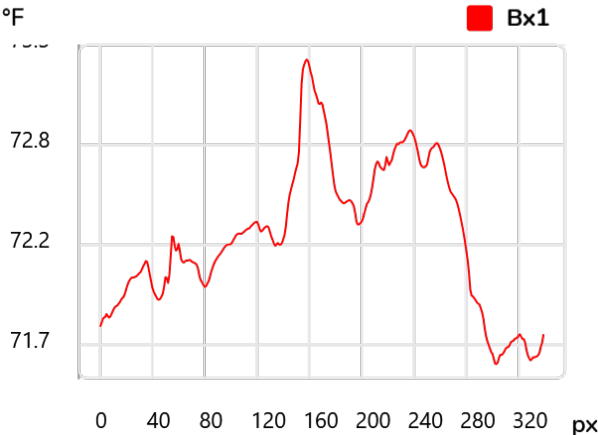
Thermogram 35 Created: 5/14/2026 2:43:02 PM

Equipment name : Production 204  
Device name : 1012  
Measurement Point : LZ-4A  
Status OK

Issue No Issue - Normal operation  
Recommended Action No action recommended at this time  
Comment No additional comments.  
Priority None

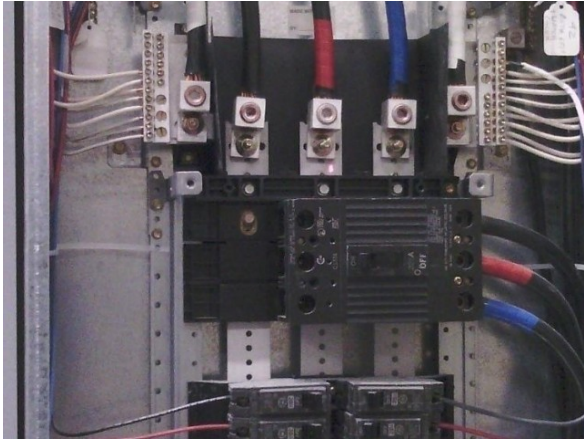
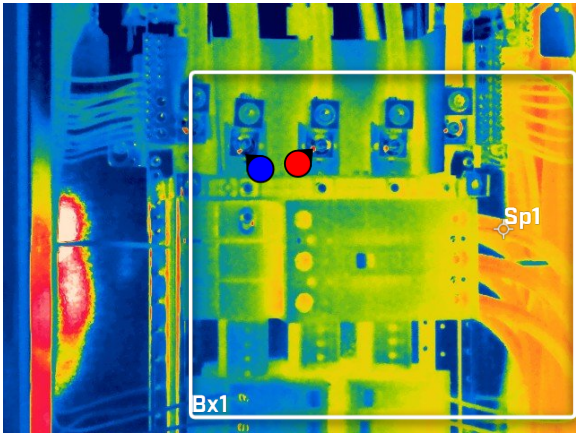
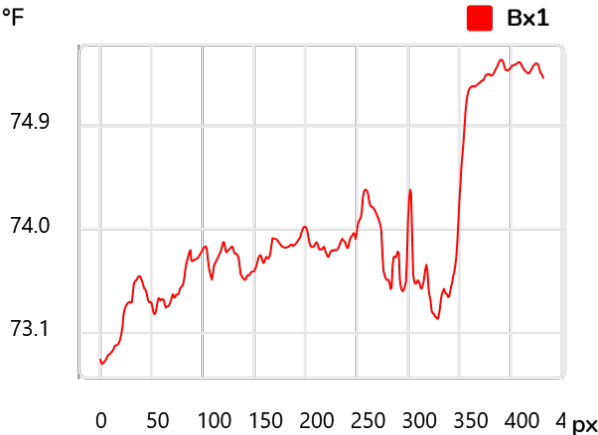
Thermogram 36 Created: 5/14/2026 2:54:40 PM

Equipment name : Production 204  
Device name : 1013  
Measurement Point : LZ-4B  
Status OK

Issue No Issue - Normal operation  
Recommended Action No action recommended at this time  
Comment No additional comments.  
Priority None
