# THERMAL ELECTRICAL INSPECTION

## SAMPLE REPORT

RETROFIT  
ELECTRIC

# Retrofit Electric - Thermal Electrical Inspection

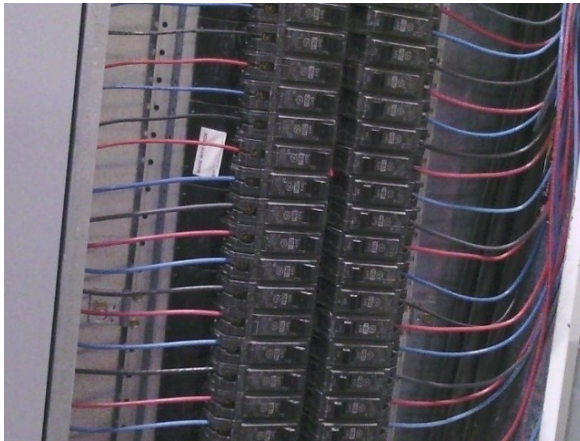
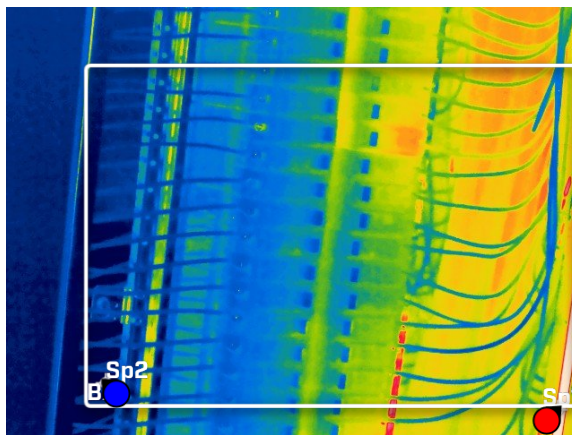
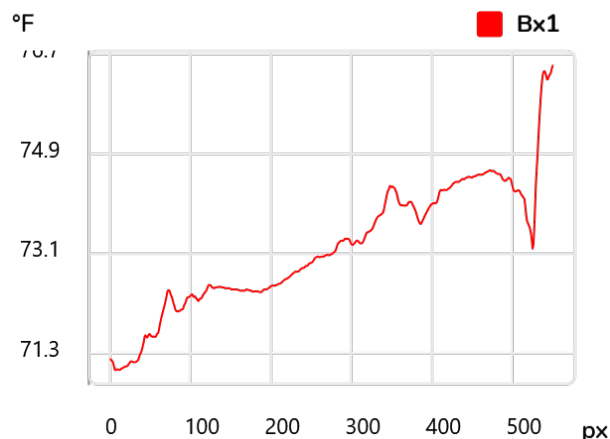
Thermogram 37 Created: 5/14/2026 2:57:02 PM

Equipment name : Production 204  
Device name : 1013  
Measurement Point : LZ-4B  
Status OK

**Issue** No Issue - Normal operation

**Recommended Action** No action recommended at this time

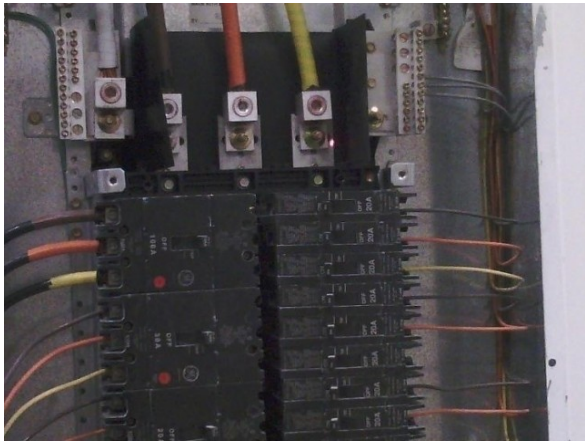
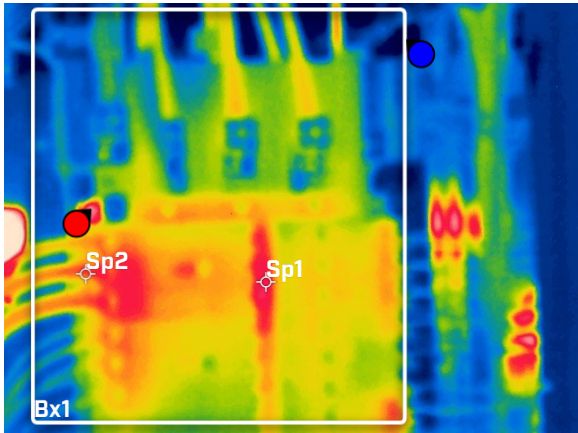
Thermogram 38 Created: 5/14/2026 3:14:16 PM

Equipment name : Production 204  
Device name : 1014  
Measurement Point : HZ-4  
Status Note

**Issue** Loose connection(s)  
**Recommended Action** Inspect connections  
**Comment** Check connection on left side. Possibly dirty or loose.  
**Priority** 2-Intermediate/Investigate

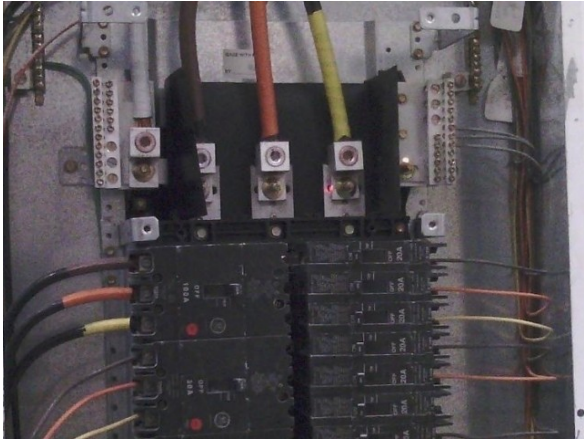
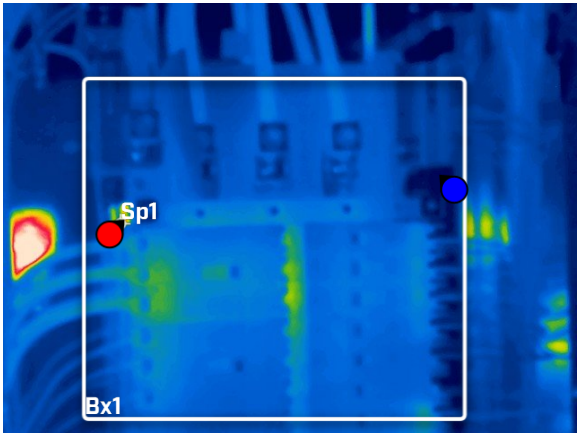
Thermogram 39 Created: 5/14/2026 3:14:56 PM

Equipment name : Production 204  
Device name : 1014  
Measurement Point : HZ-4  
Status Note

Issue Loose connection(s)  
Recommended Action Inspect connections  
Comment Check connection on left side. Possibly dirty or loose.  
Priority 2-Intermediate/Investigate

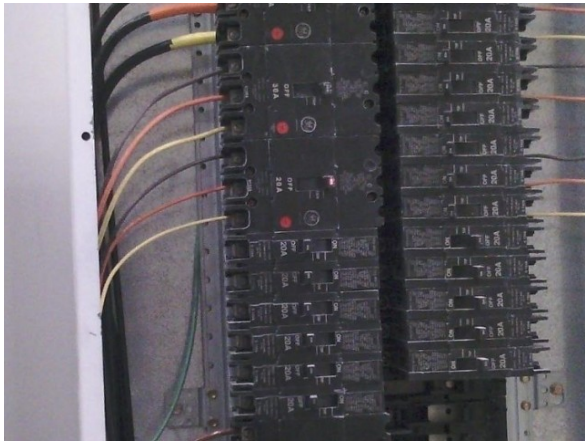
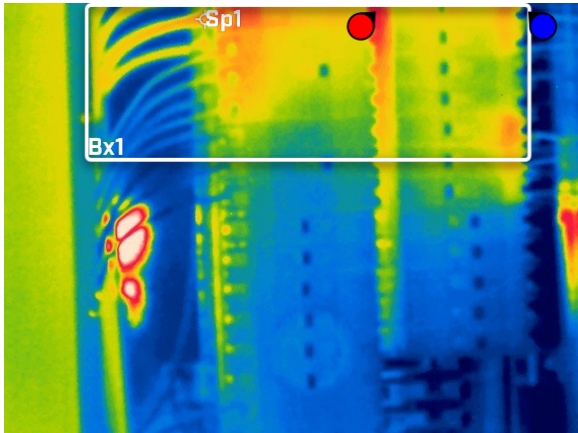
Thermogram 40 Created: 5/14/2026 3:15:28 PM

Equipment name : Production 204  
Device name : 1014  
Measurement Point : HZ-4  
Status Note

Issue Loose connection(s)  
Recommended Action Inspect connections  
Comment Check connection on left side. Possibly dirty or loose.  
Priority 2-Intermediate/Investigate

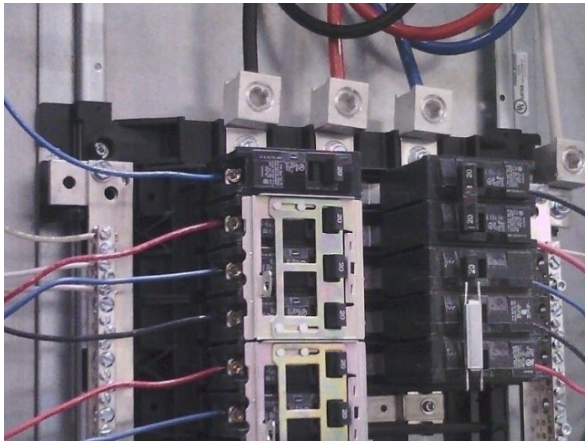
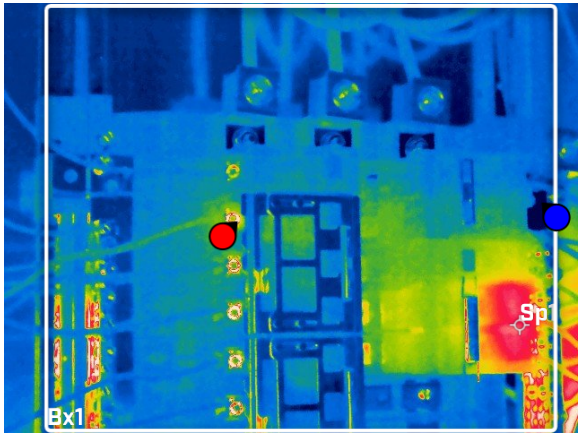
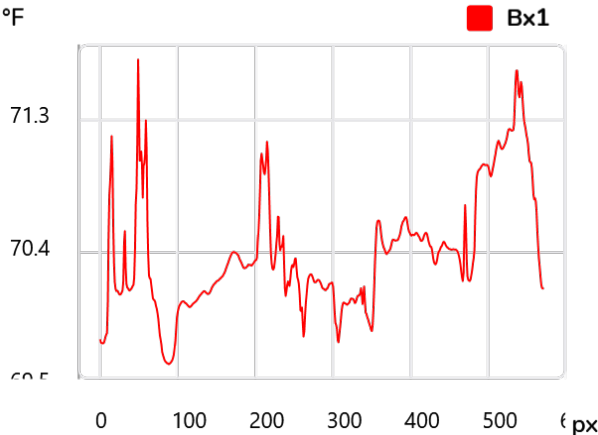
Thermogram 41 Created: 5/14/2026 3:28:19 PM

Equipment name : Production 204  
Device name : 1014  
Measurement Point : HZ-4  
Status Note

Issue Loose connection(s)  
Recommended Action Inspect connections  
Comment Check connection on left side. Possibly dirty or loose.  
Priority 2-Intermediate/Investigate

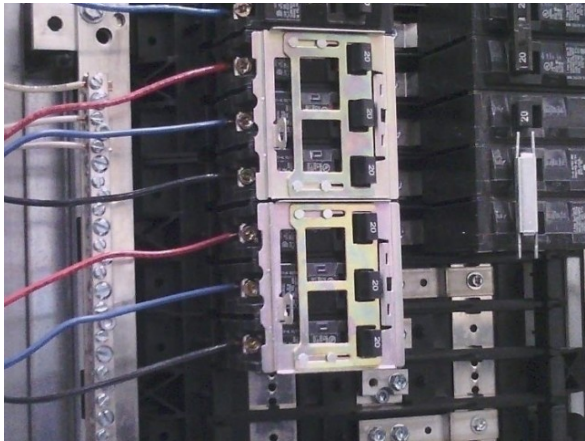
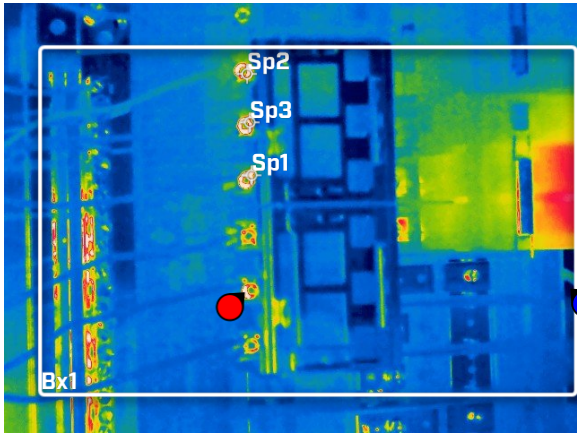
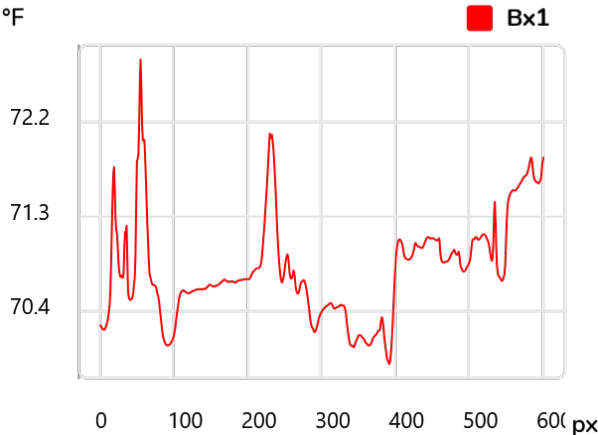
Thermogram 42 Created: 5/14/2026 3:29:25 PM

Equipment name : Production 204  
Device name : 1015  
Measurement Point : LZ-4C  
Status Note

Issue Loose connection(s)  
Recommended Action Inspect connections  
Comment Check connections on left side  
Priority 2-Intermediate/Investigate

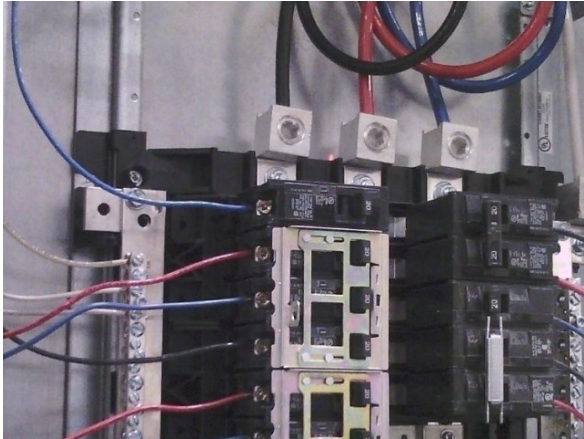
Equipment name : Production 204  
Device name : 1015  
Measurement Point : LZ-4C  
Status Note

Issue Loose connection(s)  
Recommended Action Inspect connections  
Comment Check connections on left side  
Priority 2-Intermediate/Investigate

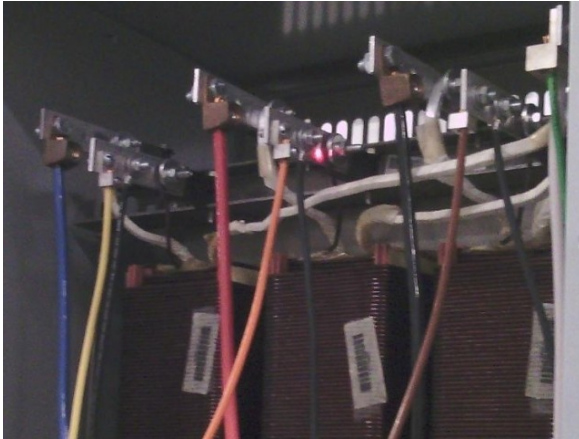
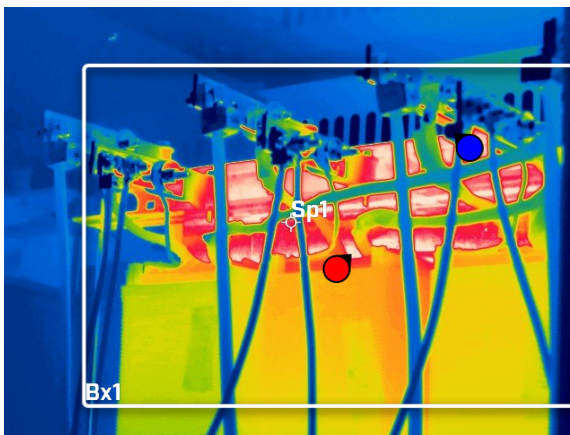
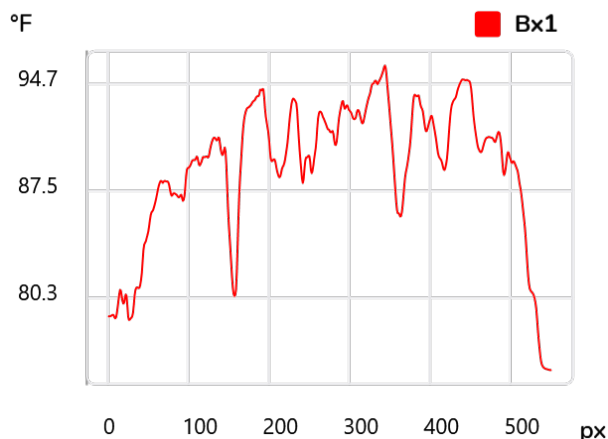
Equipment name : Production 204  
Device name : 1016  
Measurement Point : Transformer North #1  
Status OK

**Issue** No Issue - Normal operation  
**Recommended Action** No action recommended at this time  
**Comment** No additional comments.  
**Priority** None

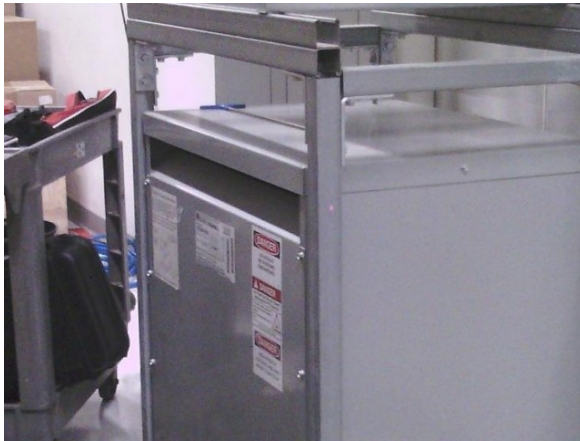
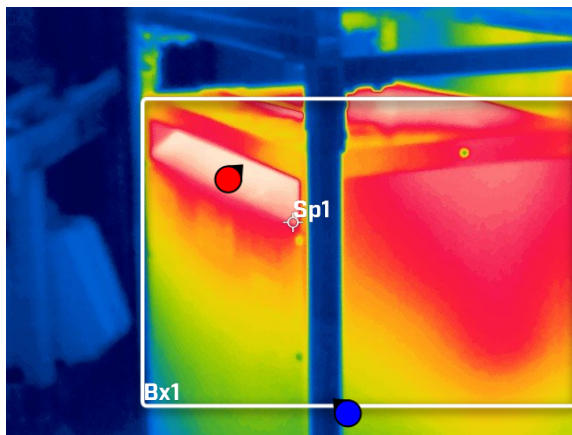
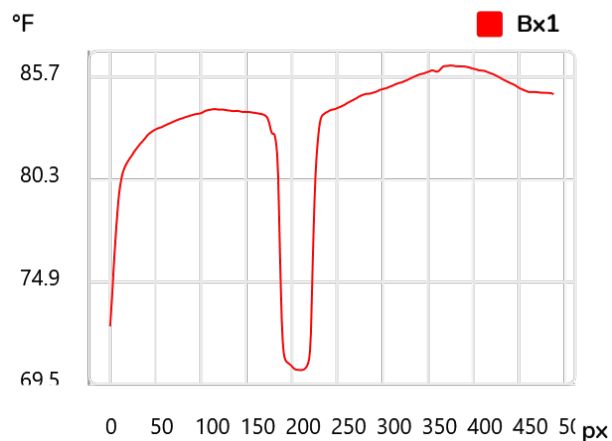
Equipment name : Production 204  
Device name : 1017  
Measurement Point : Transformer North #2  
Status OK

Issue No Issue - Normal operation

Recommended Action No action recommended at this time

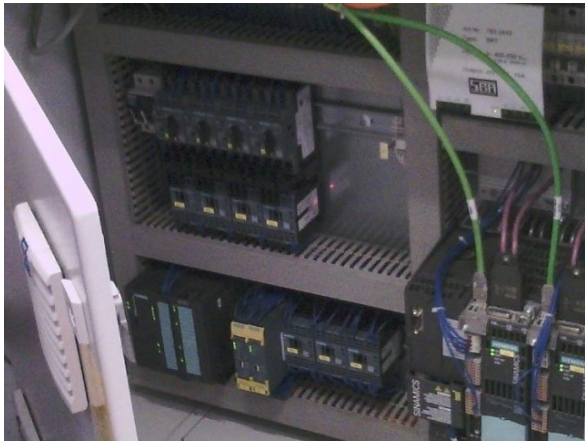
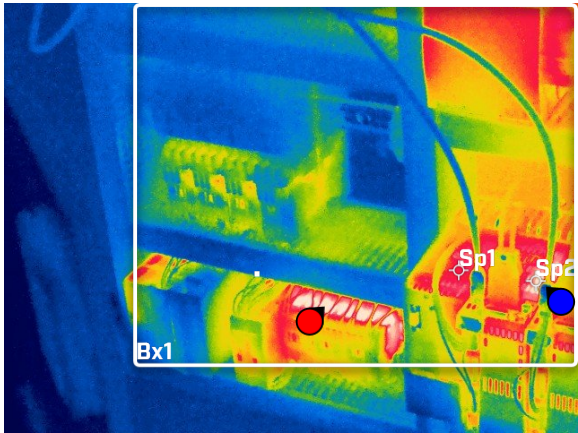
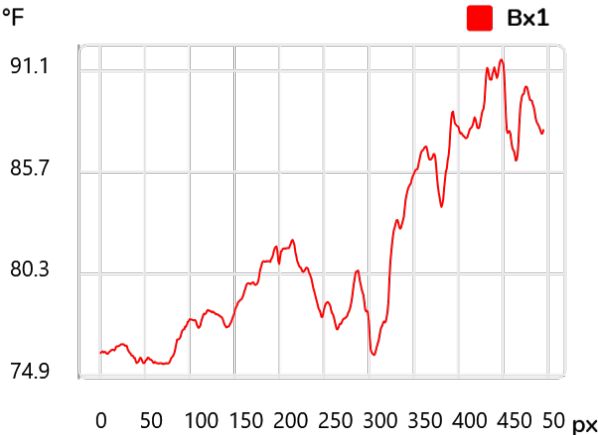
Equipment name : Styli Lab 201  
Device name : 1019  
Measurement Point : SilverCut Saw  
Status Note

Issue Loose connection(s)  
Recommended Action Inspect connections  
Comment Check connection on hot spot.  
Priority 2-Intermediate/Investigate

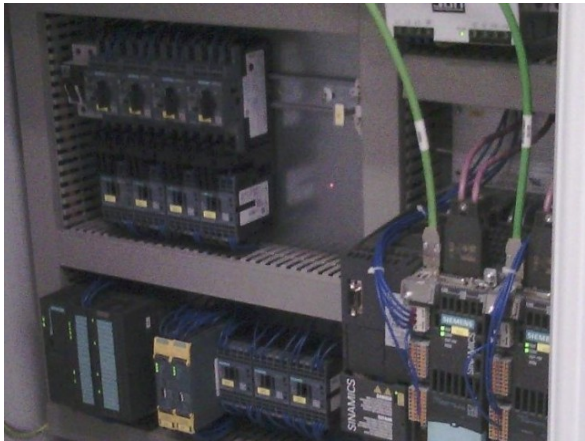
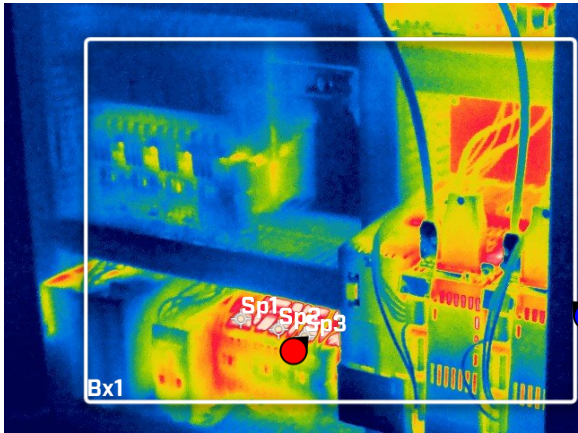
Equipment name : Styli Lab 201  
Device name : 1019  
Measurement Point : SilverCut Saw  
Status Note

Issue Loose connection(s)  
Recommended Action Inspect connections  
Comment Check connection on hot spot.  
Priority 2-Intermediate/Investigate

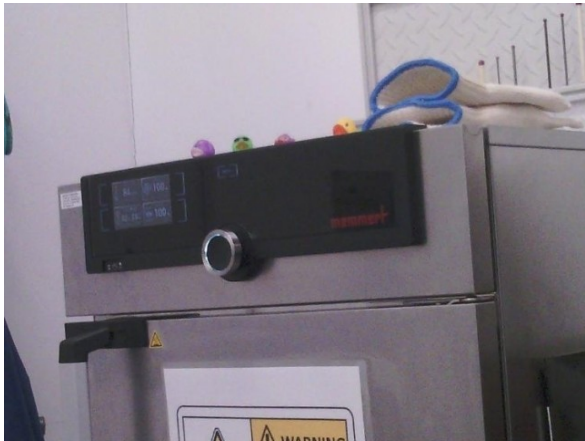
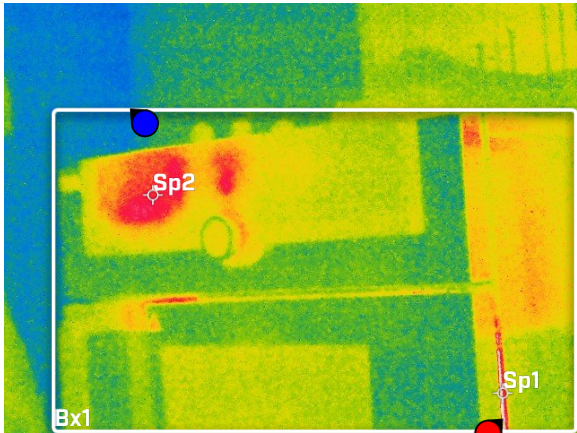
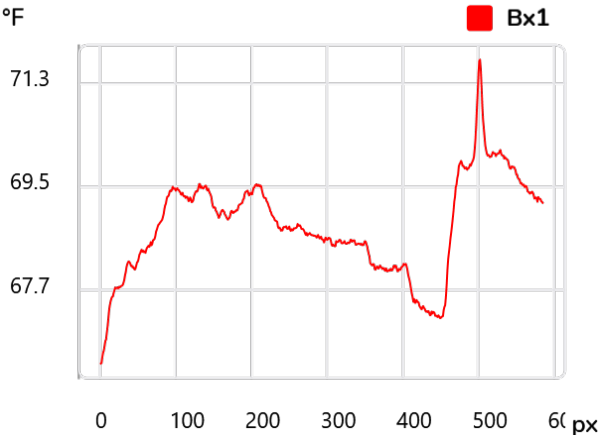
Equipment name : Styli Lab 201  
Device name : 1020  
Measurement Point : Memmert Curing Oven #1  
Status OK

**Issue** No Issue - Normal operation  
**Recommended Action** No action recommended at this time  
**Comment** No additional comments.  
**Priority** None

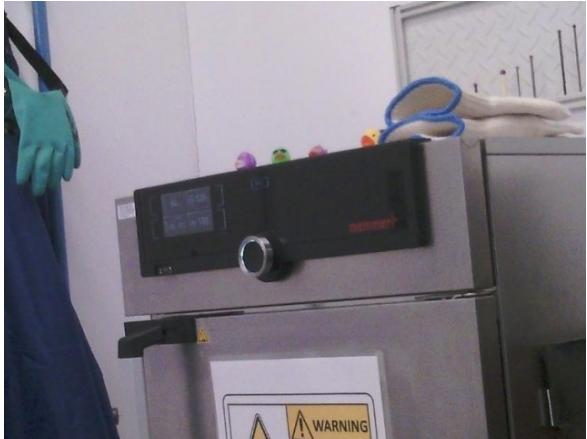
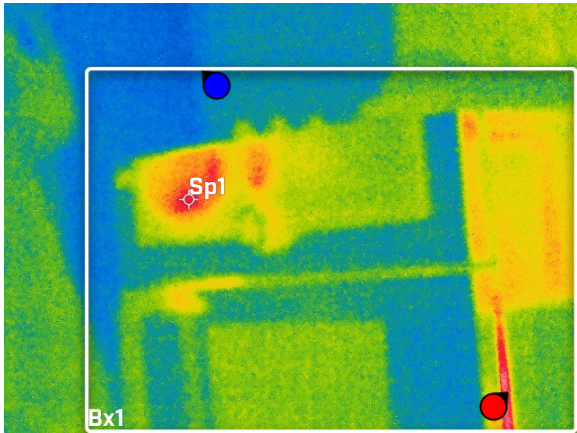
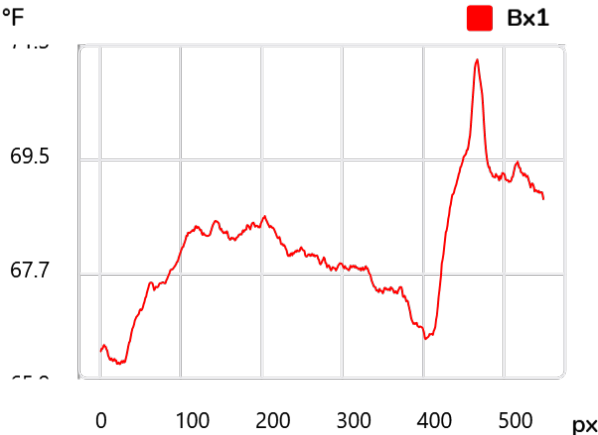
Equipment name : Styli Lab 201  
Device name : 1020  
Measurement Point : Memmert Curing  
Oven #1  
Status OK

Issue No Issue - Normal operation  
Recommended Action No action recommended at this time  
Comment No additional comments.  
Priority None

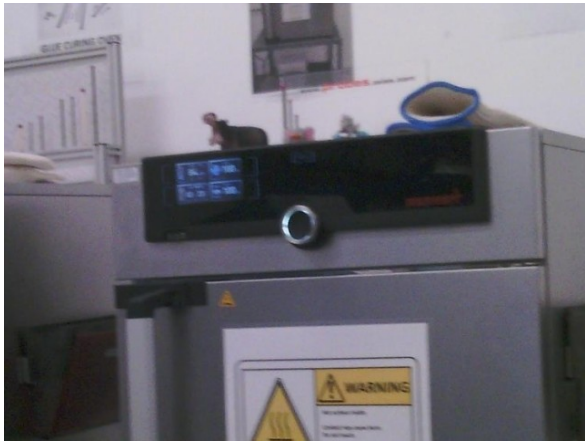
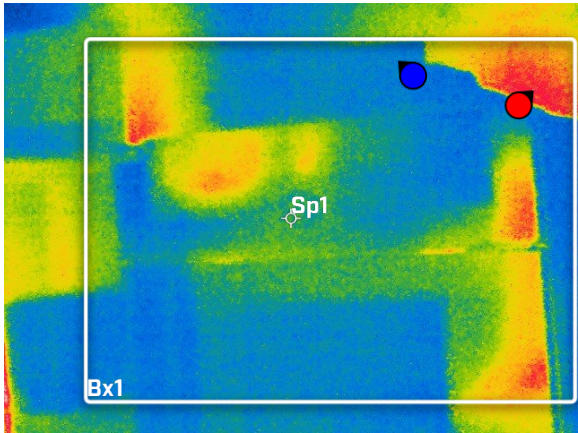
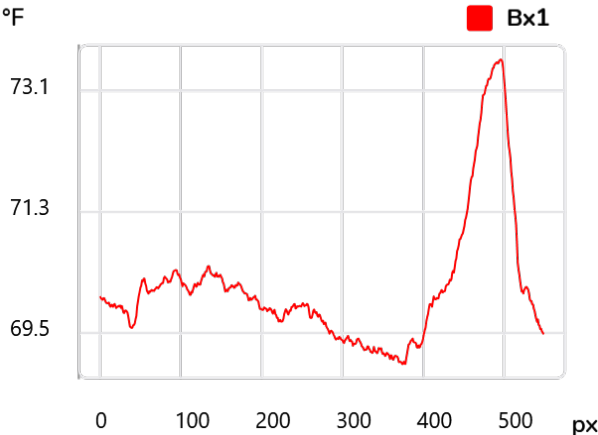
Equipment name : Styli Lab 201  
Device name : 1020  
Measurement Point : Memmert Curing  
Oven #1  
Status OK

**Issue** No Issue - Normal operation  
**Recommended Action** No action recommended at this time  
**Comment** No additional comments.  
**Priority** None

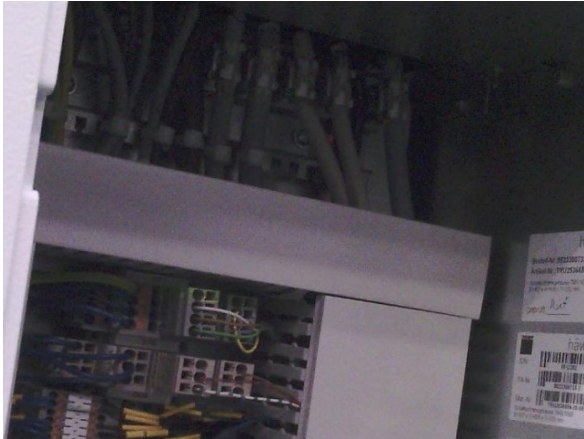
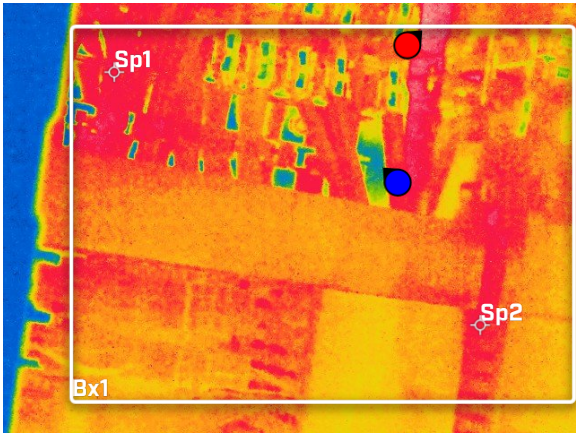
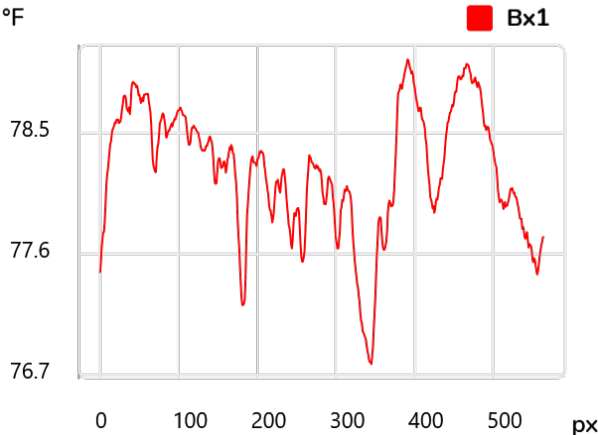
Equipment name : Styli Lab 201  
Device name : 1022  
Measurement Point : Trumark 5000 Laser  
Status OK

Issue No Issue - Normal operation  
Recommended Action No action recommended at this time  
Comment No additional comments.  
Priority None

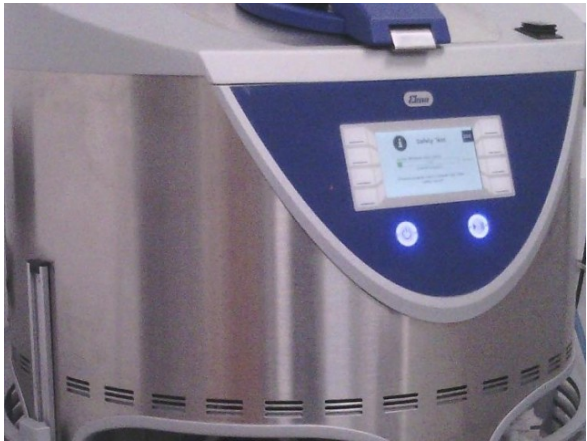
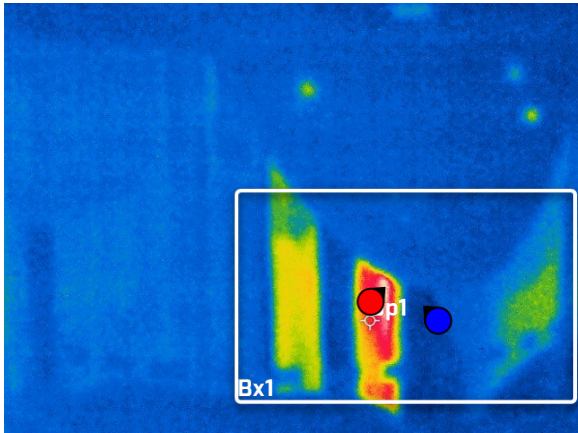
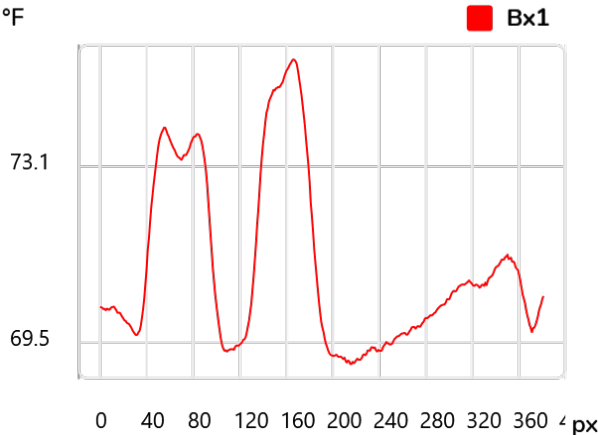
Equipment name : Styli Lab 201  
Device name : 1023  
Measurement Point : Elma Ultrasonic Washer  
Status OK

Issue No Issue - Normal operation  
Recommended Action No action recommended at this time  
Comment No additional comments.  
Priority None

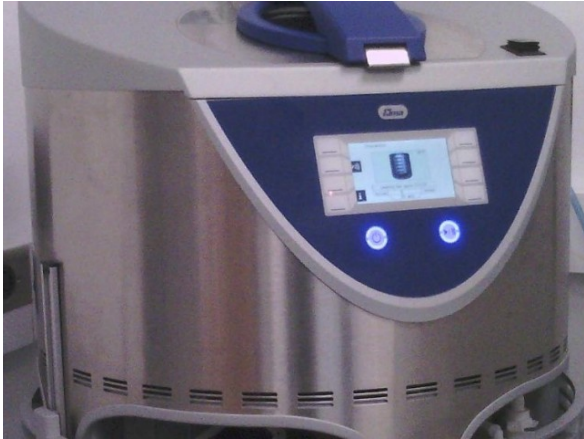
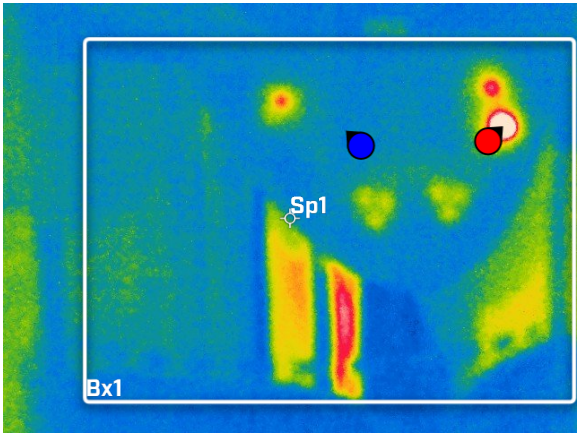
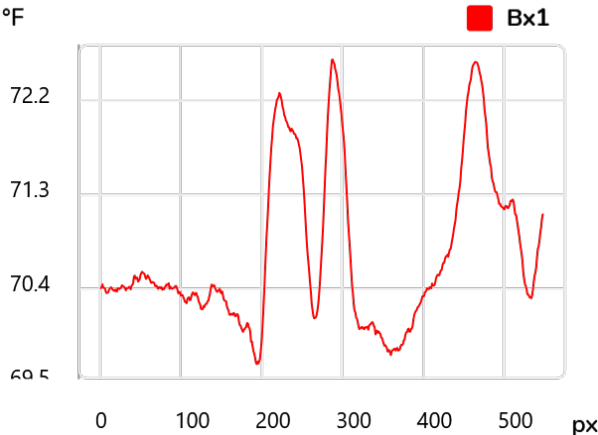
Equipment name : Styli Lab 201

Issue No Issue - Normal operation

Recommended Action No action recommended at this time

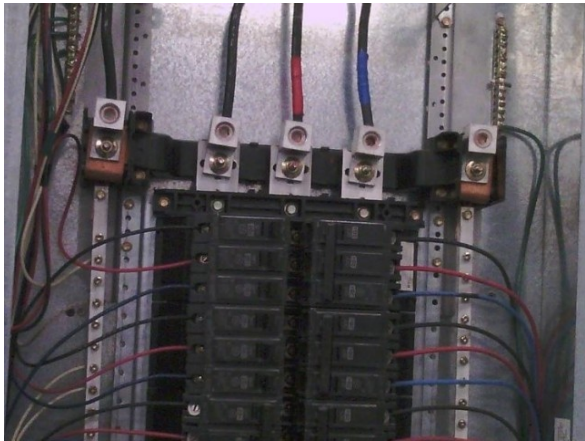
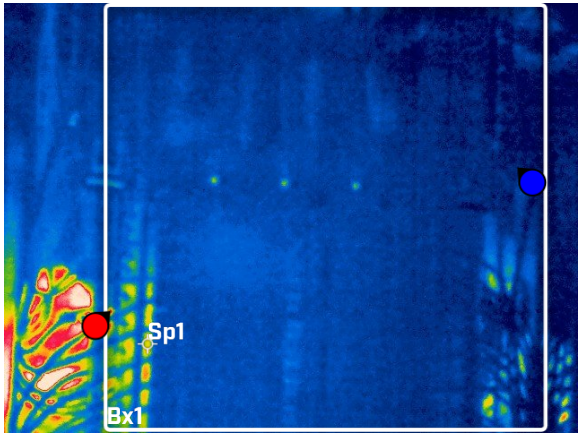
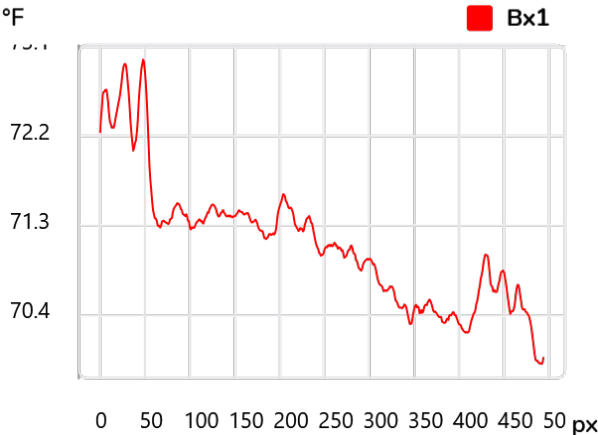
Equipment name : Styli Lab 201  
Device name : 1024  
Measurement Point : LP-4a  
Status OK

**Issue** No Issue - Normal operation  
**Recommended Action** No action recommended at this time  
**Comment** No additional comments.  
**Priority** None

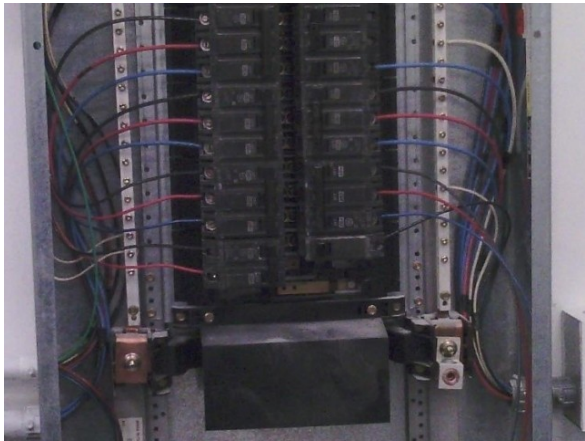
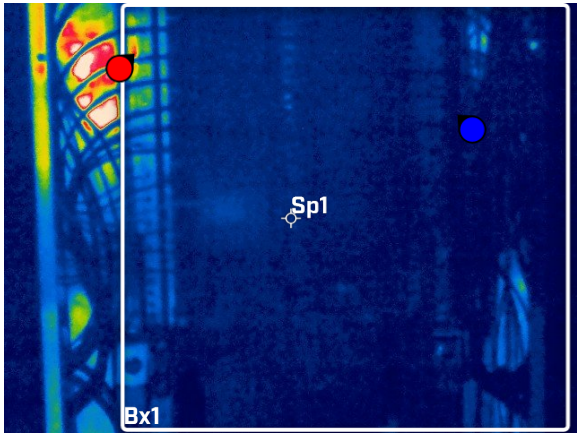
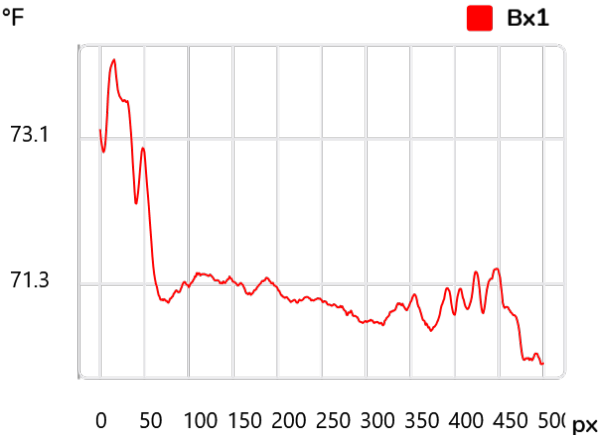
Thermogram 59 Created: 5/15/2026 12:26:42 PM

Equipment name : Styli Lab 201  
Device name : 1024  
Measurement Point : LP-4a  
Status OK

**Issue** No Issue - Normal operation  
**Recommended Action** No action recommended at this time  
**Comment** No additional comments.  
**Priority** None

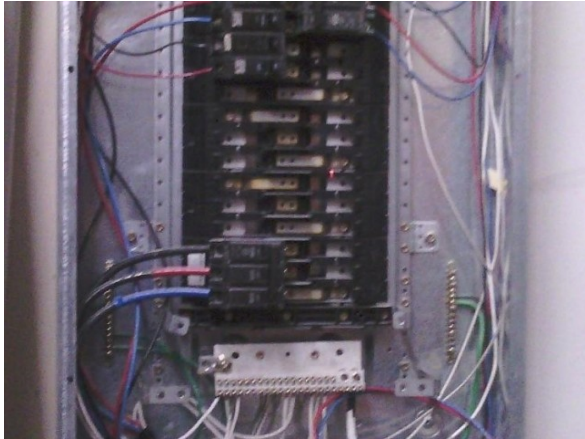
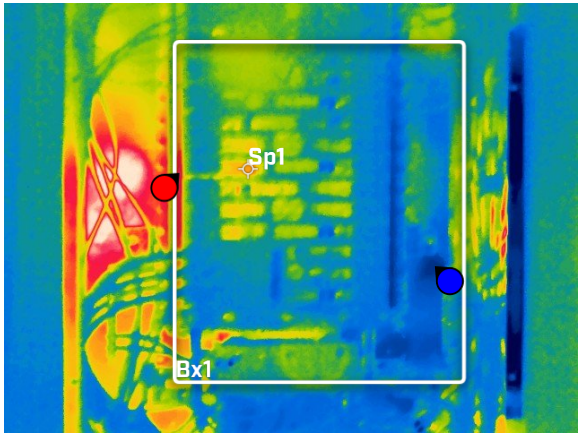
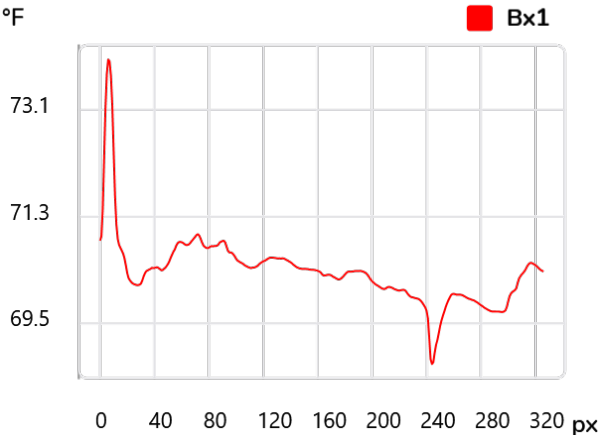
Thermogram 60 Created: 5/15/2026 10:00:50 AM

Equipment name : Mechanical Room 203

Recommended Action No action recommended at this time

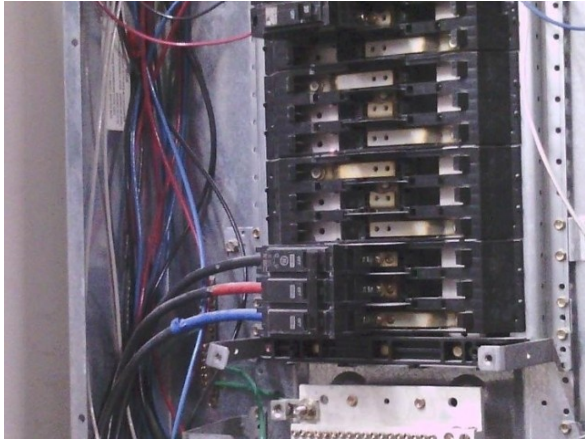
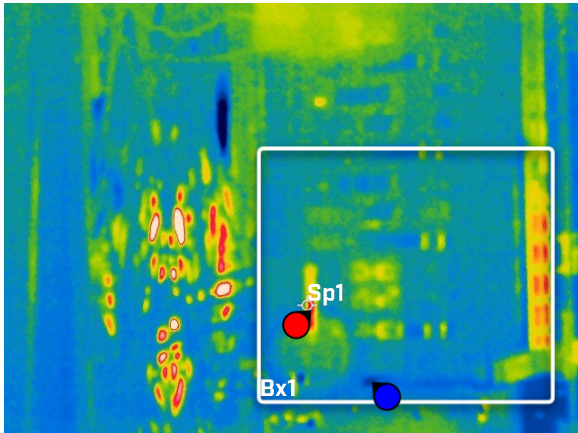
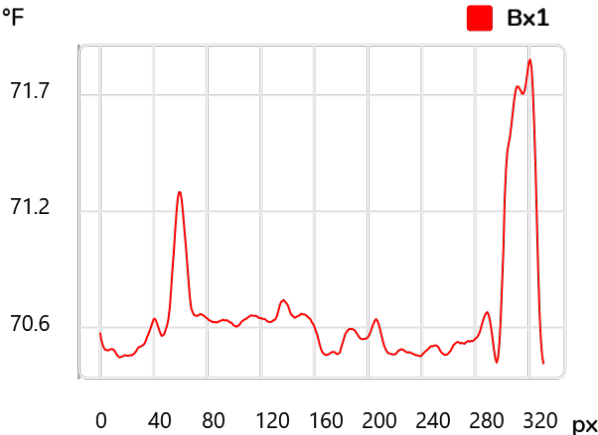
Thermogram 61 Created: 5/15/2026 10:01:23 AM

Equipment name : Mechanical Room 203

Recommended Action No action recommended at this time

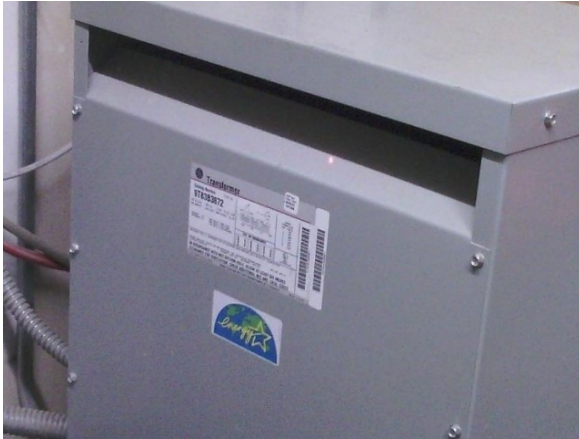
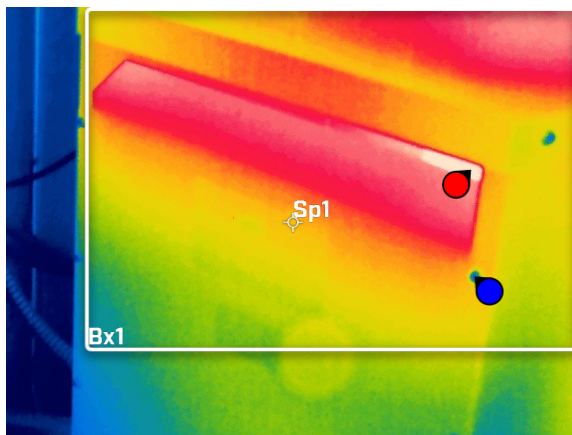
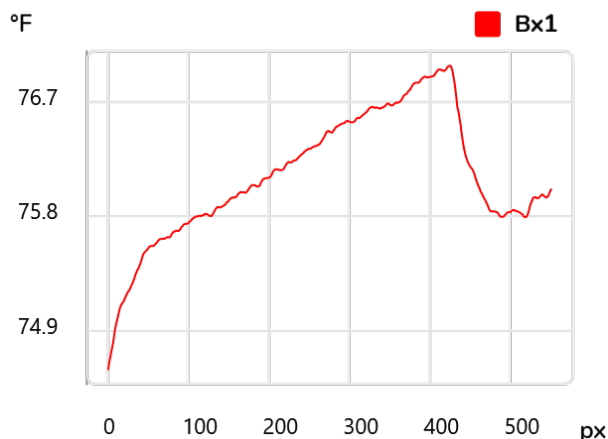
Thermogram 62 Created: 5/15/2026 10:04:17 AM

Equipment name : Mechanical Room 203

Issue No Issue - Normal operation

Recommended Action No action recommended at this time

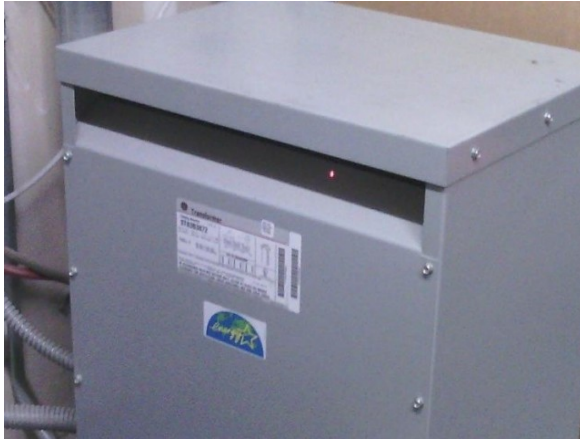
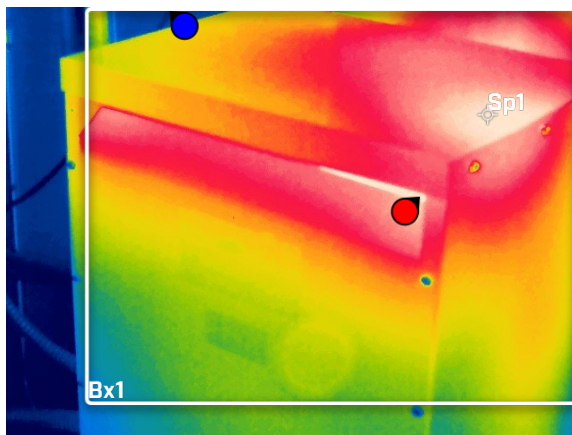
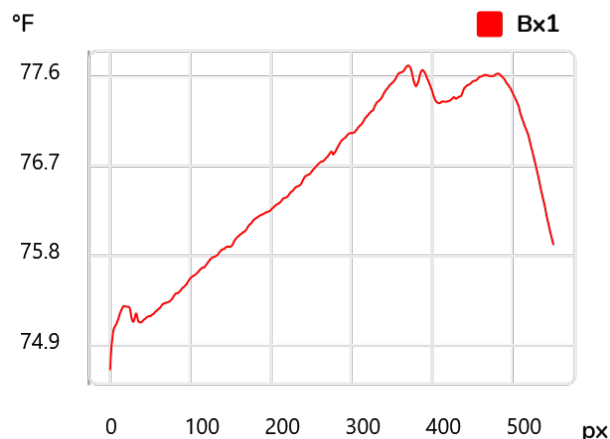
Thermogram 63 Created: 5/15/2026 10:12:18 AM

Equipment name : Mechanical Room 203

Issue No Issue - Normal operation

Recommended Action No action recommended at this time

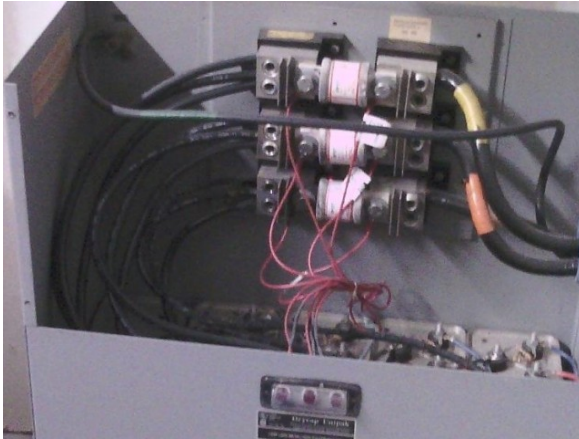
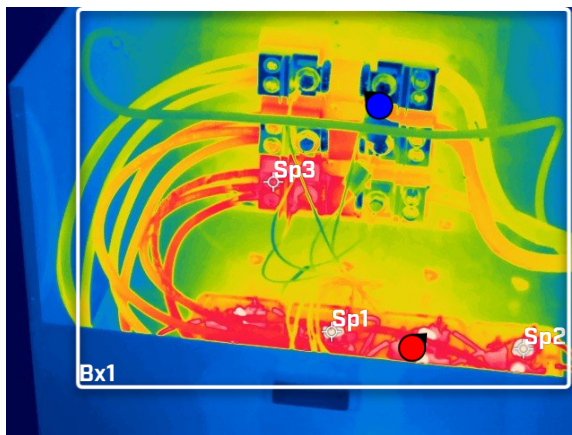
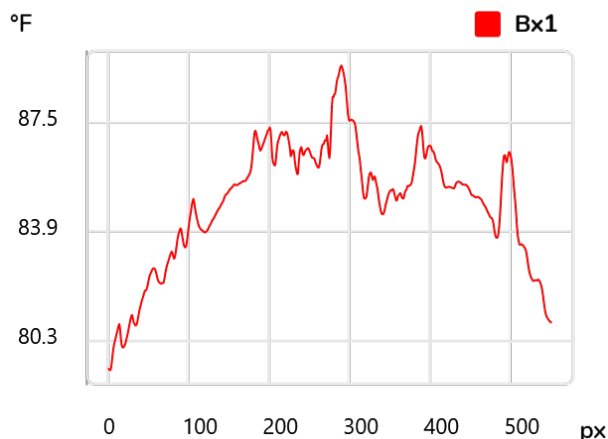
## Thermogram 64

Equipment name : Mechanical Room 203

Issue Loose connection(s)

Comment Inspect connections of lower phase. Could be loose connections or load imbalance.

Recommended Action Inspect connections

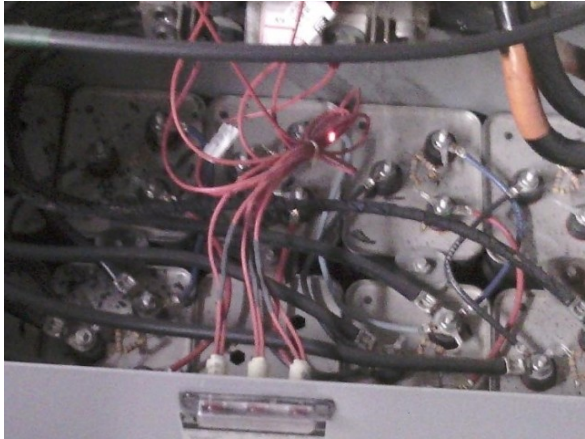
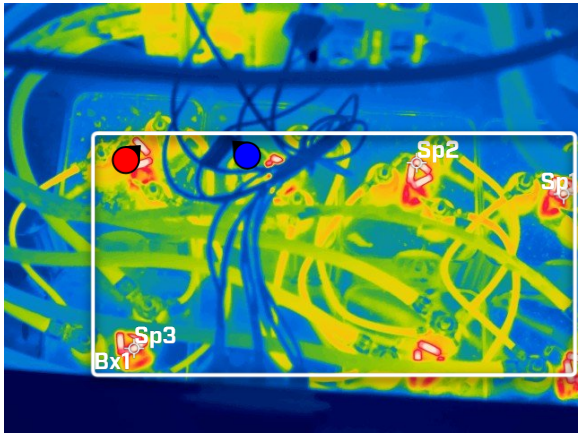
Thermogram 65 Created: 5/15/2026 10:32:40 AM

Equipment name : Mechanical Room 203  
Device name : 1027  
Measurement Point : #2 Transformer

| Value | |
|---|---|
| Sp3 | 189.5 °F |

Issue Loose connection(s)  
Recommended Action Inspect connections  
Comment Inspect connections of lower phase. Could be loose connections or load imbalance.  
Priority 2-Intermediate/Investigate

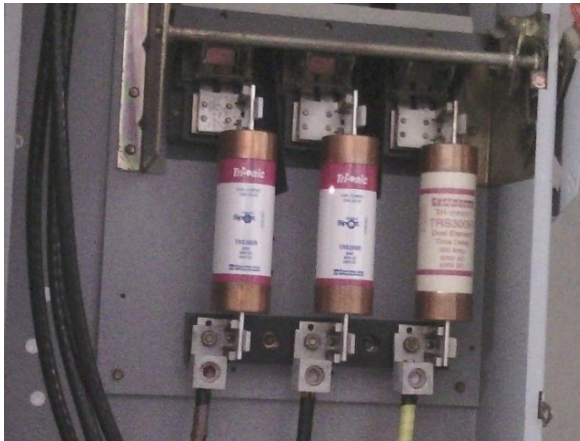
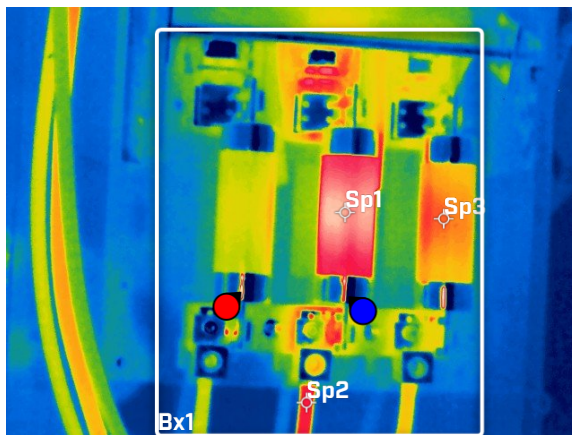
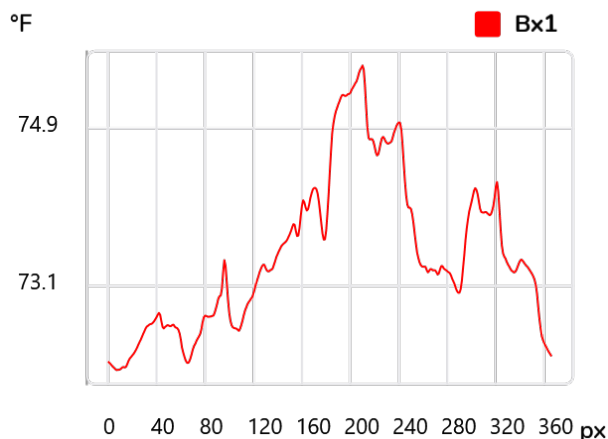
Thermogram 66 Created: 5/15/2026 10:34:52 AM

Equipment name : Mechanical Room 203

Status Note

Recommended Action Monitor changes

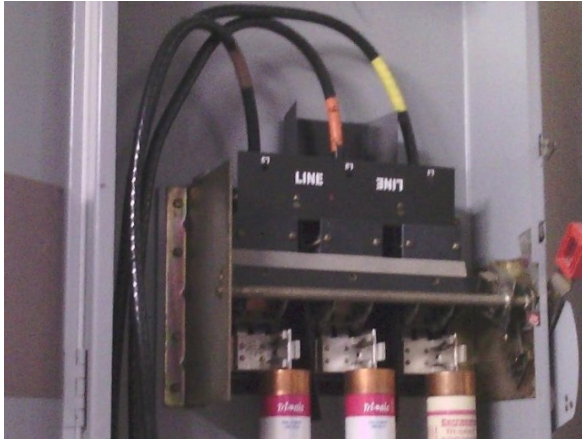
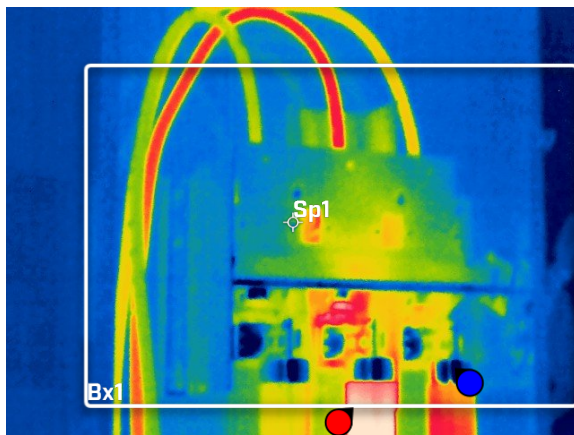
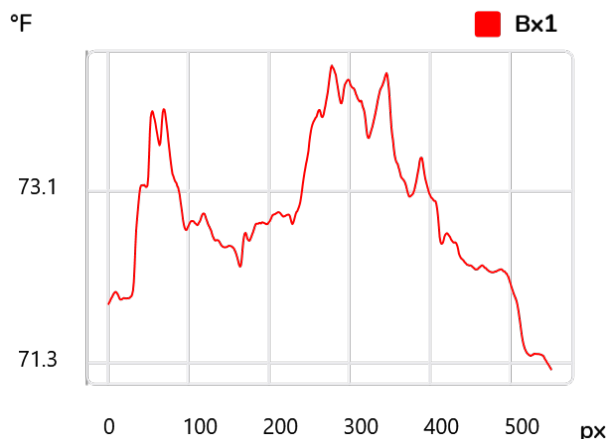
Thermogram 67 Created: 5/15/2026 10:35:51 AM

Equipment name : Mechanical Room 203

Max 79.6 °F  
Min 69.0 °F  
Area 2.777 ft<sup>2</sup>  
Sp1 72.9 °F

Recommended Action Monitor changes

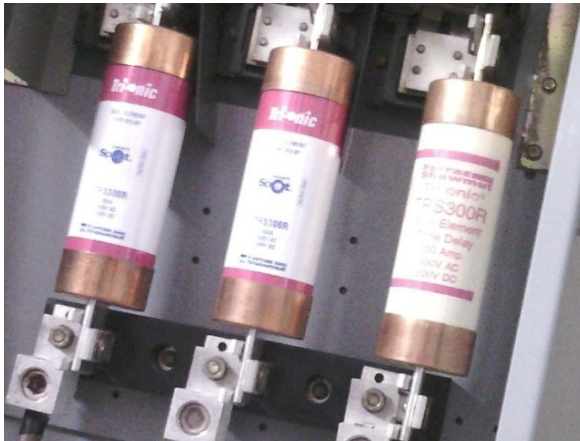
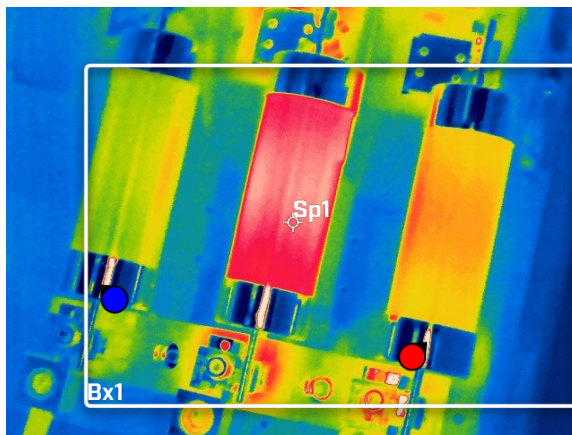
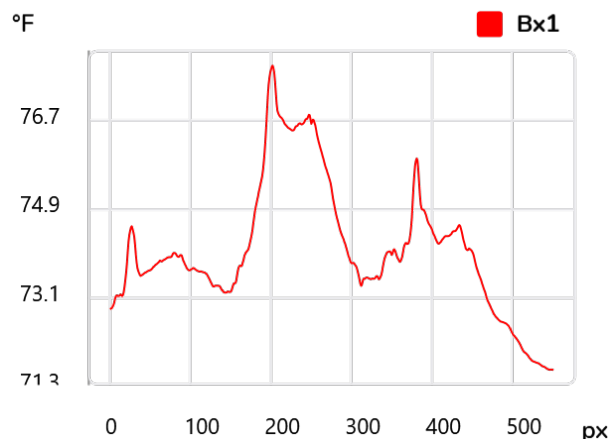
Thermogram 68 Created: 5/15/2026 10:39:25 AM

Equipment name : Mechanical Room 203

| <b>Sp1</b> | 79.2 °F |

Recommended Action Monitor changes

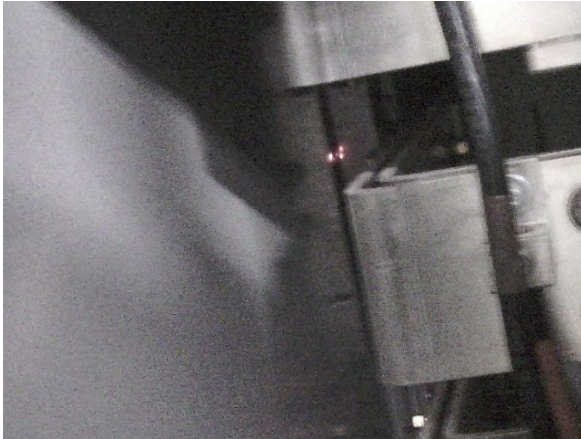
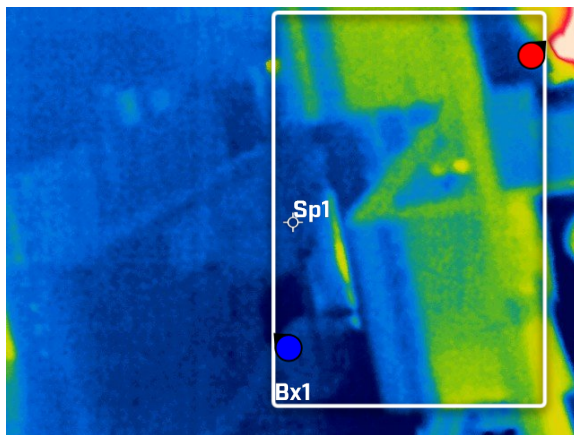
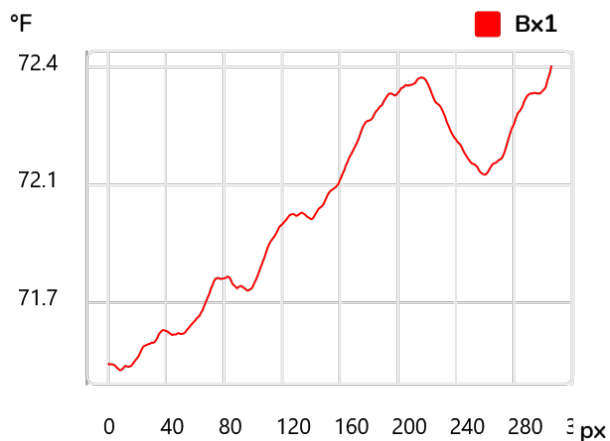
Thermogram 69 Created: 5/15/2026 11:58:45 AM

Equipment name : Mechanical Room 203

Recommended Action No action recommended at this time

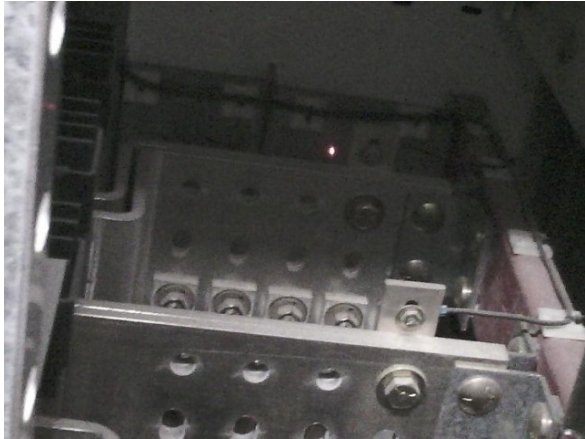
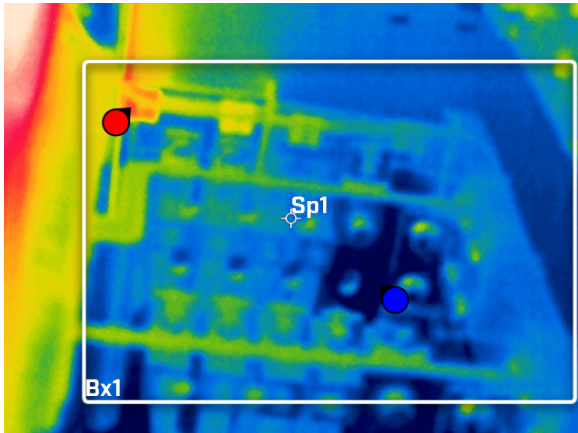
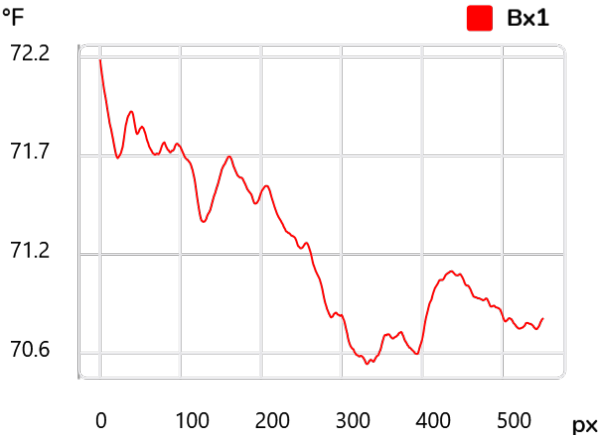
Thermogram 70 Created: 5/15/2026 12:02:26 PM

Equipment name : Mechanical Room 203

Issue No Issue - Normal operation

Recommended Action No action recommended at this time
