# THERMAL ELECTRICAL INSPECTION

## SAMPLE REPORT

RETROFIT  
ELECTRIC

# Retrofit Electric - Thermal Electrical Inspection

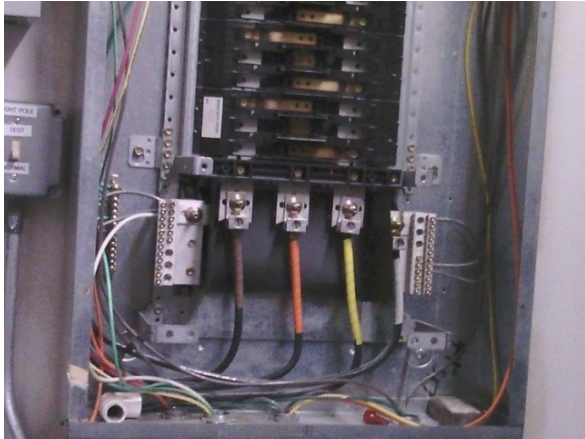
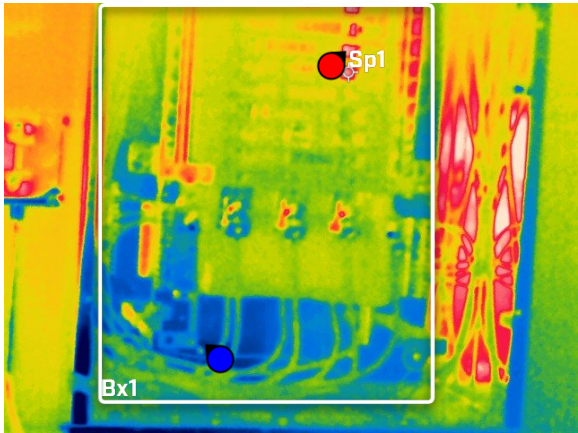
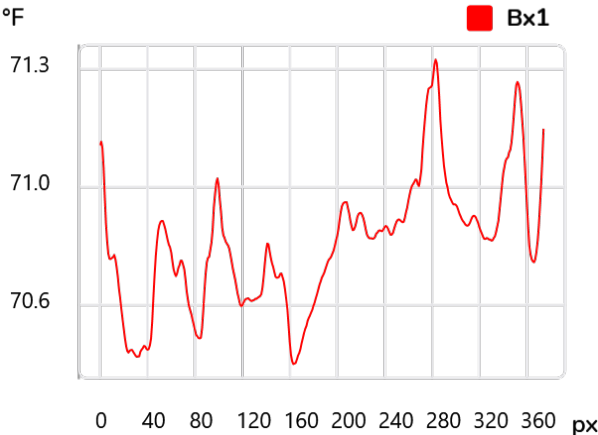
Thermogram 71 Created: 5/15/2026 12:08:15 PM

Equipment name : Mechanical Room 203

Issue No Issue - Normal operation

Recommended Action No action recommended at this time

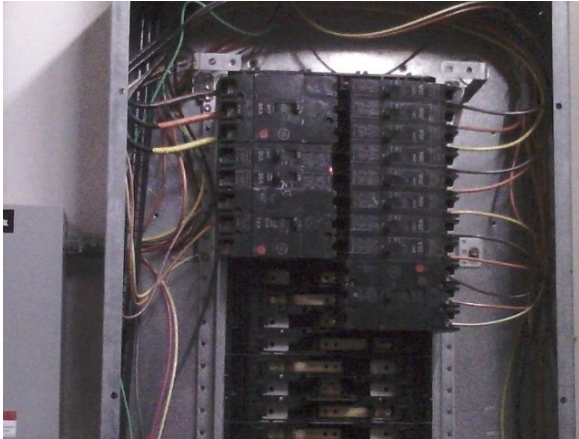
Equipment name : Mechanical Room 203

**Recommended Action** No action recommended at this time

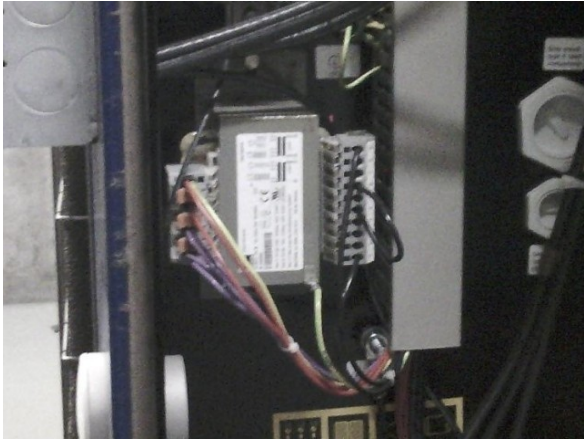
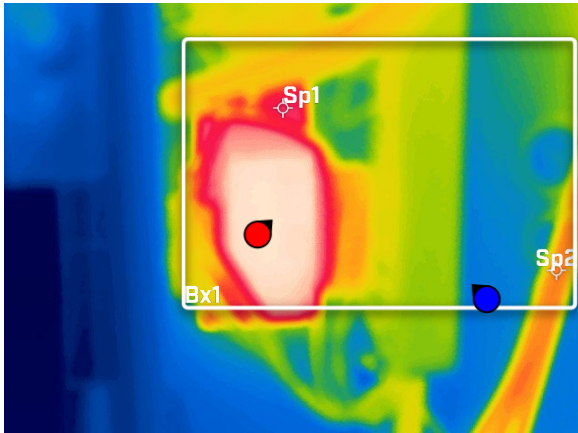
Thermogram 73 Created: 5/19/2026 11:51:52 AM

Equipment name : Compressor #1  
Device name : Compressor room  
Measurement Point : Compressor #1  
Status Note

| <b>Sp2</b> | 95.7 °F |

**Issue** Loose connection(s)  
**Recommended Action** Inspect connections  
**Comment** Verify connections  
**Priority** 2-Intermediate/Investigate

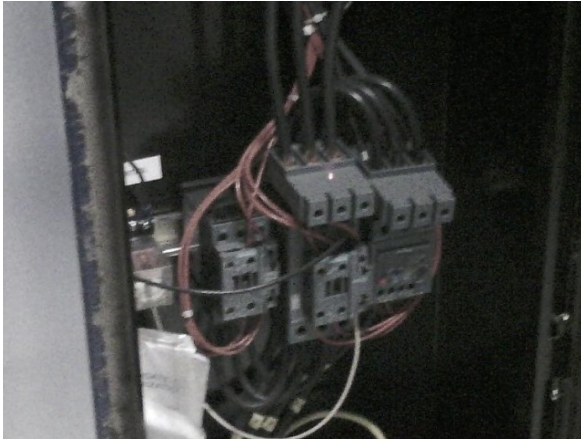
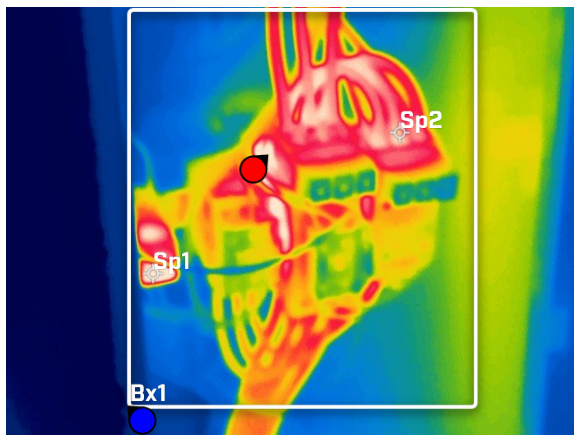
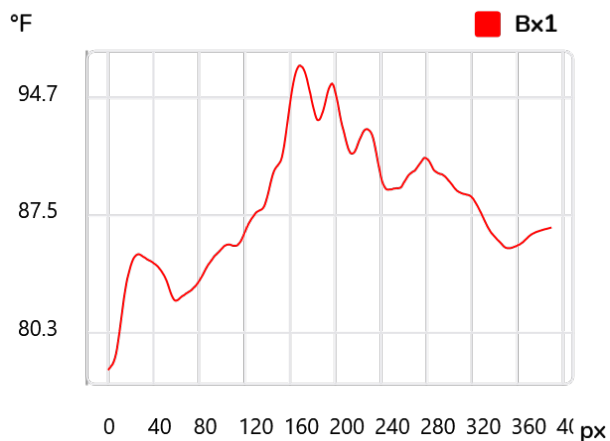
Thermogram 74 Created: 5/19/2026 11:52:45 AM

Equipment name : Compressor #1  
Device name : Compressor room  
Measurement Point : Compressor #1  
Status Note

Sp2 105.3 °F

Issue Loose connection(s)

Recommended Action Inspect connections

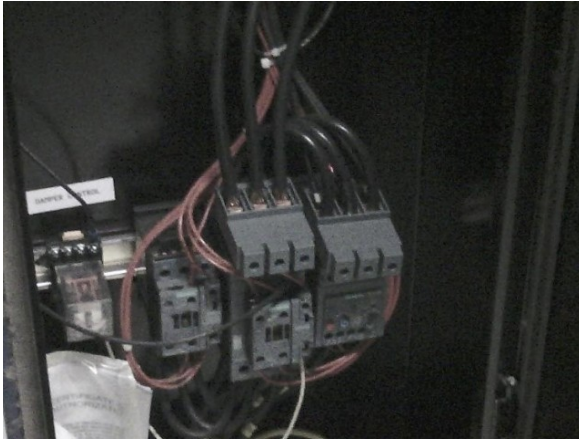
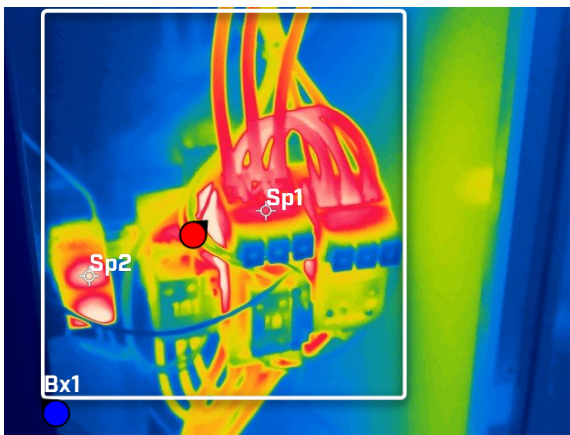
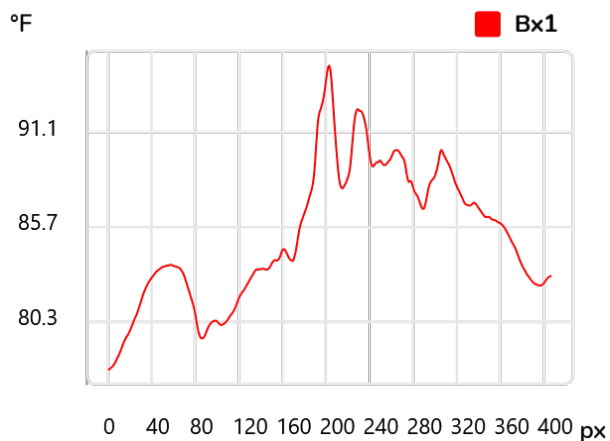
## Thermogram 75

Equipment name : Compressor #1  
Device name : Compressor room  
Measurement Point : Compressor #1  
Status Note

Issue Loose connection(s)

Recommended Action Inspect connections

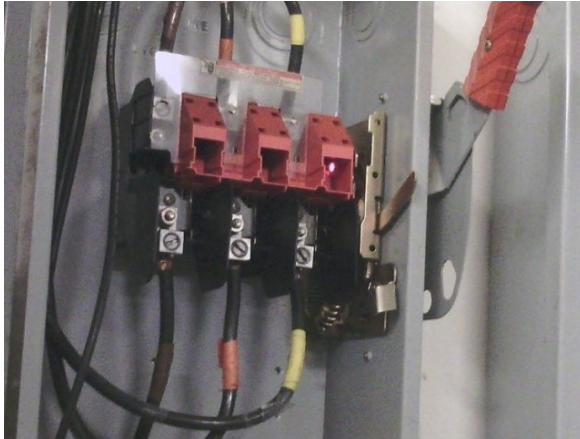
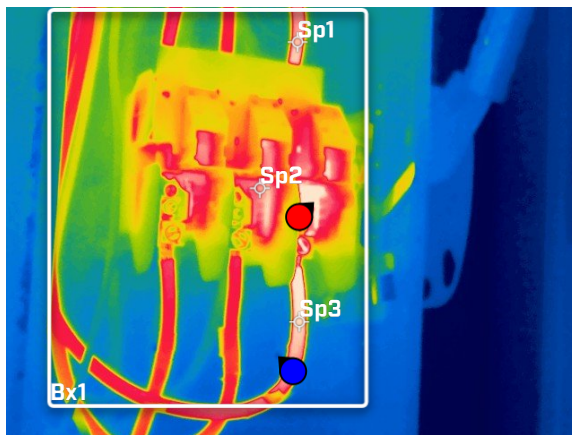
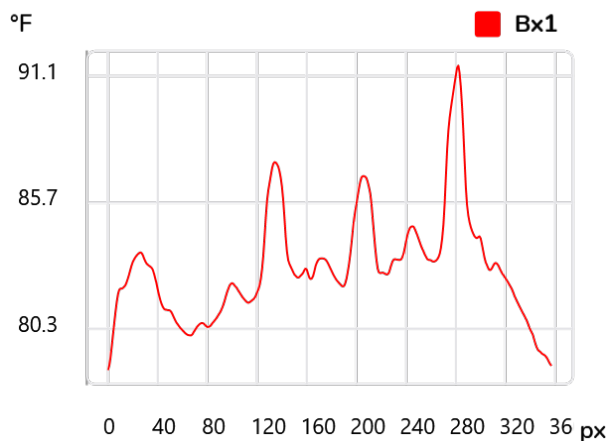
## Thermogram 76

Equipment name : Compressor #1  
Device name : Compressor room  
Measurement Point : Compressor #1  
Status Note

Issue Loose connection(s)  
Recommended Action Inspect connections  
Comment Verify connections  
Priority 2-Intermediate/Investigate

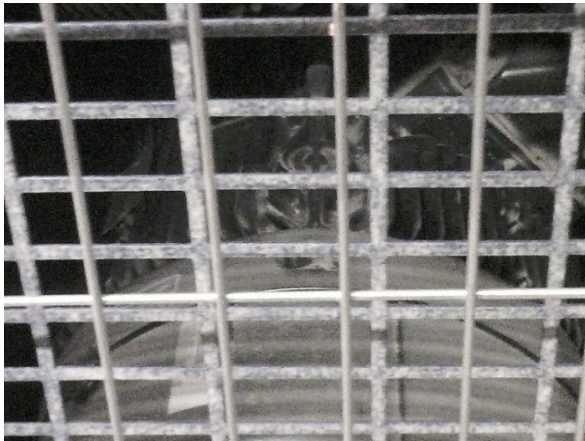
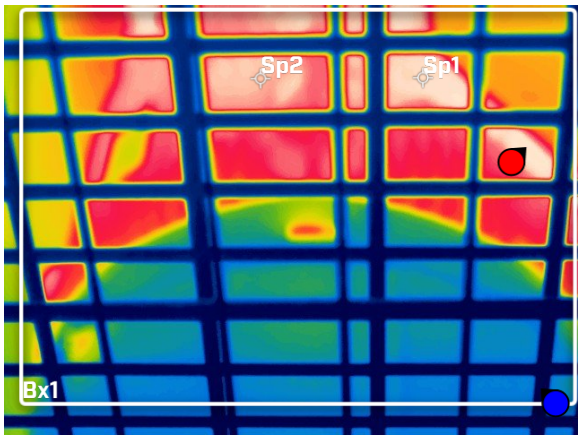
Thermogram 77 Created: 5/20/2026 12:08:01 PM

Equipment name : Compressor #1

| Value | |
|---|---|
| Sp2 | 111.5 °F |

Issue Loose connection(s)

Recommended Action Inspect connections

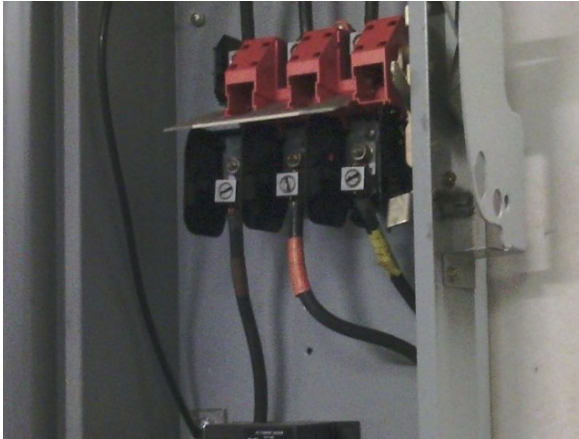
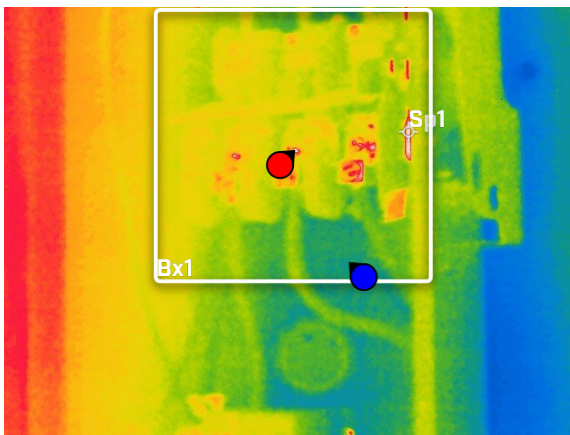
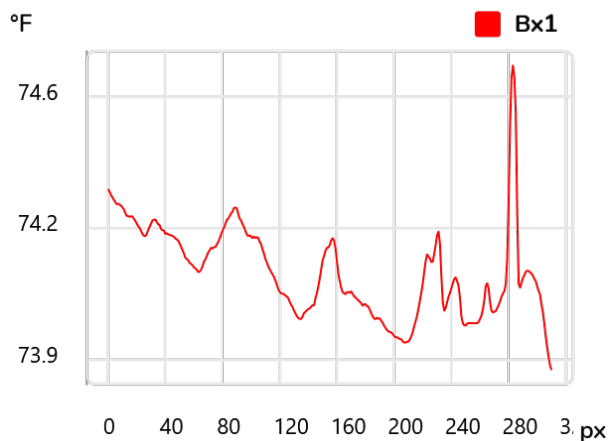
Thermogram 79 Created: 5/19/2026 12:10:47 PM

Equipment name : Compressor #2  
Device name : Compressor room  
Measurement Point : Compressor #2  
Status OK

Max 79.3 °F  
Min 73.4 °F  
Area 0.322 ft²  
Sp1 77.8 °F

Issue No Issue - Normal operation

Recommended Action No action recommended at this time

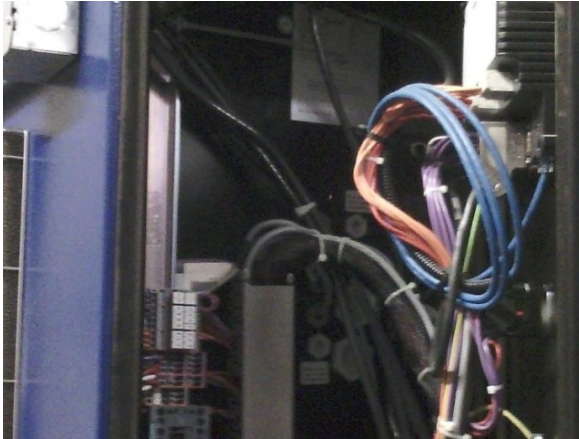
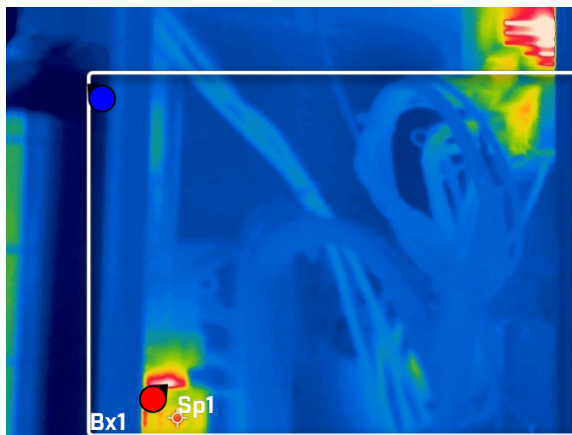
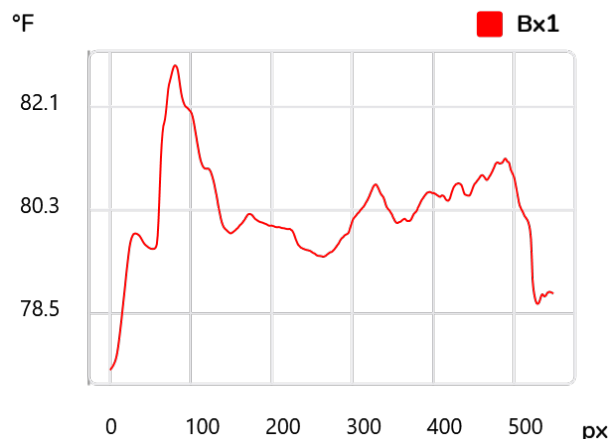
## Thermogram 81

Equipment name : Compressor #2  
Device name : Compressor room  
Measurement Point : Compressor #2  
Status OK

Issue No Issue - Normal operation

Recommended Action No action recommended at this time

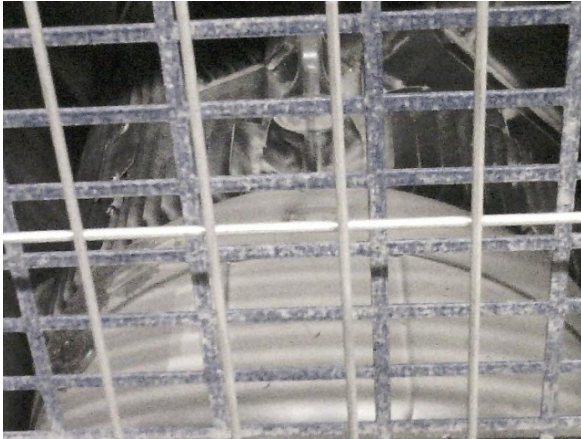
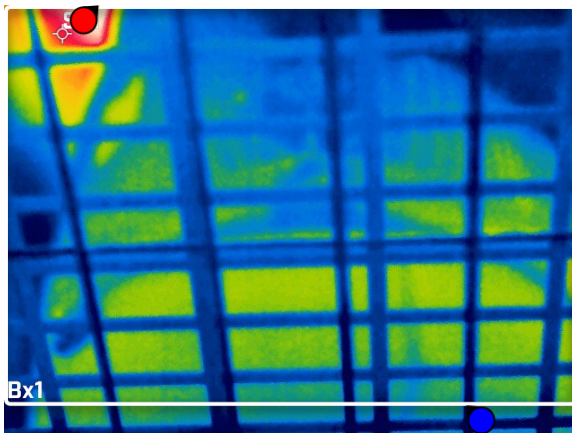
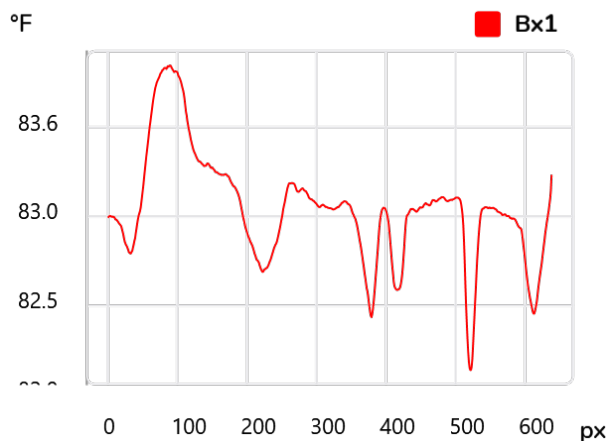
Thermogram 83 Created: 5/20/2026 12:03:03 PM

Equipment name : Compressor #2  
Device name : Compressor room  
Measurement Point : Compressor #2  
Status OK

| <b>Sp1</b> | 87.4 °F |

**Issue** No Issue - Normal operation  
**Recommended Action** No action recommended at this time  
**Comment** No additional comments.  
**Priority** None

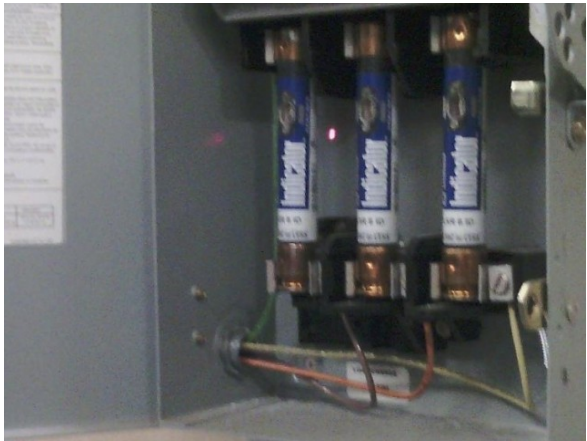
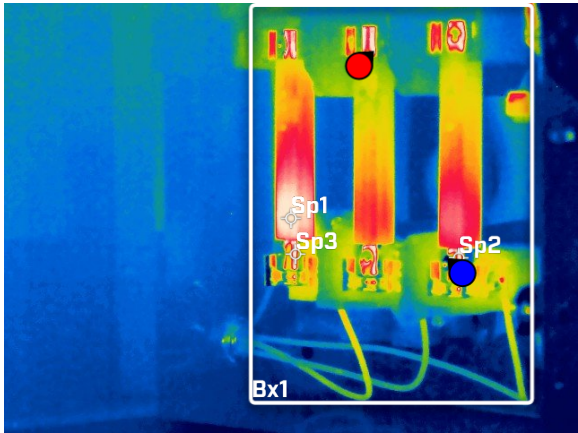
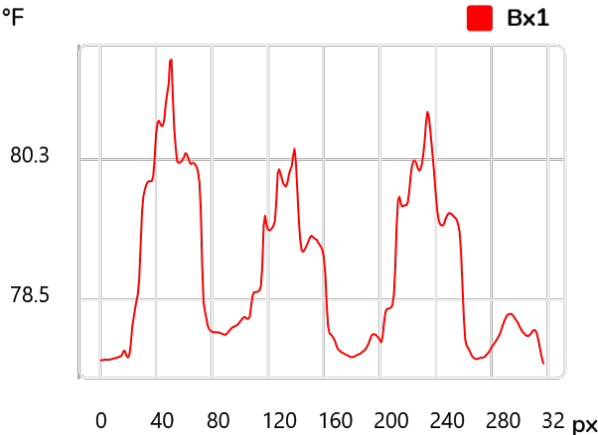
Thermogram 85 Created: 5/19/2026 12:17:21 PM

Equipment name : Dryer #1  
Device name : Compressor room  
Measurement Point : Dryer #1  
Status OK

| Value | |
|---|---|
| <b>Sp3</b> | 85.4 °F |

**Issue** No Issue - Normal operation  
**Recommended Action** No action recommended at this time  
**Comment** No additional comments.  
**Priority** None

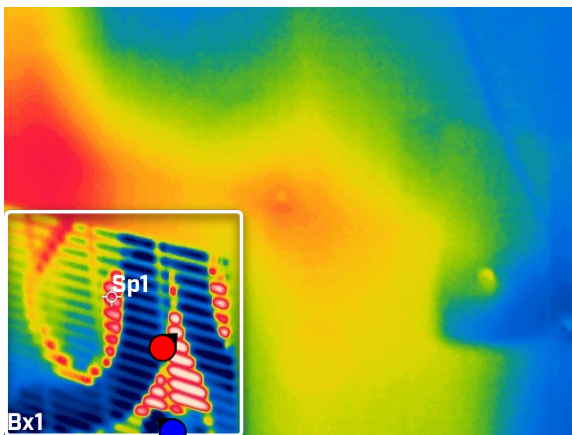
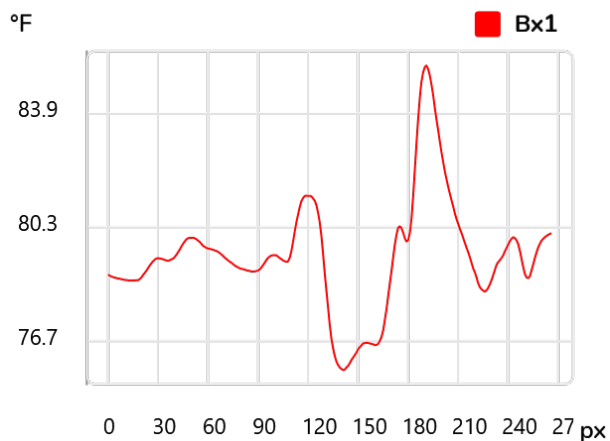
Thermogram 86 Created: 5/19/2026 12:19:32 PM

| <b>Sp1</b> | 86.3 °F |

**Recommended Action** No action recommended at this time

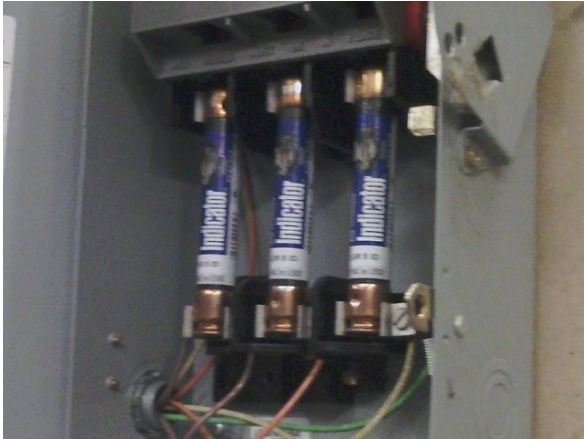
Equipment name : Dryer #1  
Device name : Compressor room  
Measurement Point : Dryer #1  
Status OK

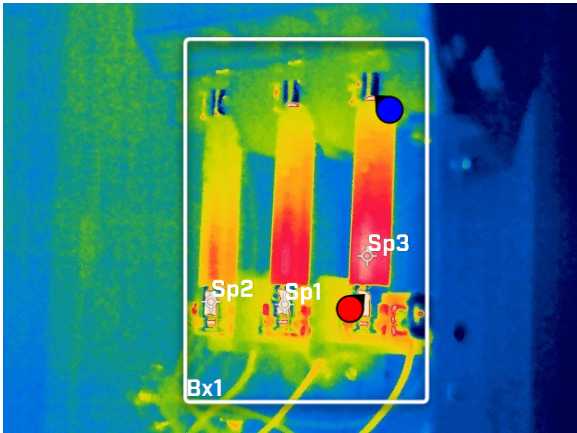
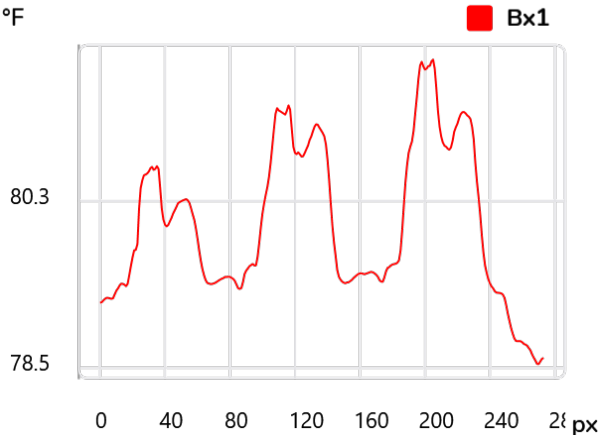
Thermogram 87 Created: 5/19/2026 12:20:31 PM

| Value | |
|---|---|
| Sp3 | 84.9 °F |

Issue No Issue - Normal operation  
Recommended Action No action recommended at this time  
Comment No additional comments.  
Priority None

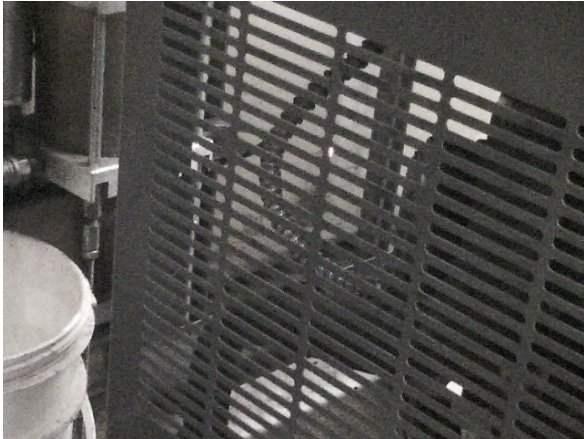
Equipment name : Dryer #1  
Device name : Compressor room  
Measurement Point : Dryer #1  
Status OK

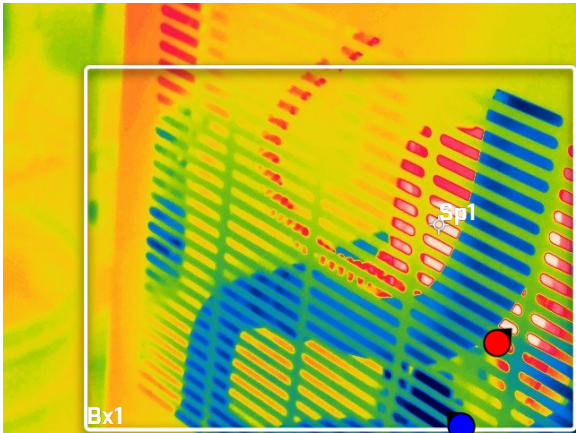
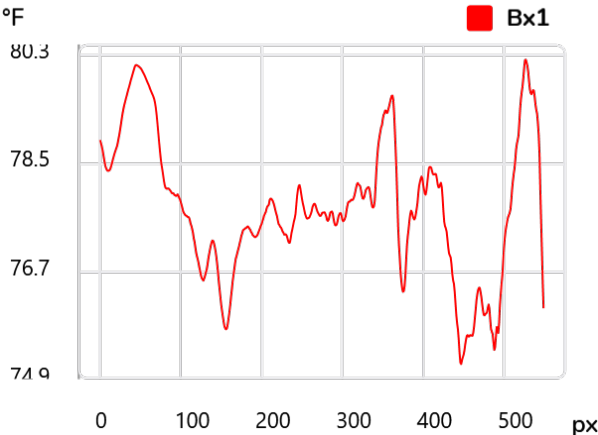
Thermogram 88 Created: 5/19/2026 12:21:23 PM

| Value | |
|---|---|
| Sp1 | 101.2 °F |

Issue No Issue - Normal operation  
Recommended Action No action recommended at this time  
Comment No additional comments.  
Priority None

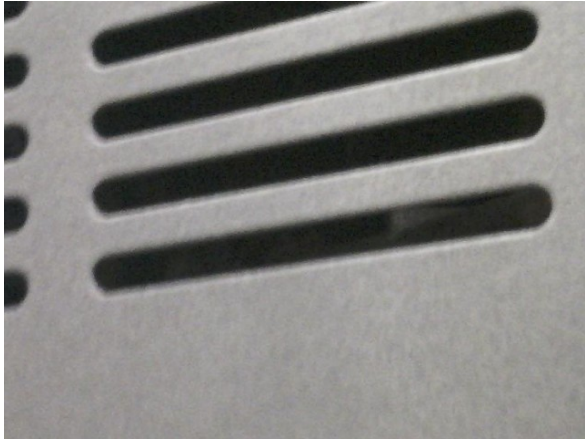
Equipment name : Dryer #1  
Device name : Compressor room  
Measurement Point : Dryer #1  
Status OK

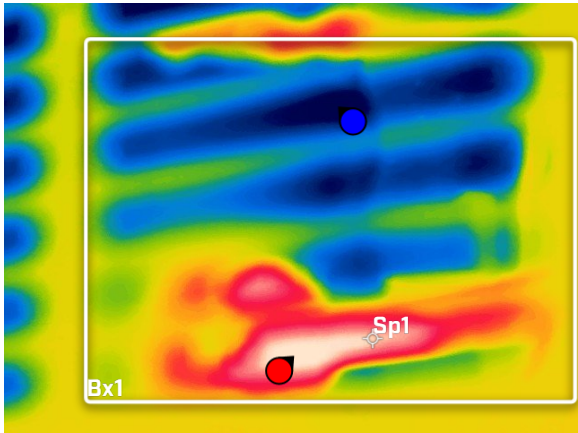
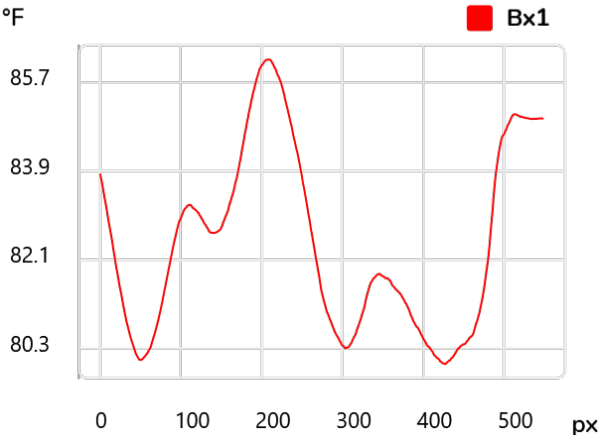
Thermogram 89 Created: 5/21/2026 1:28:21 PM

| Value | |
|---|---|
| Sp1 | 106.3 °F |

Issue No Issue - Normal operation  
Recommended Action No action recommended at this time  
Comment No additional comments.  
Priority None

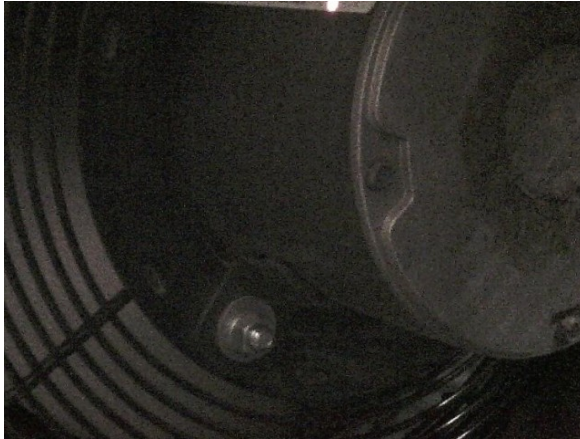
Equipment name : Dryer #1  
Device name : Compressor room  
Measurement Point : Dryer #1  
Status OK

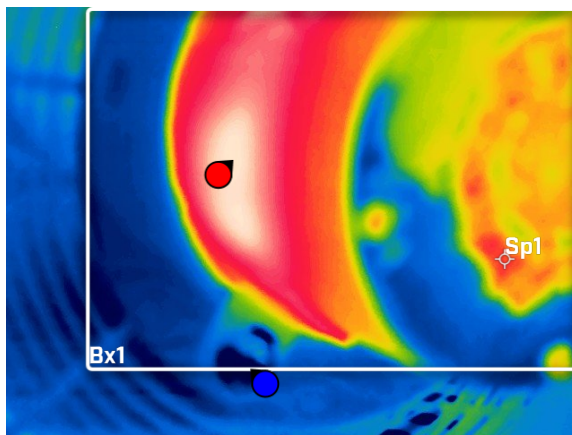
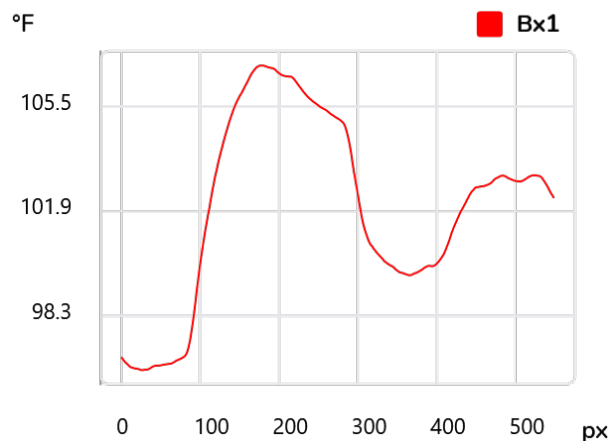
Thermogram 90 Created: 5/21/2026 1:29:14 PM

Sp1 105.9 °F

Issue No Issue - Normal operation

Recommended Action No action recommended at this time

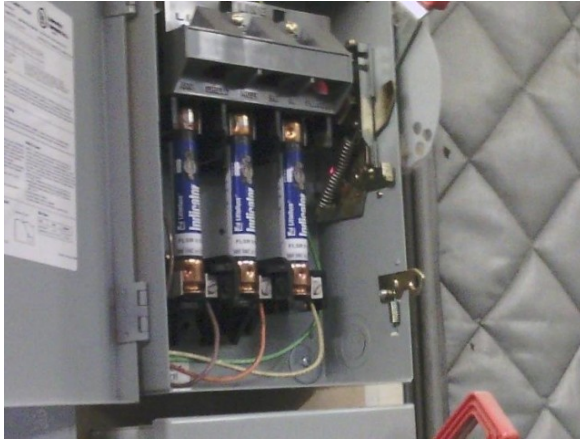
Equipment name : Dryer #2  
Device name : Compressor room  
Measurement Point : Dryer #2  
Status OK

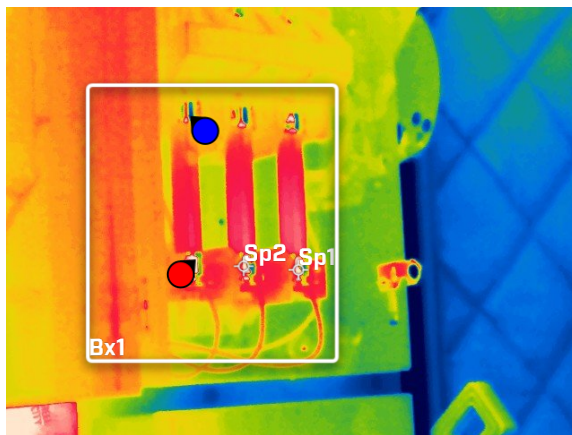
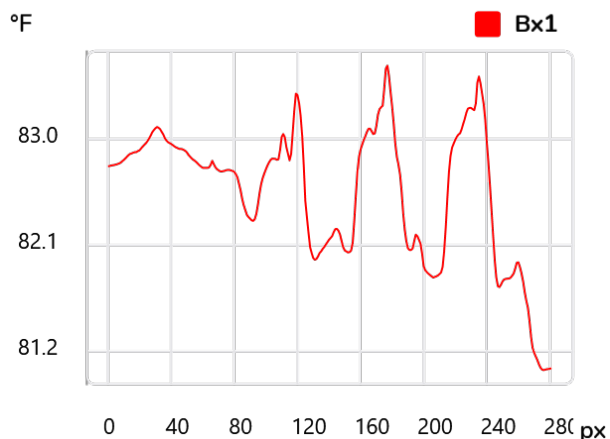
Thermogram 91 Created: 5/21/2026 1:24:56 PM

| <b>Sp2</b> | 91.1 °F |

**Issue** No Issue - Normal operation

**Recommended Action** No action recommended at this time

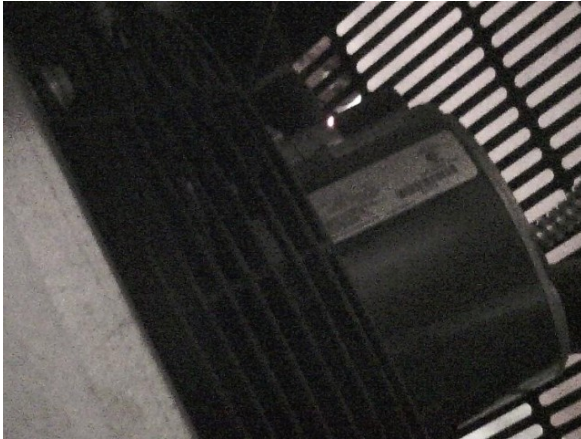
Equipment name : Dryer #2  
Device name : Compressor room  
Measurement Point : Dryer #2  
Status OK

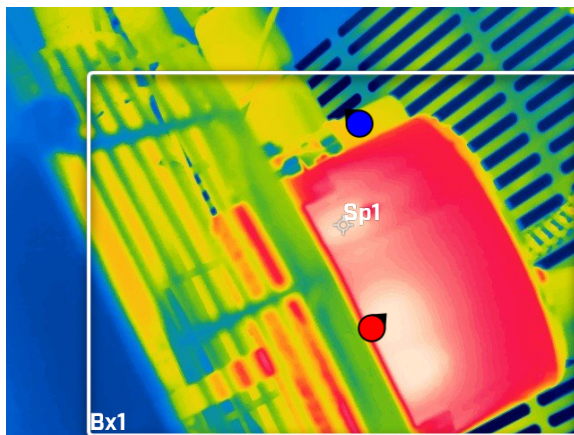
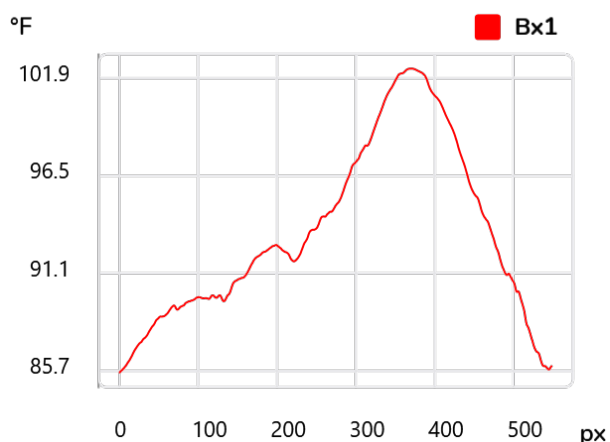
Thermogram 92 Created: 5/21/2026 1:26:26 PM

| <b>Sp1</b> | 108.3 °F |

**Recommended Action** No action recommended at this time

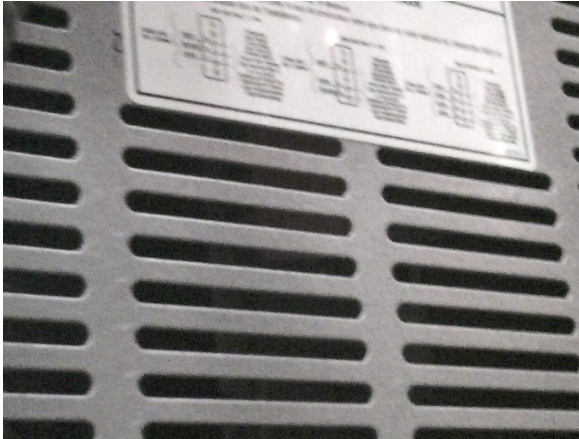
Equipment name : Dryer #2  
Device name : Compressor room  
Measurement Point : Dryer #2  
Status OK

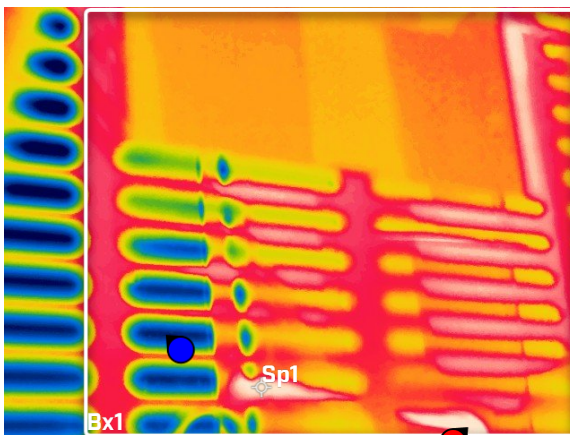
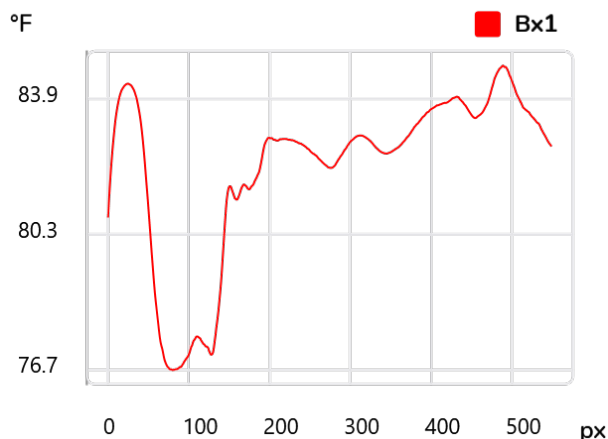
Thermogram 93 Created: 5/21/2026 1:26:58 PM

Max 96.2 °F  
Min 58.2 °F  
Area 0.230 ft²  
Sp1 91.1 °F

Issue No Issue - Normal operation

Recommended Action No action recommended at this time

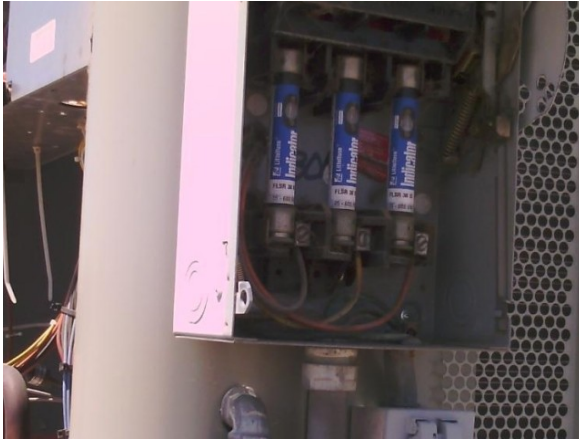
Equipment name : RTU #1  
Device name : Roof Top Units  
Measurement Point : #1  
Status OK

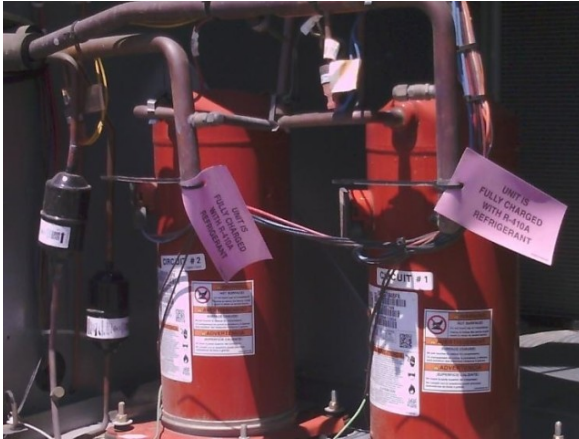
Equipment name : RTU #1  
Device name : Roof Top Units  
Measurement Point : #1  
Status OK

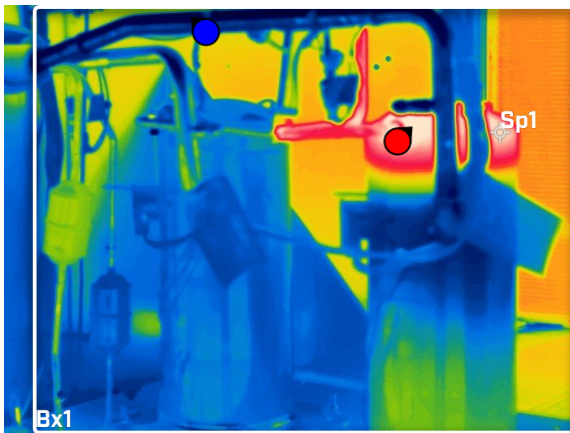
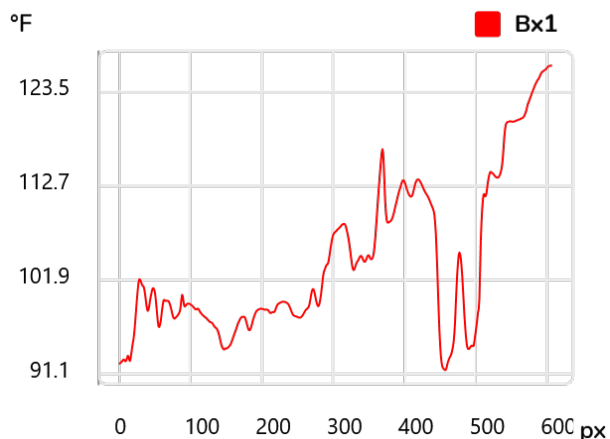
Thermogram 95 Created: 5/27/2026 1:12:43 PM

Sp1 179.0 °F

Recommended Action No action recommended at this time

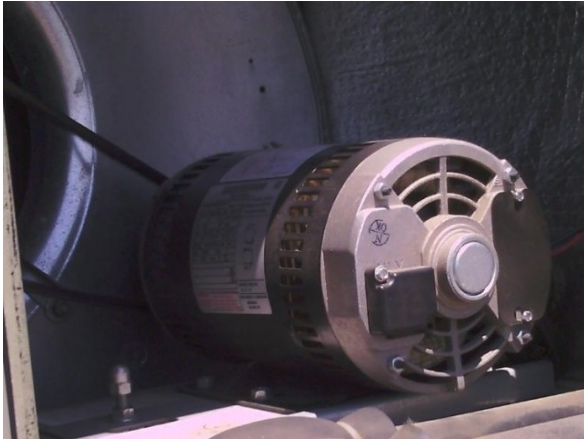
Equipment name : RTU #1  
Device name : Roof Top Units  
Measurement Point : #1  
Status OK

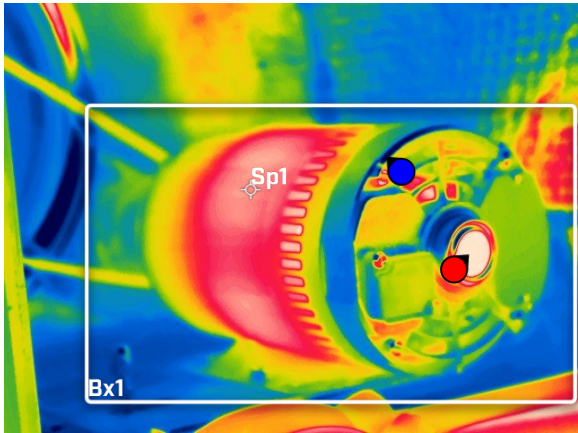
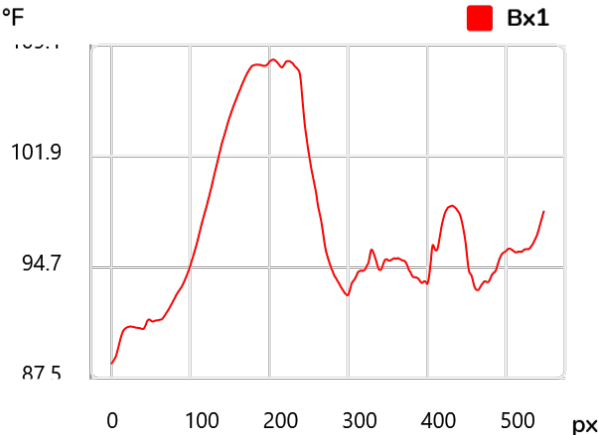
Thermogram 96 Created: 5/27/2026 1:18:57 PM

| Value | |
|---|---|
| Sp1 | 115.6 °F |

Issue No Issue - Normal operation  
Recommended Action No action recommended at this time  
Comment No additional comments.  
Priority None

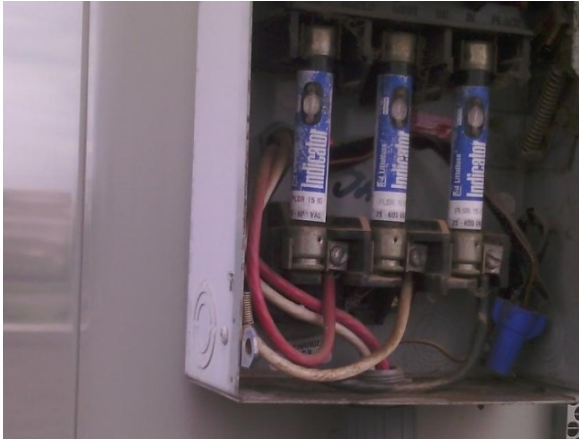
Equipment name : RTU #2  
Device name : Roof Top Units  
Measurement Point : #2  
Status OK

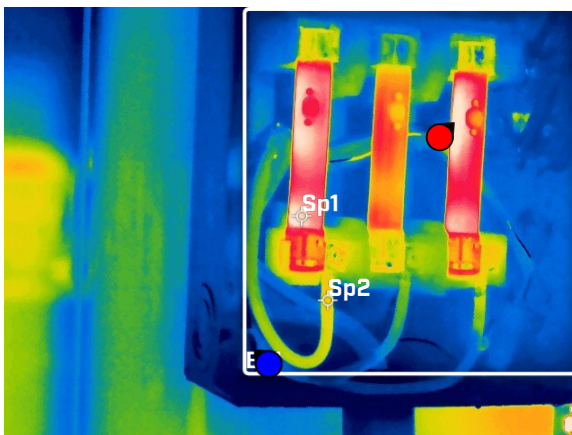
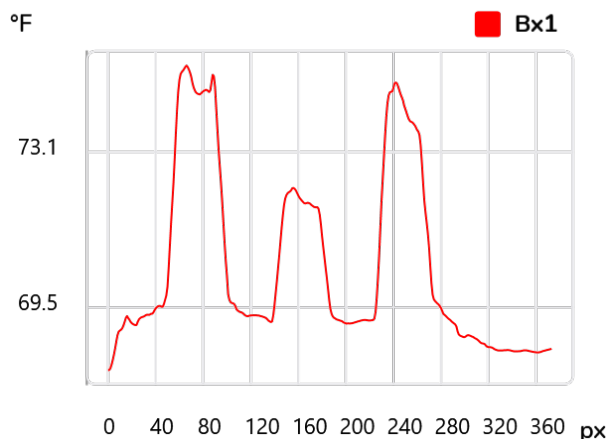
Thermogram 97 Created: 6/4/2026 8:08:17 AM

| Sp1 | 80.6 °F |
| Sp2 | 72.8 °F |

**Issue** No Issue - Normal operation

**Recommended Action** No action recommended at this time

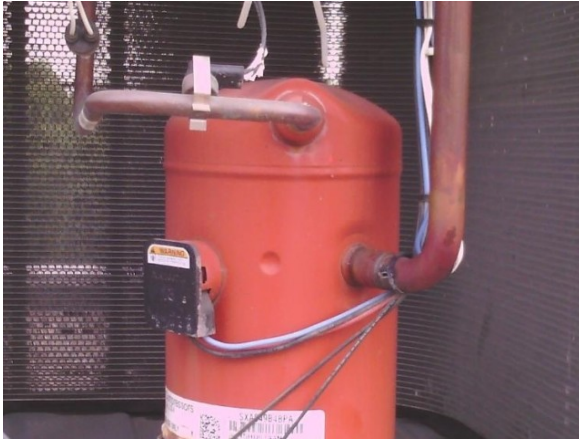
Equipment name : RTU #2  
Device name : Roof Top Units  
Measurement Point : #2  
Status OK

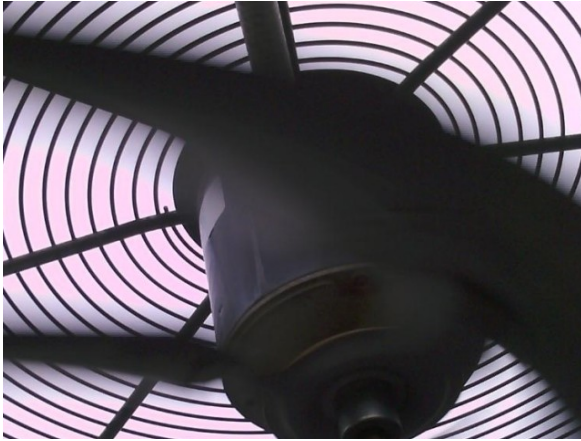
Equipment name : RTU #2  
Device name : Roof Top Units  
Measurement Point : #2  
Status OK

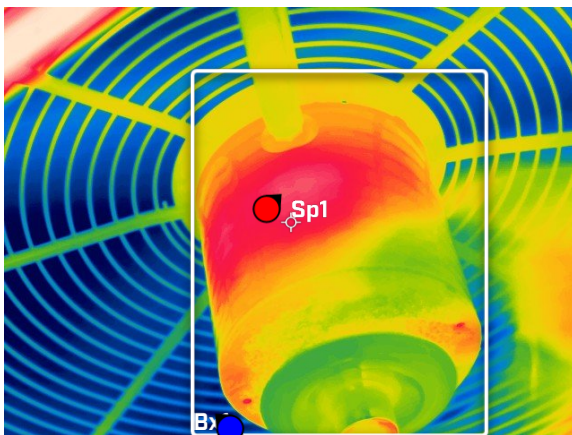
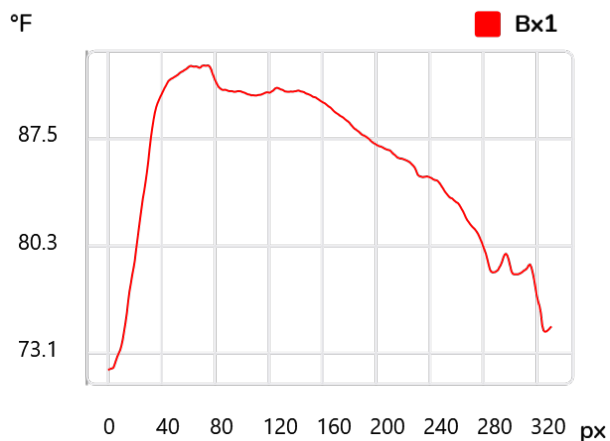
## Thermogram 99

Recommended Action No action recommended at this time

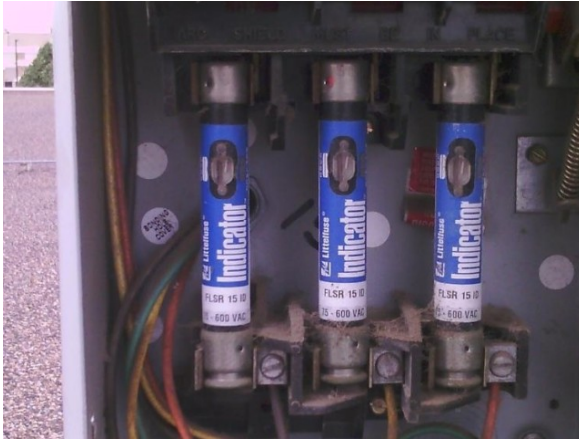
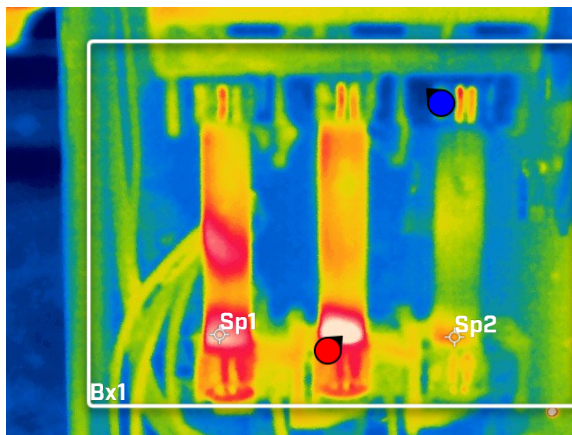
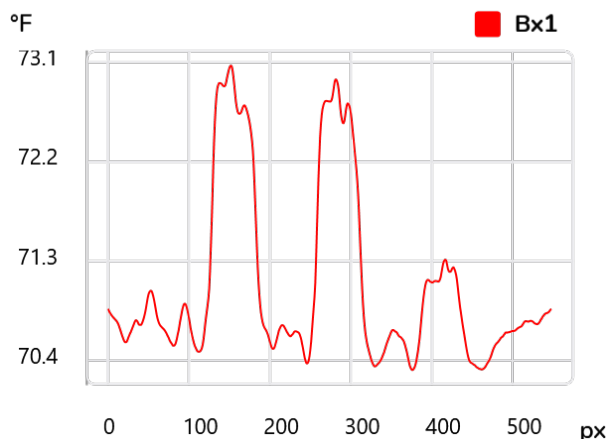
Thermogram 100 Created: 6/4/2026 8:23:54 AM

Equipment name : RTU #2  
Device name : Roof Top Units  
Measurement Point : #2  
Status OK

Max 80.5 °F  
Min 68.9 °F  
Area 0.293 ft<sup>2</sup>  
Sp1 76.0 °F  
Sp2 72.7 °F

Issue No Issue - Normal operation

Recommended Action No action recommended at this time

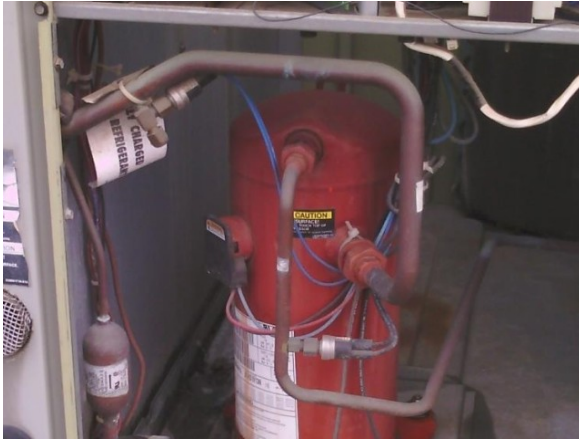
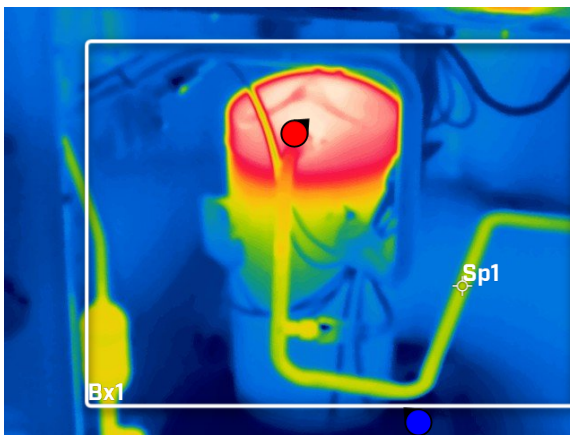
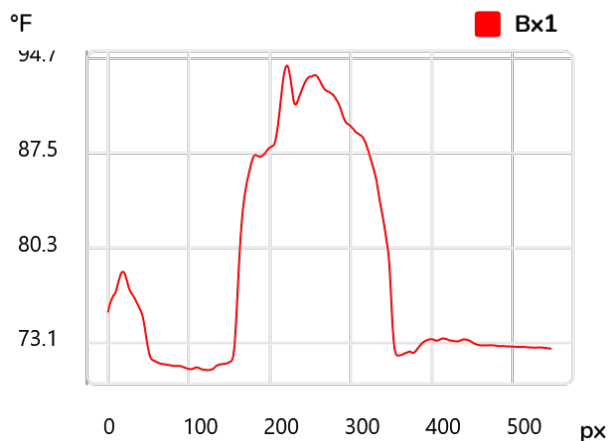
Thermogram 101 Created: 6/4/2026 8:26:09 AM

Equipment name : RTU #2  
Device name : Roof Top Units  
Measurement Point : #2  
Status OK

Issue No Issue - Normal operation

Recommended Action No action recommended at this time

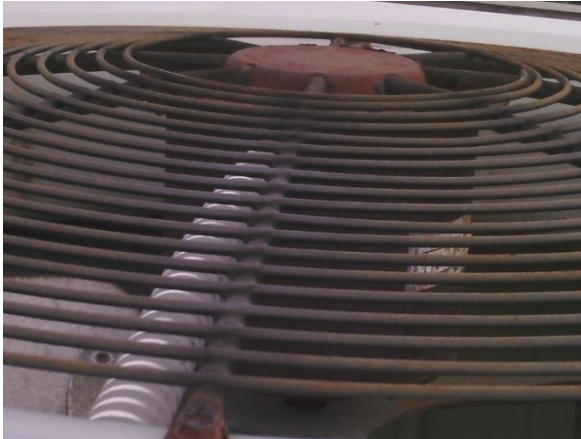
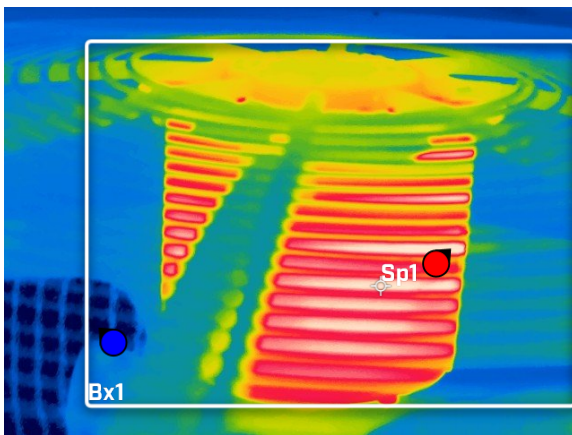
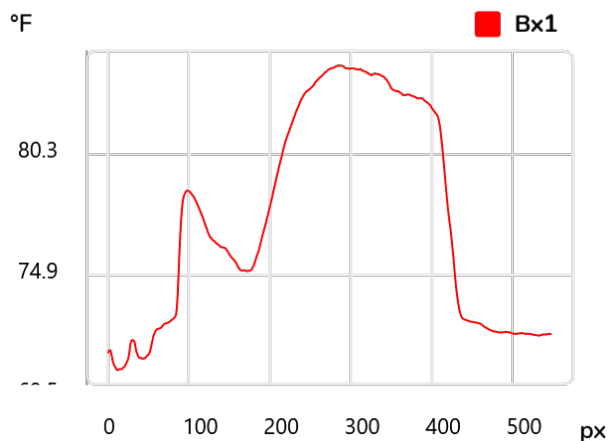
Thermogram 102 Created: 6/4/2026 8:27:50 AM

Equipment name : RTU #2  
Device name : Roof Top Units  
Measurement Point : #2  
Status OK

Issue No Issue - Normal operation

Recommended Action No action recommended at this time

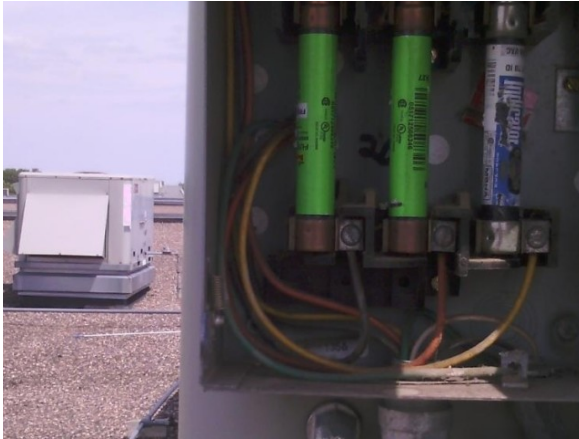
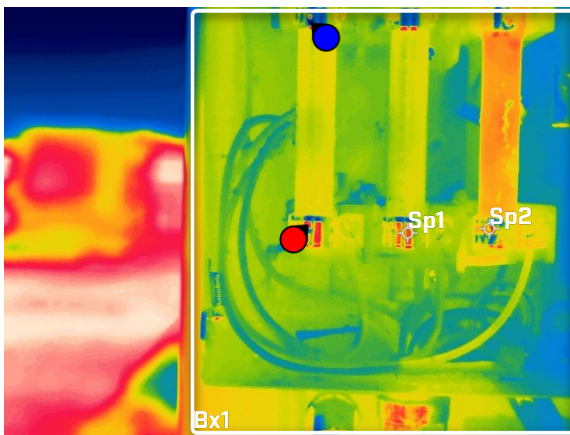
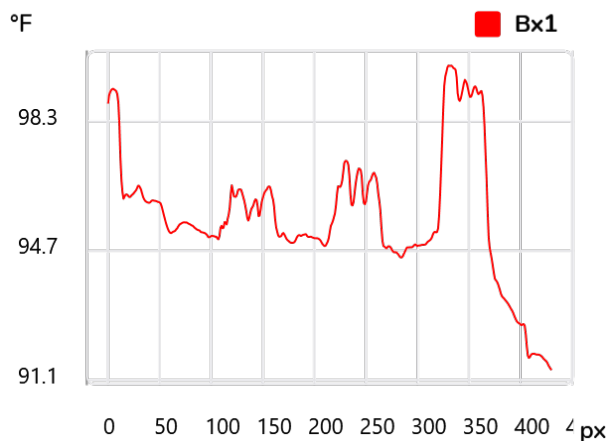
Thermogram 103 Created: 6/3/2026 2:46:46 PM

Equipment name : RTU #3  
Device name : Roof Top Units  
Measurement Point : #3  
Status OK

Sp2 101.3 °F

Recommended Action No action recommended at this time

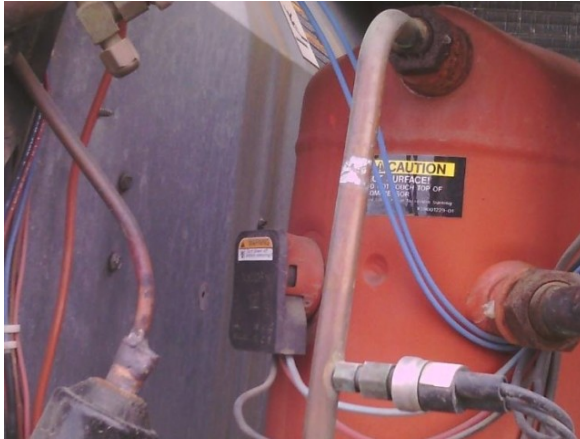
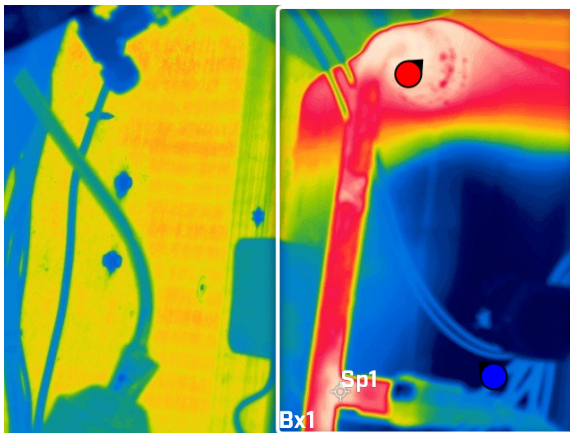
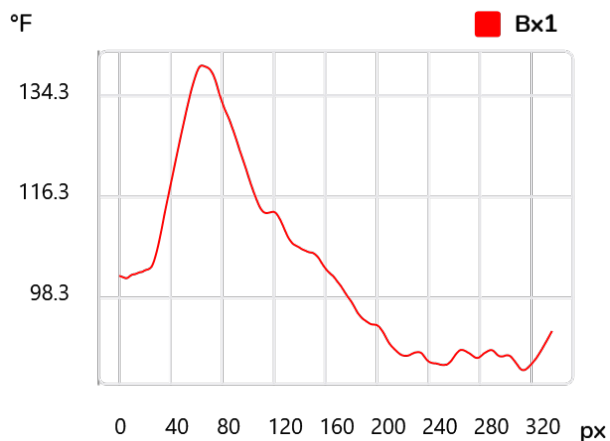
Thermogram 104 Created: 6/3/2026 3:47:08 PM

Equipment name : RTU #3  
Device name : Roof Top Units  
Measurement Point : #3  
Status OK

Sp1 177.1 °F

Issue No Issue - Normal operation

Recommended Action No action recommended at this time
