# THERMAL ELECTRICAL INSPECTION

## SAMPLE REPORT

RETROFIT  
ELECTRIC

# Retrofit Electric - Thermal Electrical Inspection

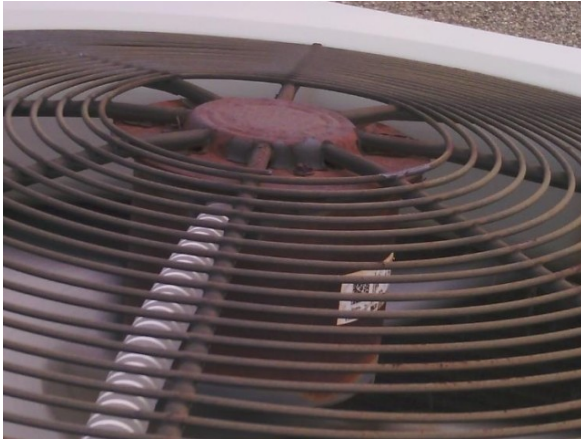
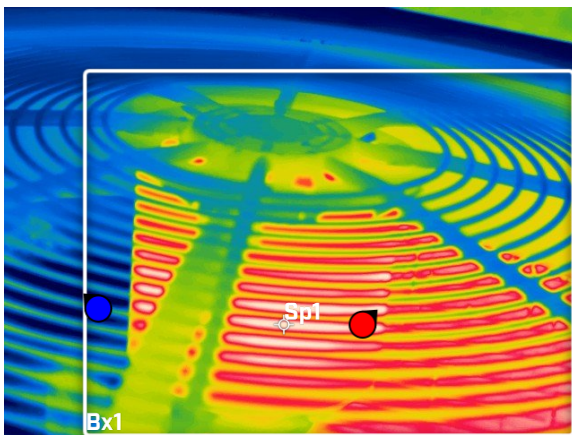
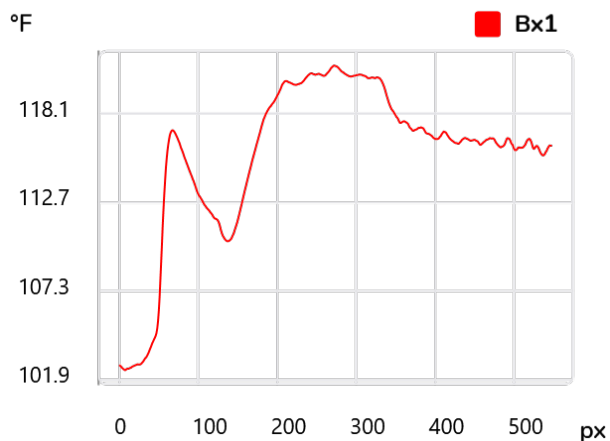
Thermogram 105 Created: 6/3/2026 3:48:03 PM

Equipment name : RTU #3  
Device name : Roof Top Units  
Measurement Point : #3  
Status OK

Sp1 154.4 °F

Recommended Action No action recommended at this time

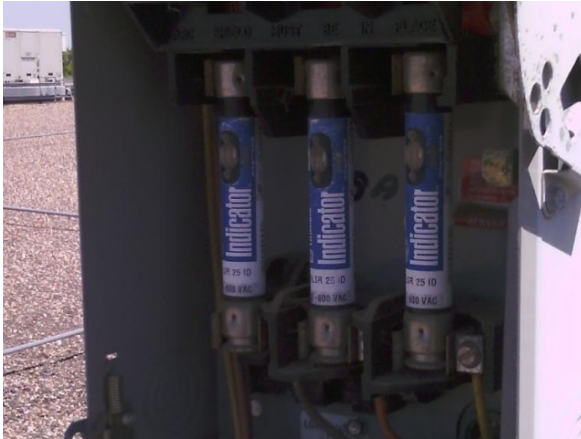
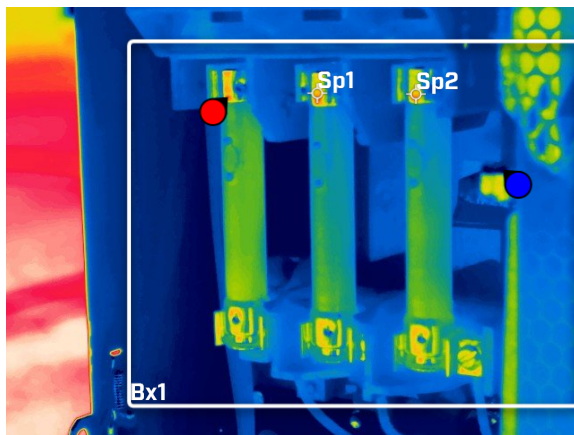
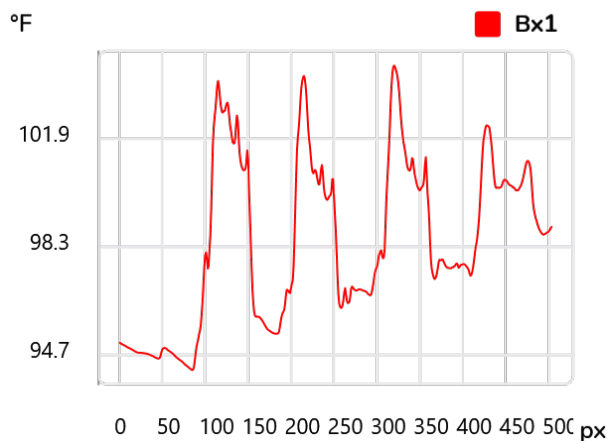
Thermogram 106 Created: 5/27/2026 1:26:52 PM

Equipment name : RTU #4  
Device name : Roof Top Units  
Measurement Point : #4  
Status OK

Issue No Issue - Normal operation

Recommended Action No action recommended at this time

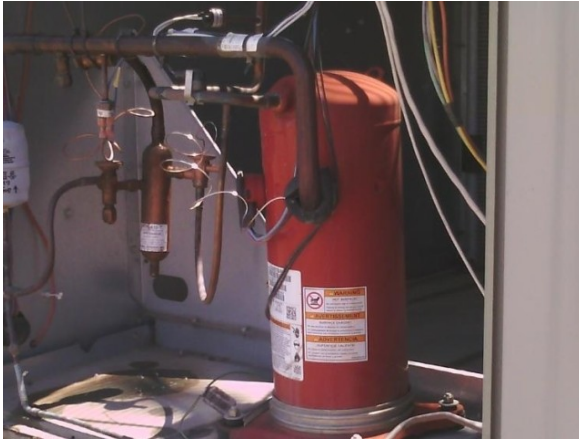
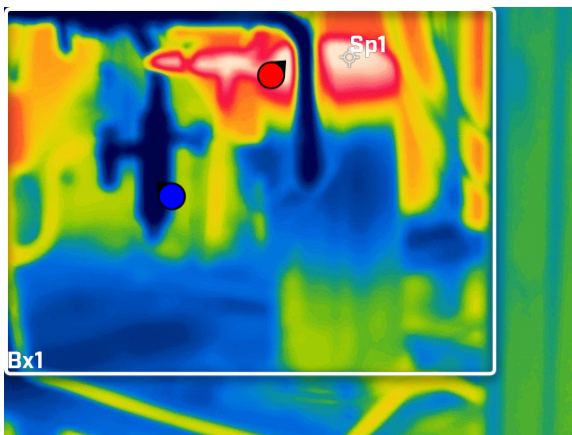
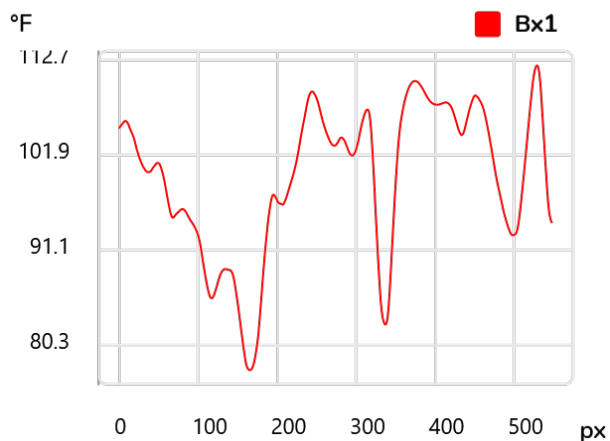
Thermogram 107 Created: 5/27/2026 1:28:01 PM

Equipment name : RTU #4  
Device name : Roof Top Units  
Measurement Point : #4  
Status OK

Sp1 184.4 °F

Issue No Issue - Normal operation

Recommended Action No action recommended at this time

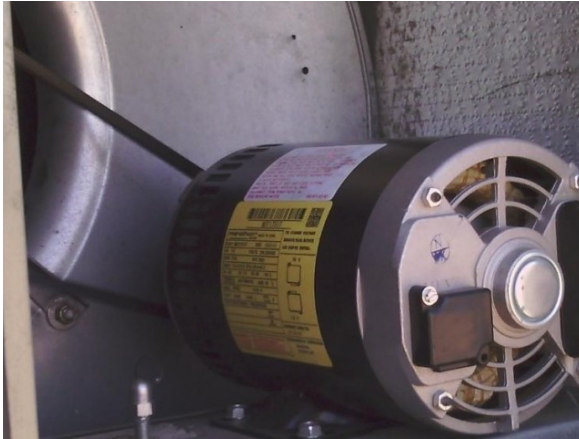
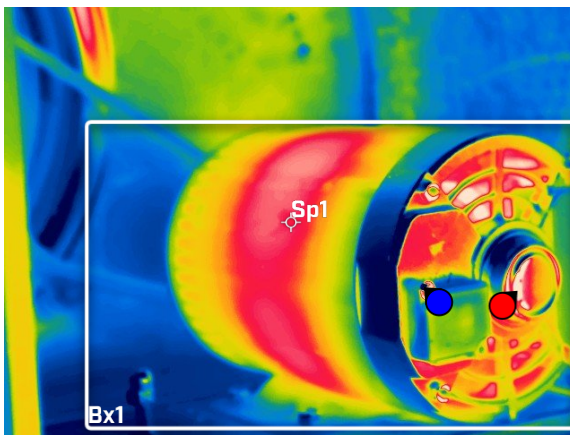
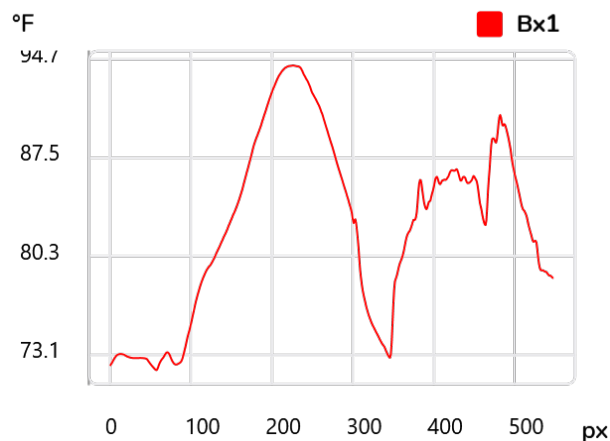
Thermogram 108 Created: 5/27/2026 1:33:27 PM

Equipment name : RTU #4  
Device name : Roof Top Units  
Measurement Point : #4  
Status OK

Issue No Issue - Normal operation

Recommended Action No action recommended at this time

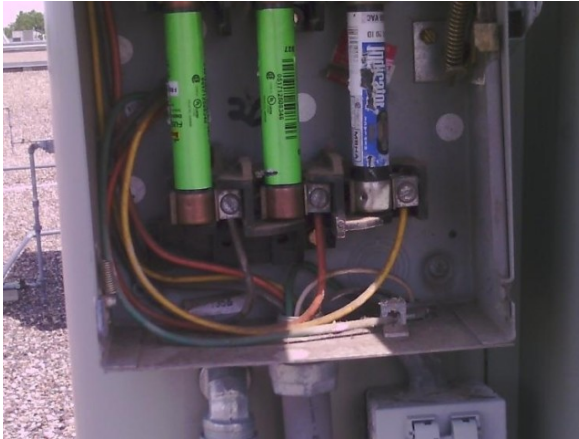
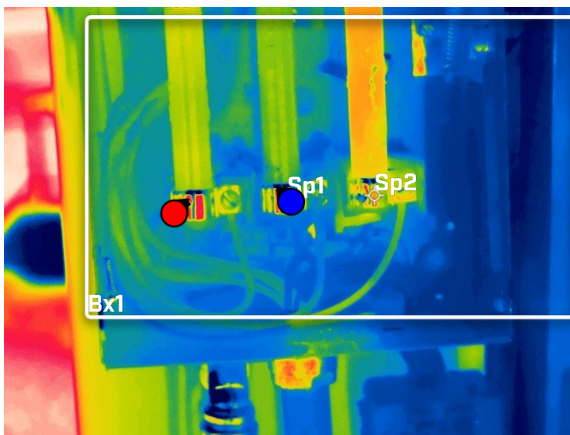
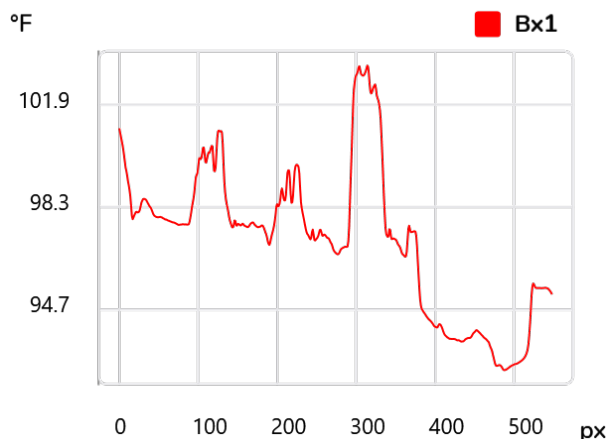
Thermogram 109 Created: 6/3/2026 2:46:11 PM

Equipment name : RTU #4  
Device name : Roof Top Units  
Measurement Point : #4  
Status OK

**Recommended Action** No action recommended at this time

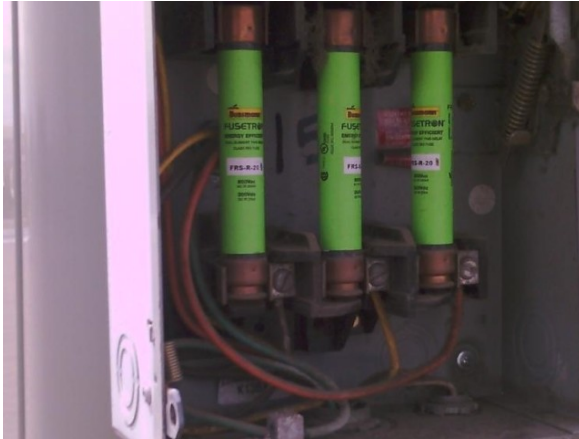
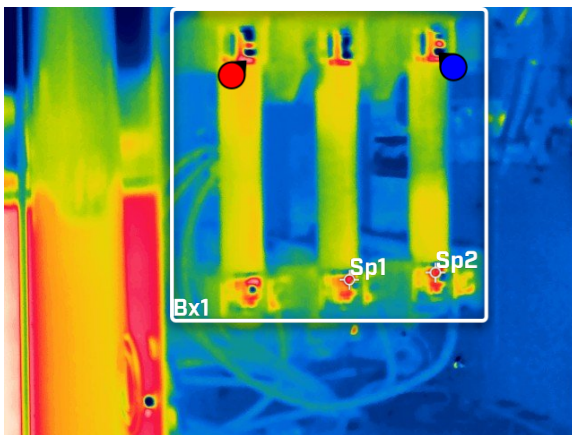
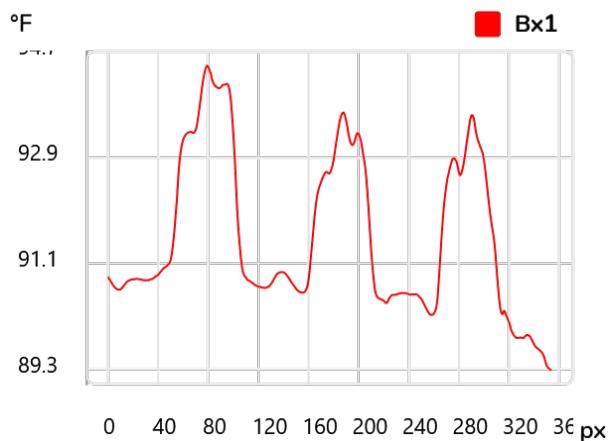
Thermogram 110 Created: 6/3/2026 3:36:28 PM

Equipment name : RTU #5  
Device name : Roof Top Units  
Measurement Point : #5  
Status OK

Recommended Action No action recommended at this time

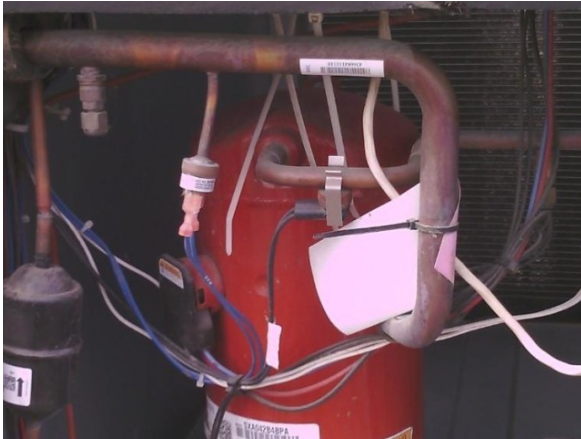
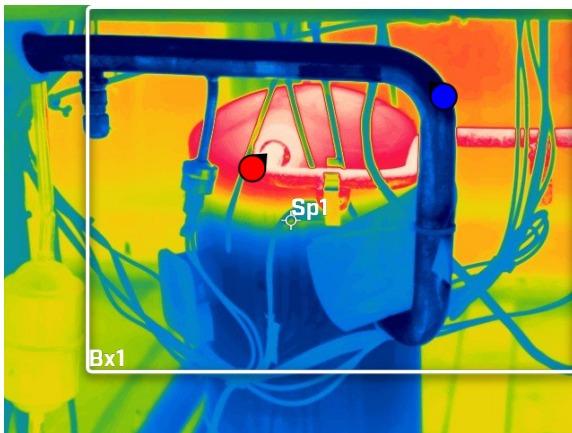
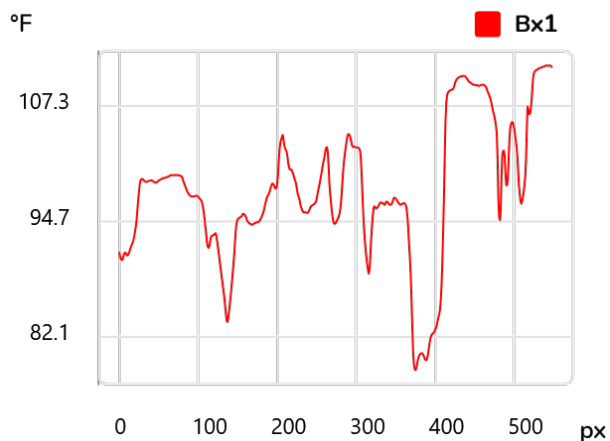
Thermogram 111 Created: 6/3/2026 3:40:03 PM

Equipment name : RTU #5  
Device name : Roof Top Units  
Measurement Point : #5  
Status OK

Issue No Issue - Normal operation

Recommended Action No action recommended at this time

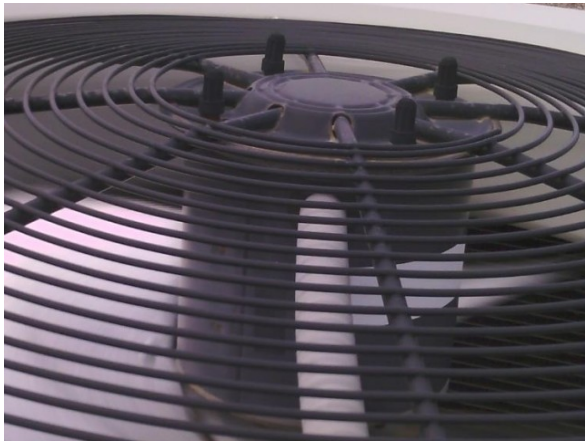
Equipment name : RTU #5  
Device name : Roof Top Units  
Measurement Point : #5  
Status OK

**Issue** No Issue - Normal operation  
**Recommended Action** No action recommended at this time  
**Comment** 5,4.8,5.6 amps  
**Priority** None

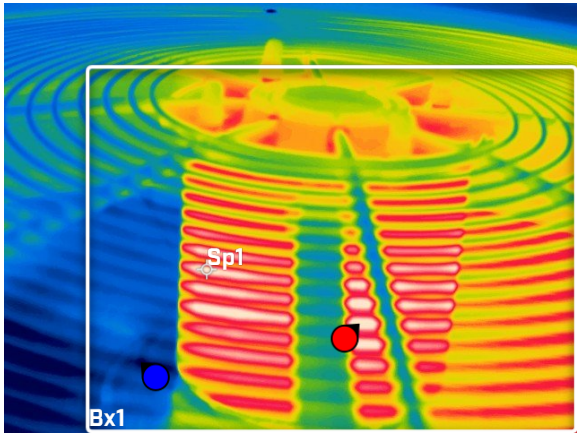
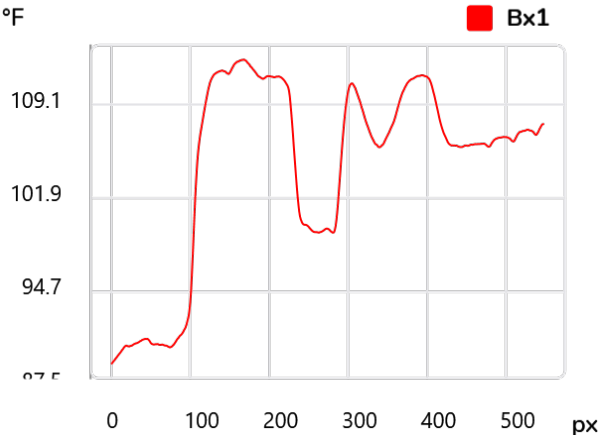
Thermogram 112 Created: 6/3/2026 3:40:38 PM

| Value | |
|---|---|
| <b>Sp1</b> | 138.2 °F |

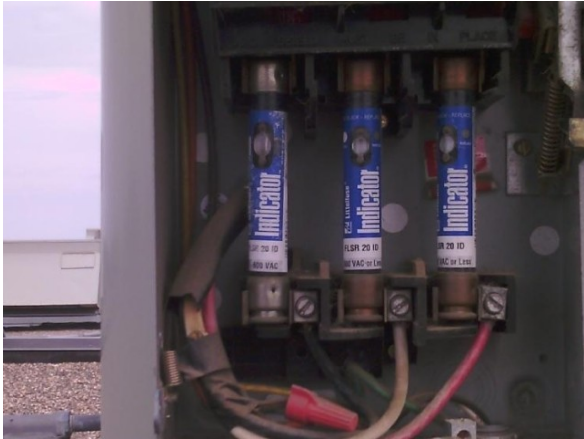
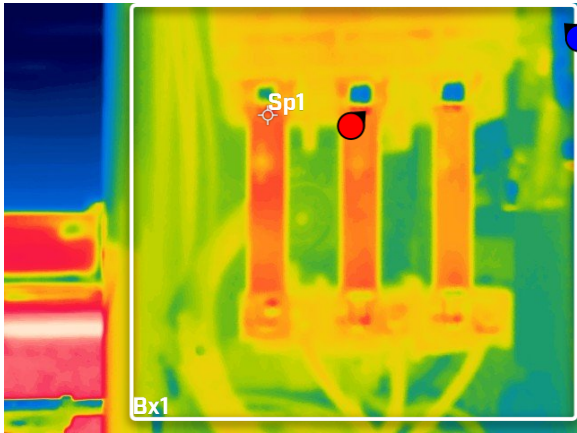
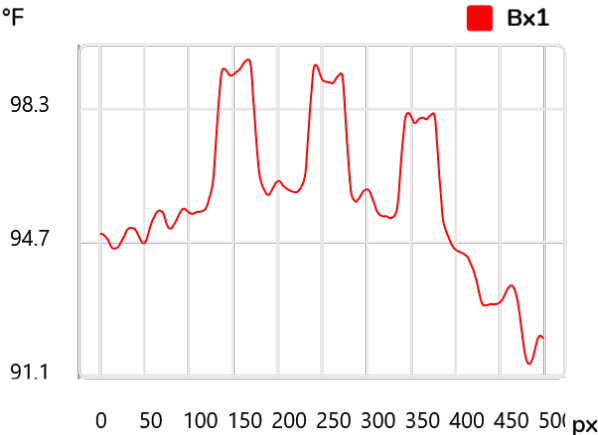
Thermogram 113 Created: 6/3/2026 3:20:20 PM

Equipment name : RTU #7  
Device name : Roof Top Units  
Measurement Point : #7  
Status OK

| Value | |
|---|---|
| Sp1 | 102.0 °F |

Issue No Issue - Normal operation  
Recommended Action No action recommended at this time  
Comment No additional comments.  
Priority None

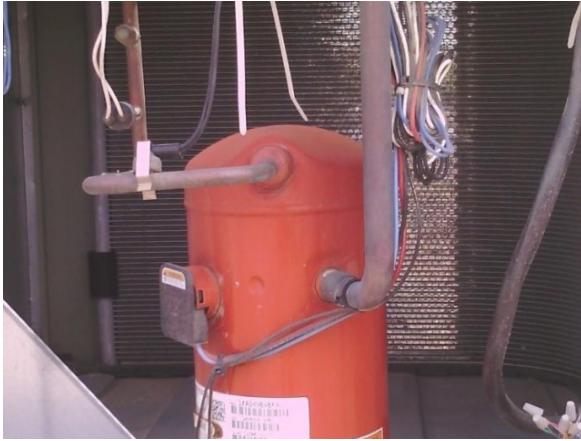
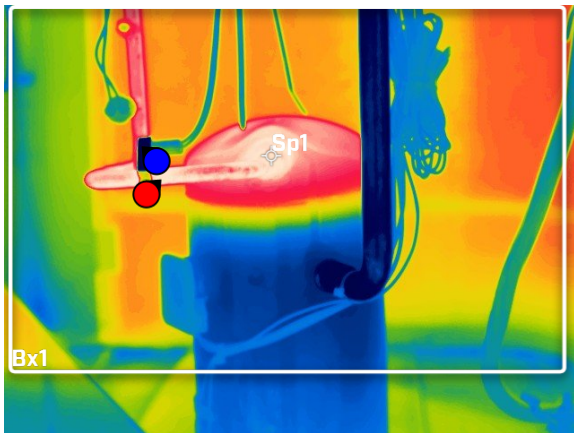
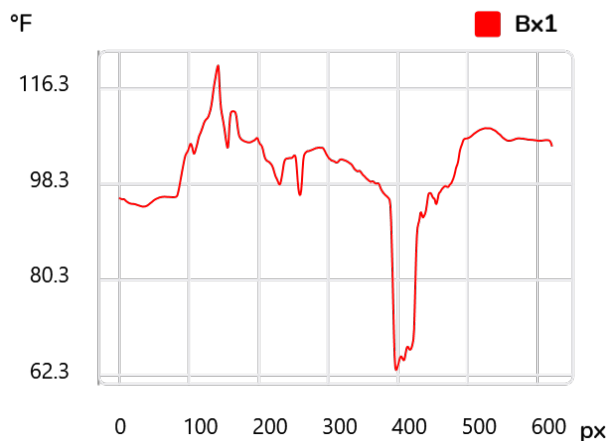
Thermogram 114 Created: 6/3/2026 3:21:53 PM

Equipment name : RTU #7  
Device name : Roof Top Units  
Measurement Point : #7  
Status OK

Sp1 150.4 °F

Recommended Action No action recommended at this time

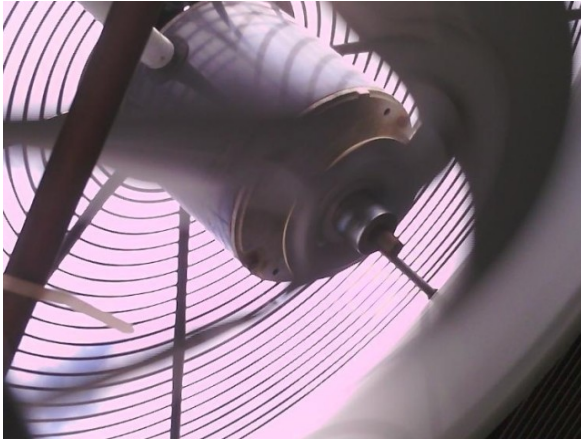
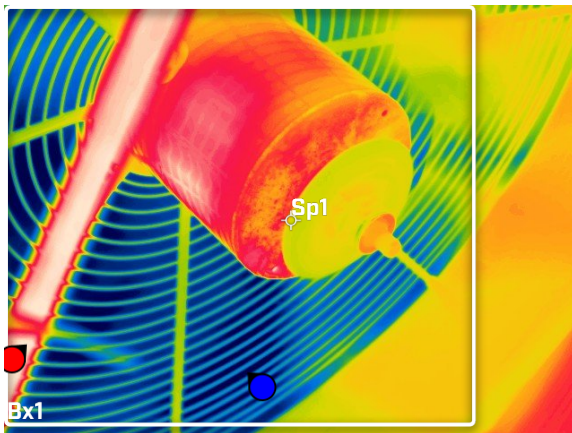
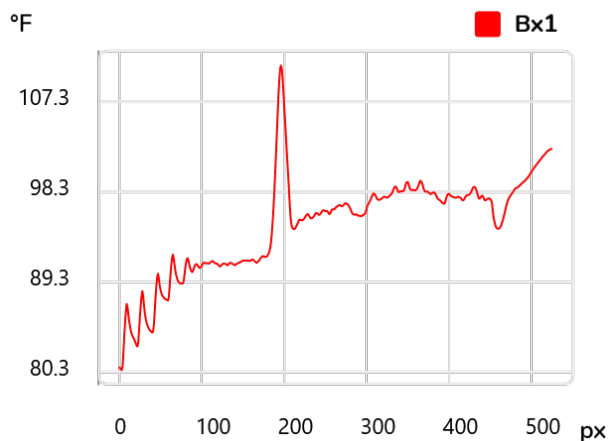
**Thermogram 115** Created: 6/3/2026 3:22:33 PM

**Equipment name :** RTU #7  
**Device name :** Roof Top Units  
**Measurement Point :** #7  
**Status** OK

Max 149.6 °F  
Min 29.3 °F  
Area 0.708 ft²  
Sp1 100.4 °F

**Recommended Action** No action recommended at this time

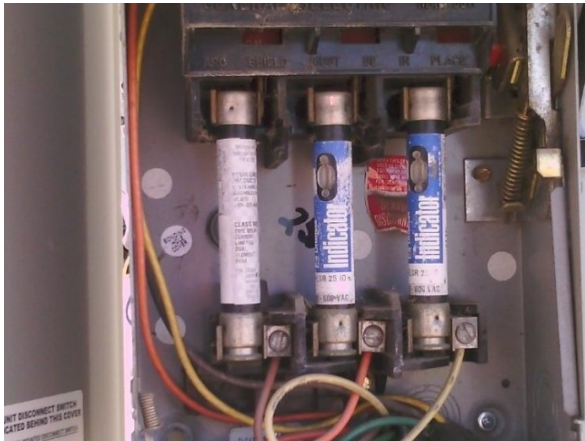
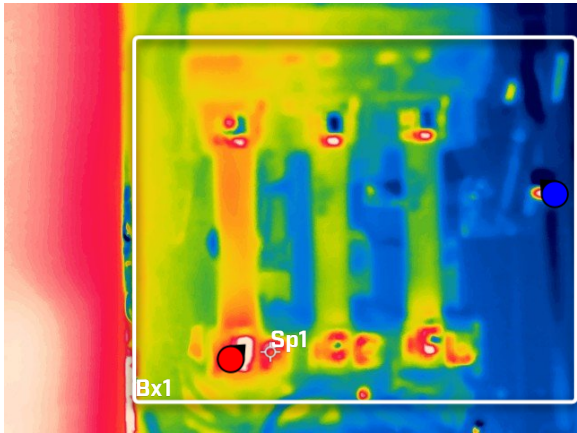
Thermogram 116 Created: 5/27/2026 3:25:13 PM

Equipment name : RTU #11  
Device name : Roof Top Units  
Measurement Point : #11  
Status Note

| Value | |
|---|---|
| Sp1 | 109.4 °F |

Issue Loose connection(s)  
Recommended Action Inspect connections  
Comment Look for loose fuse connection. Monitor fuse function.  
Priority 2-Intermediate/Investigate

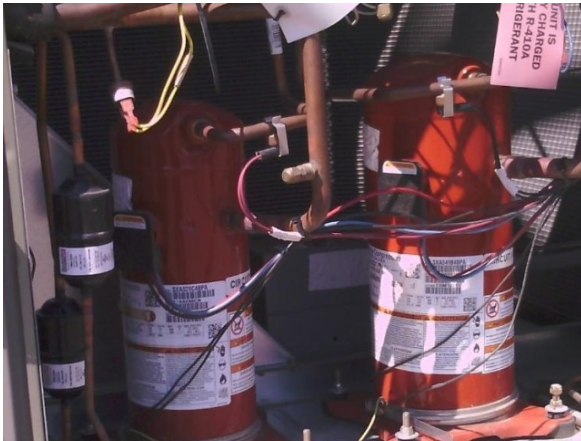
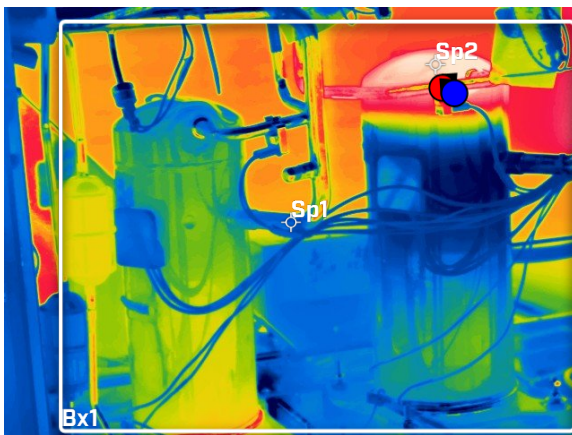
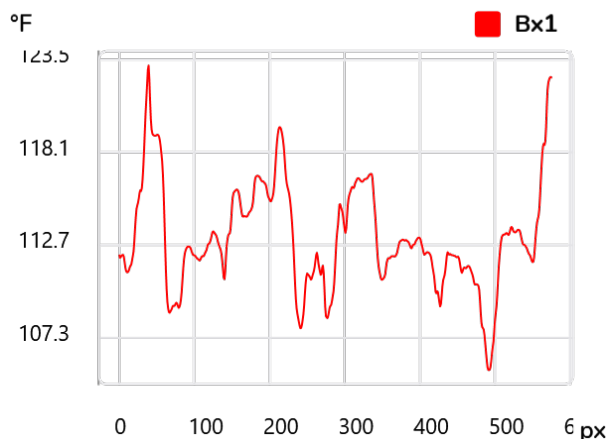
Thermogram 117 Created: 5/27/2026 3:26:26 PM

Equipment name : RTU #11  
Device name : Roof Top Units  
Measurement Point : #11  
Status Note

Sp2 170.1 °F

Issue Loose connection(s)

Comment Look for loose fuse connection. Monitor fuse function.

Recommended Action Inspect connections

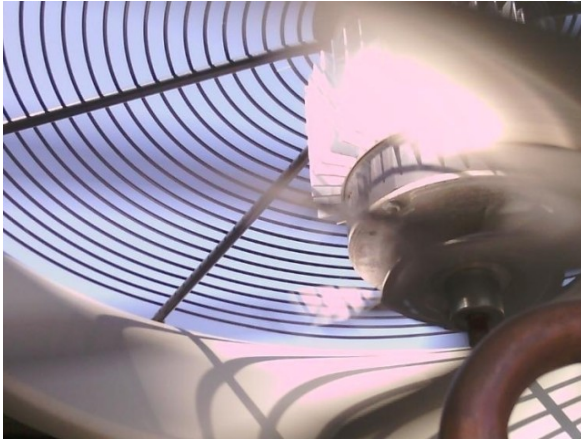
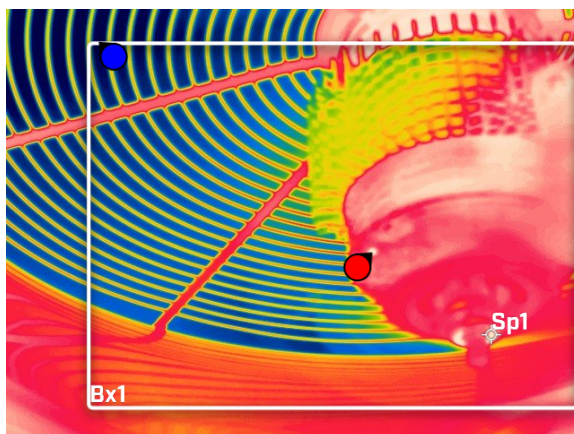
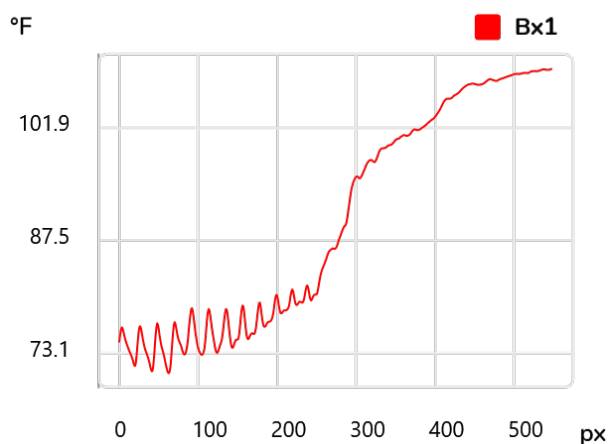
Thermogram 118 Created: 5/27/2026 3:28:29 PM

Equipment name : RTU #11  
Device name : Roof Top Units  
Measurement Point : #11  
Status Note

| <b>Sp1</b> | 117.6 °F |

**Issue** Loose connection(s)

**Comment** Look for loose fuse connection. Monitor fuse function.

**Recommended Action** Inspect connections

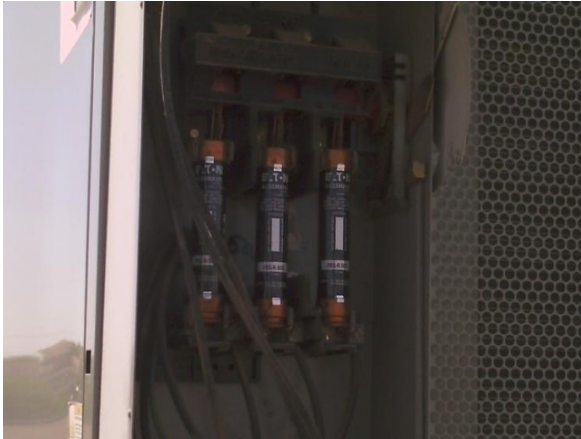
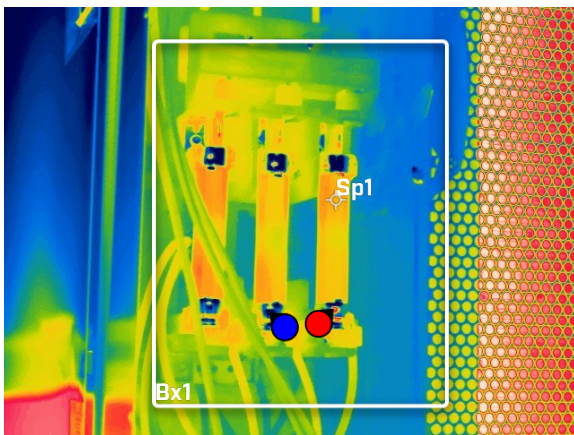
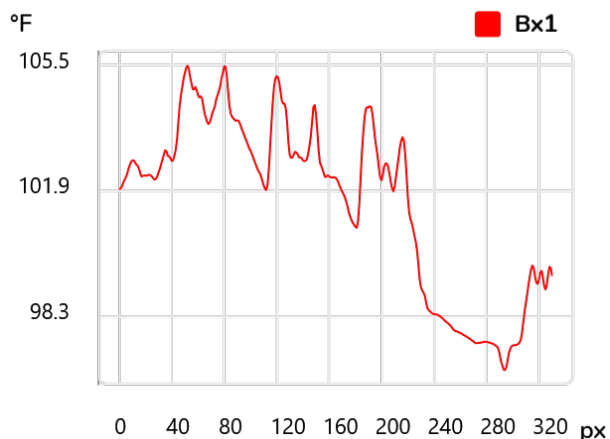
Thermogram 119 Created: 5/27/2026 3:39:59 PM

Equipment name : RTU #15  
Device name : Roof Top Units  
Measurement Point : #15  
Status OK

Sp1 108.8 °F

Issue No Issue - Normal operation

Recommended Action No action recommended at this time

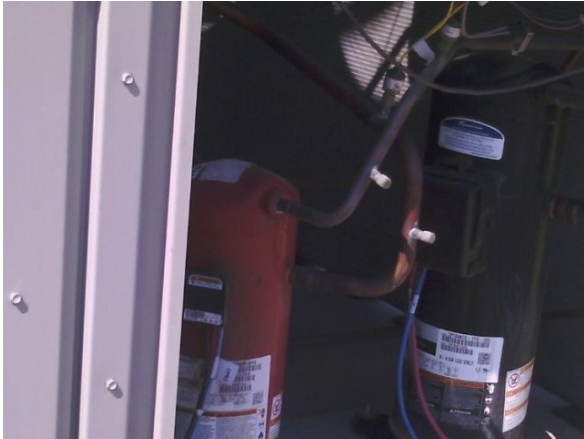
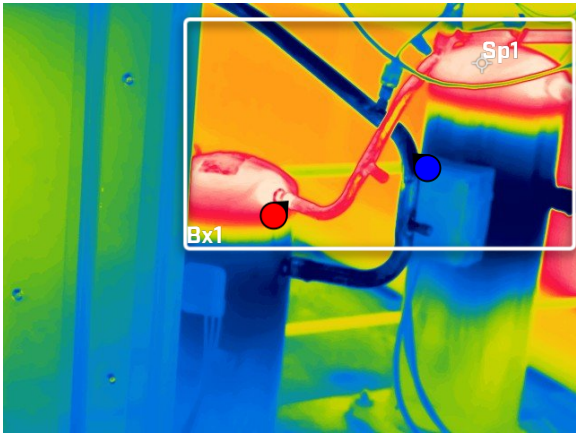
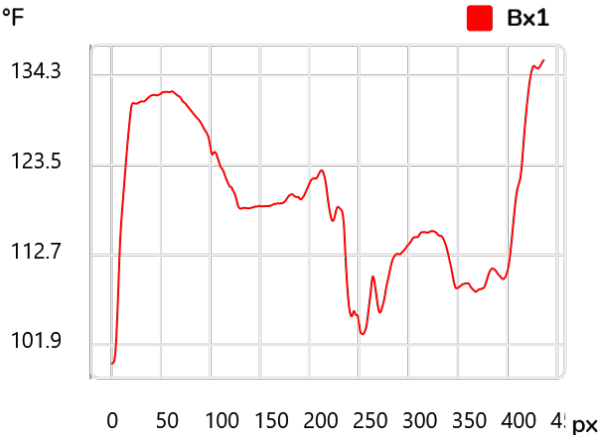
Thermogram 120 Created: 5/27/2026 3:42:28 PM

Equipment name : RTU #15  
Device name : Roof Top Units  
Measurement Point : #15  
Status OK

| Value | |
|---|---|
| Sp1 | 167.3 °F |

Issue No Issue - Normal operation  
Recommended Action No action recommended at this time  
Comment No additional comments.  
Priority None

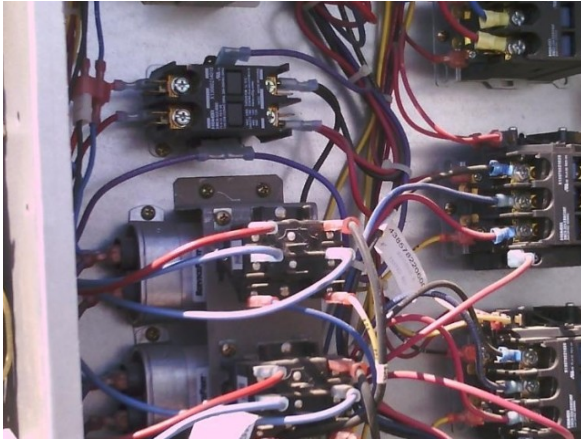
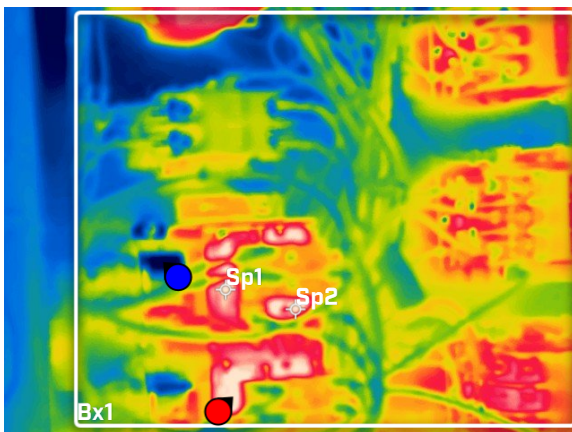
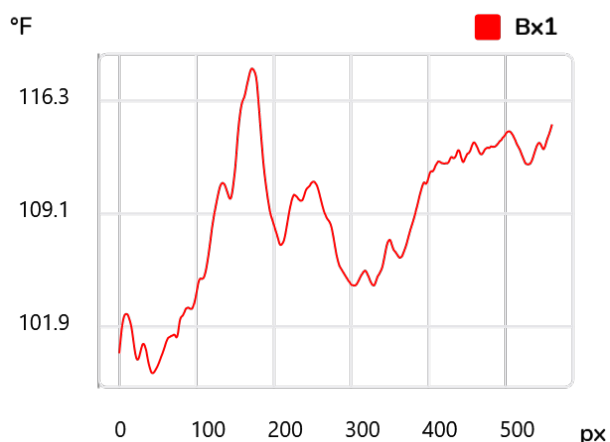
Thermogram 121 Created: 5/27/2026 3:43:46 PM

Equipment name : RTU #15  
Device name : Roof Top Units  
Measurement Point : #15  
Status OK

Sp2 143.6 °F

Recommended Action No action recommended at this time

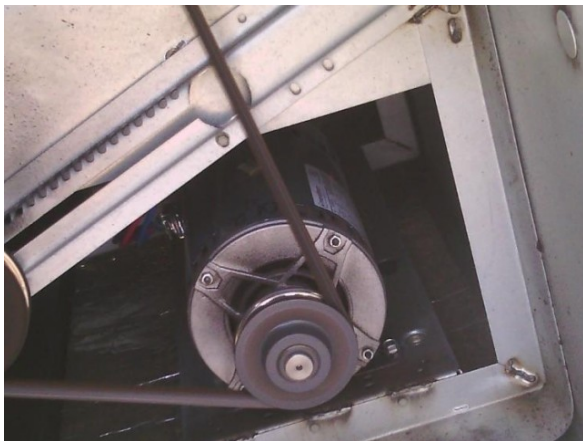
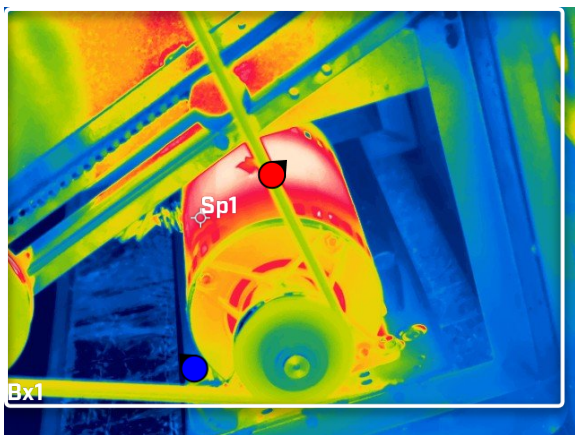
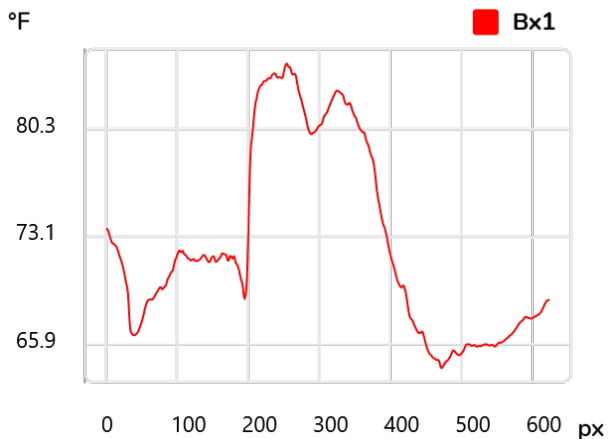
Thermogram 122 Created: 5/27/2026 3:49:28 PM

Equipment name : RTU #15  
Device name : Roof Top Units  
Measurement Point : #15  
Status OK

Sp1 100.4 °F

Recommended Action No action recommended at this time

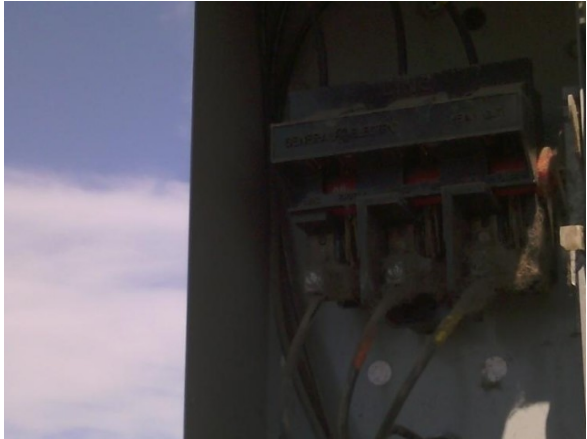
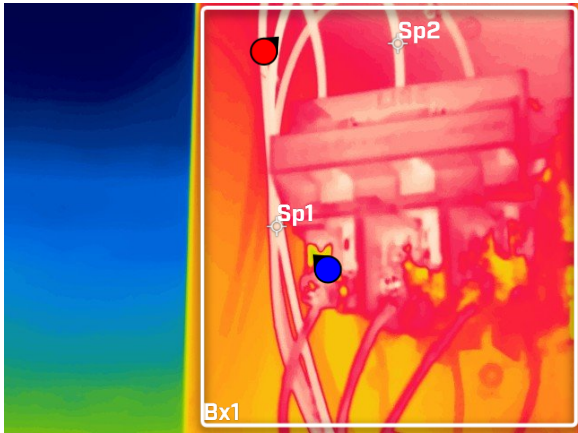
Thermogram 123 Created: 5/27/2026 4:01:13 PM

Equipment name : RTU #17

| <b>Sp2</b> | 117.5 °F |

**Issue** Dirty/corroded connection(s)

**Recommended Action** Clean equipment

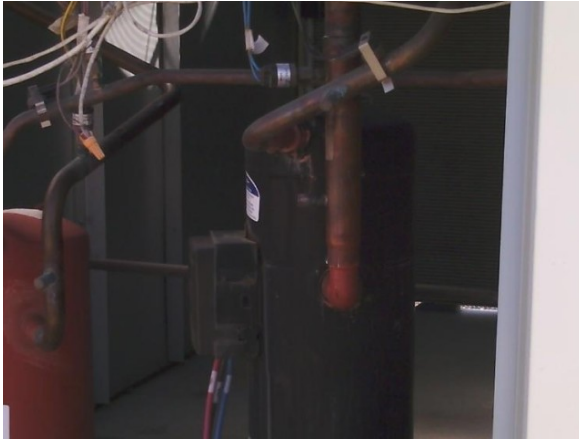
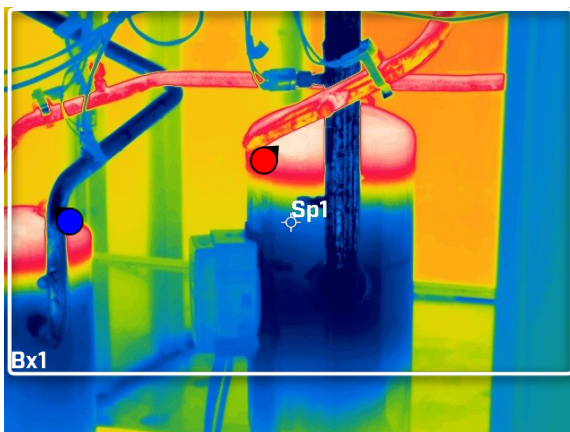
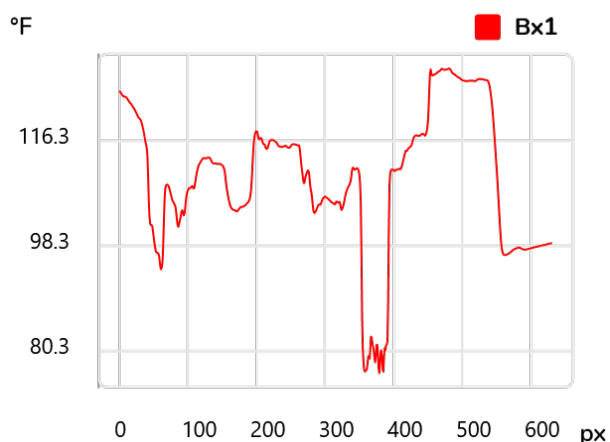
Thermogram 124 Created: 5/27/2026 4:04:31 PM

Equipment name : RTU #17  
Device name : Roof Top Units  
Measurement Point : #17  
Status Note

| <b>Sp1</b> | 91.9 °F |

**Issue** Dirty/corroded connection(s)  
**Recommended Action** Clean equipment  
**Comment** Clean with compressed air  
**Priority** 2-Intermediate/Investigate

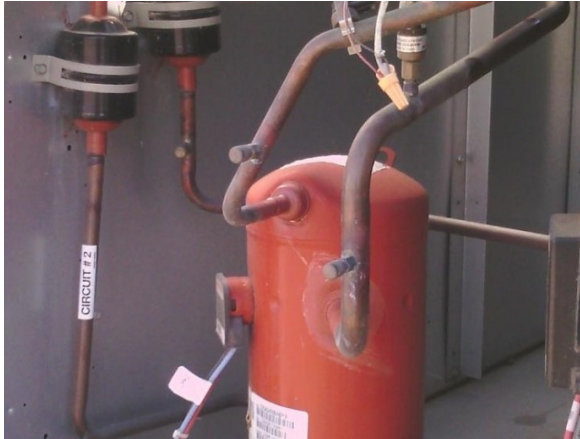
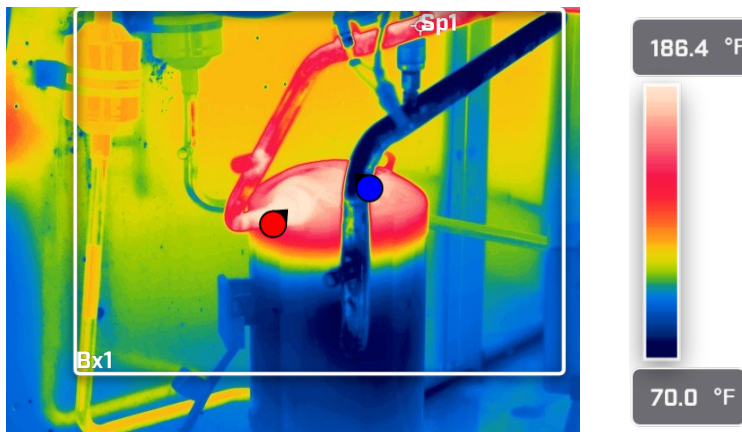
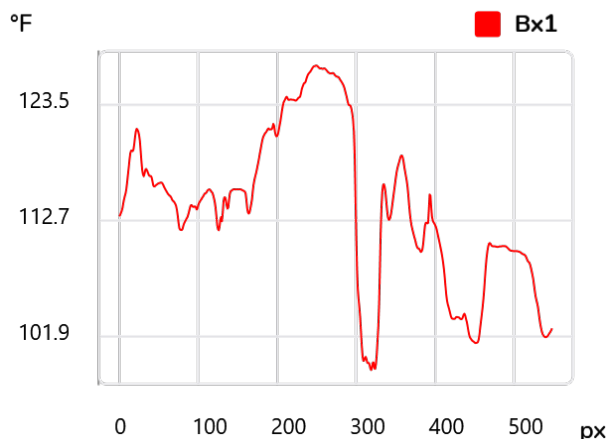
Thermogram 125 Created: 5/27/2026 4:06:04 PM

Equipment name : RTU #17  
Device name : Roof Top Units  
Measurement Point : #17  
Status Note

| <b>Sp1</b> | 155.7 °F |

**Issue** Dirty/corroded connection(s)  
**Recommended Action** Clean equipment  
**Comment** Clean with compressed air  
**Priority** 2-Intermediate/Investigate

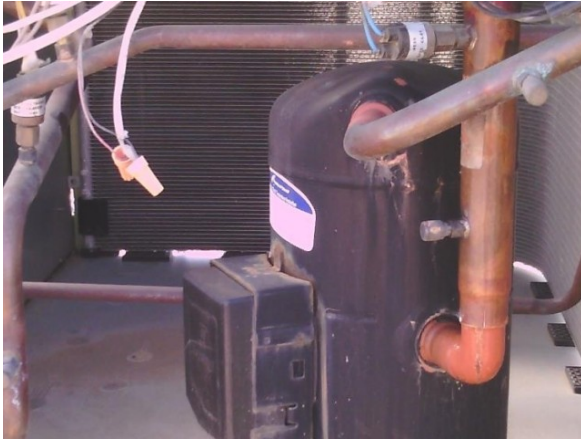
Equipment name : RTU #17  
Device name : Roof Top Units  
Measurement Point : #17  
Status Note

Issue Dirty/corroded connection(s)

Recommended Action Clean equipment

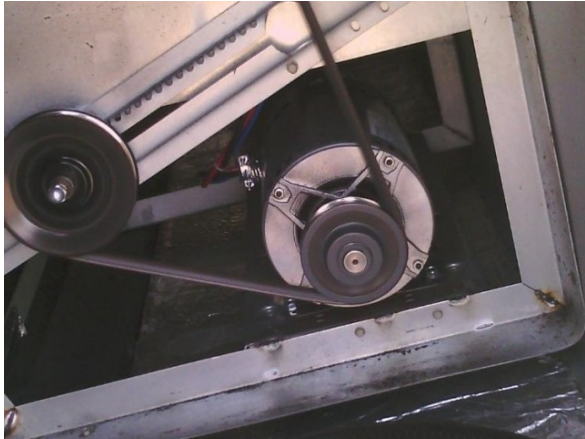
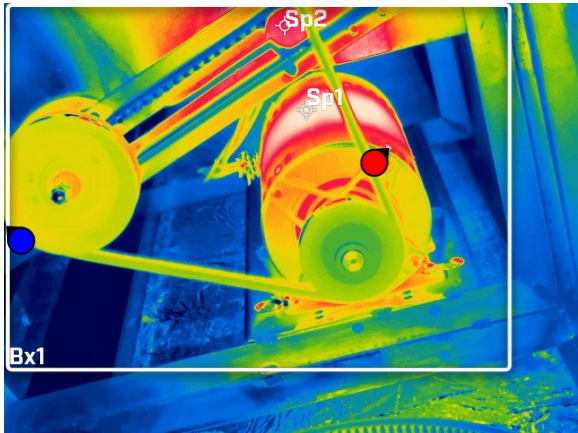
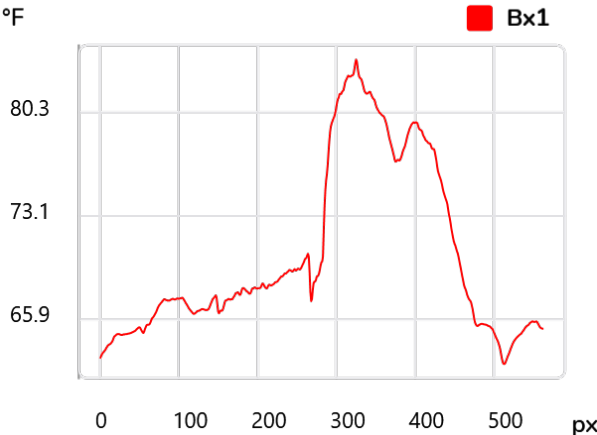
Equipment name : RTU #17  
Device name : Roof Top Units  
Measurement Point : #17  
Status Note

| Value | |
|---|---|
| Sp2 | 98.3 °F |

Issue Dirty/corroded connection(s)  
Recommended Action Clean equipment  
Comment Clean with compressed air  
Priority 2-Intermediate/Investigate

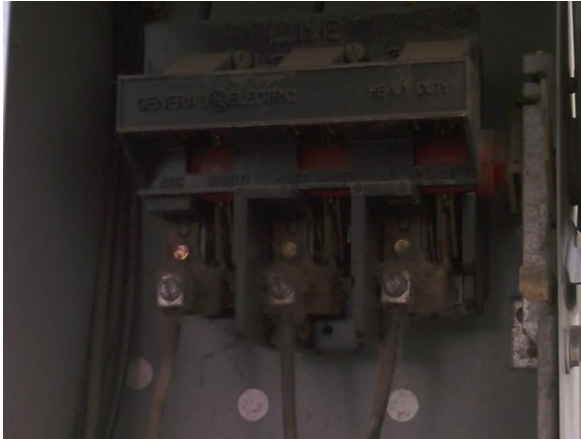
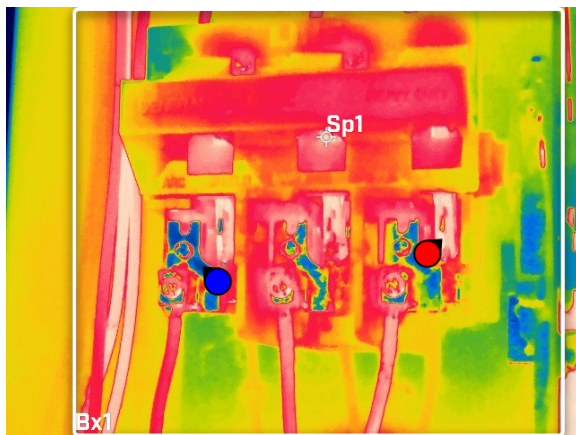
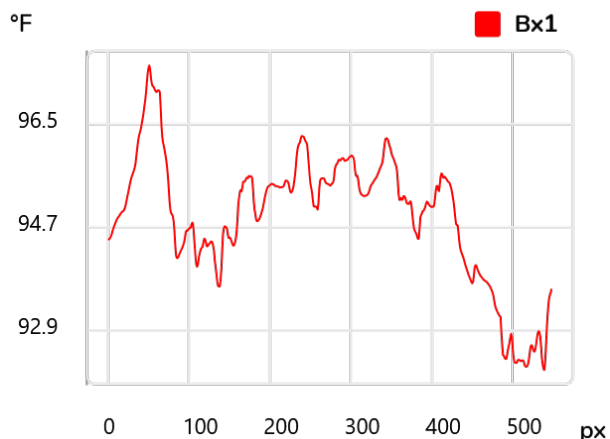
Equipment name : RTU #18  
Device name : Roof Top Units  
Measurement Point : #18  
Status Note

Sp1 99.0 °F

Issue Dirty/corroded connection(s)

Recommended Action Clean equipment

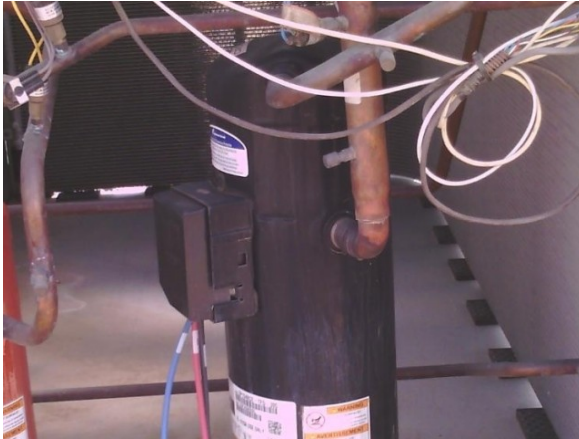
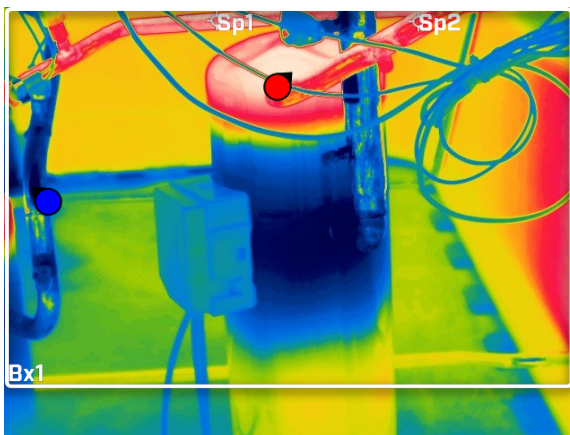
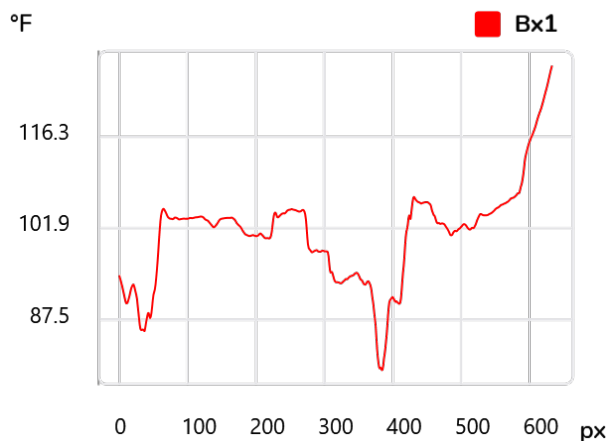
Equipment name : RTU #18  
Device name : Roof Top Units  
Measurement Point : #18  
Status Note

Sp2 124.5 °F

Issue Dirty/corroded connection(s)

Recommended Action Clean equipment

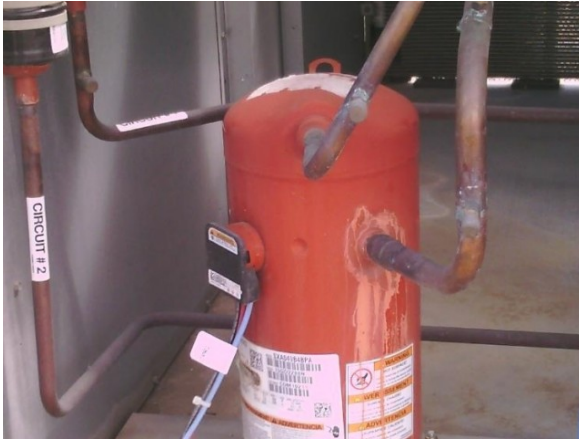
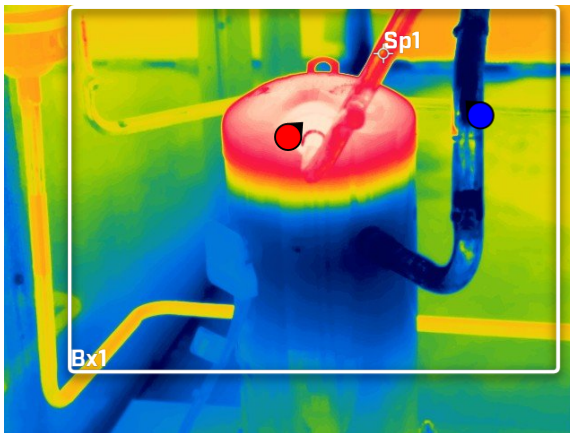
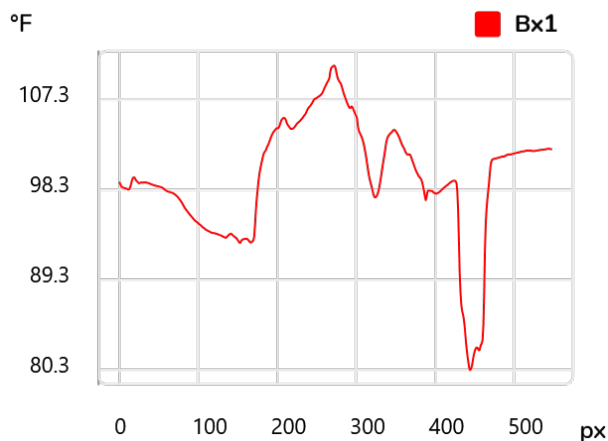
Equipment name : RTU #18  
Device name : Roof Top Units  
Measurement Point : #18  
Status Note

Sp1 126.6 °F

Issue Dirty/corroded connection(s)

Recommended Action Clean equipment

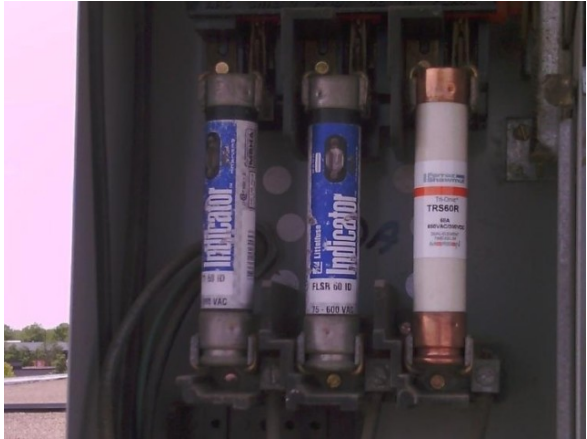
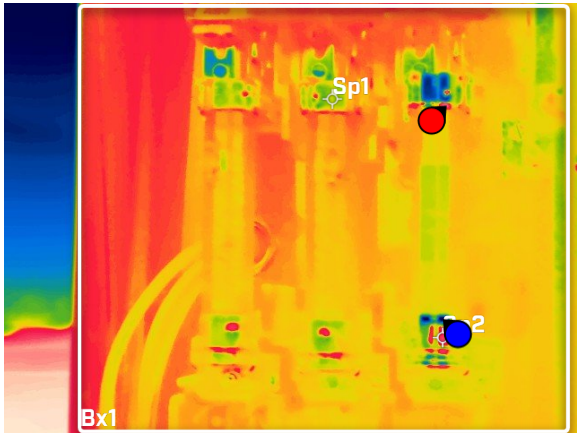
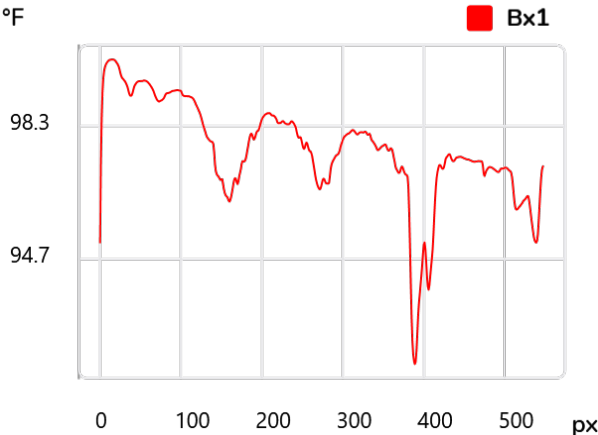
Equipment name : RTU #21  
Device name : Roof Top Units  
Measurement Point : #21  
Status Note

| <b>Sp2</b> | 107.8 °F |

**Issue** Dirty/corroded connection(s)  
**Recommended Action** Inspect connections  
**Comment** This unit blew a fuse the day before inspection  
**Priority** 2-Intermediate/Investigate

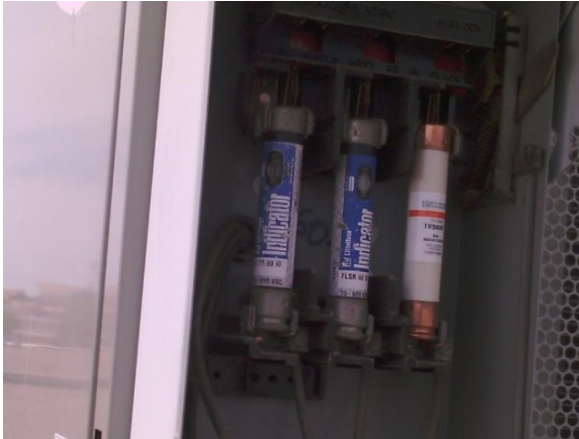
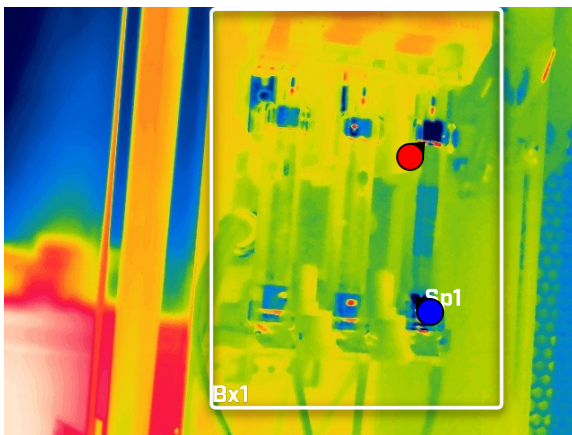
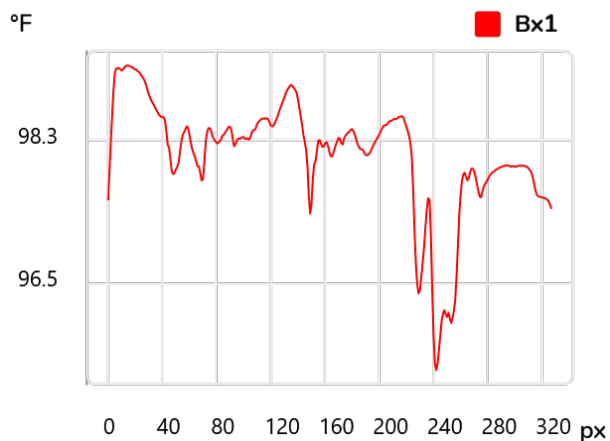
Equipment name : RTU #21  
Device name : Roof Top Units  
Measurement Point : #21  
Status Note

| <b>Sp1</b> | 107.2 °F |

**Issue** Dirty/corroded connection(s)

**Recommended Action** Inspect connections
