# THERMAL ELECTRICAL INSPECTION

## SAMPLE REPORT

RETROFIT  
ELECTRIC

# Retrofit Electric - Thermal Electrical Inspection

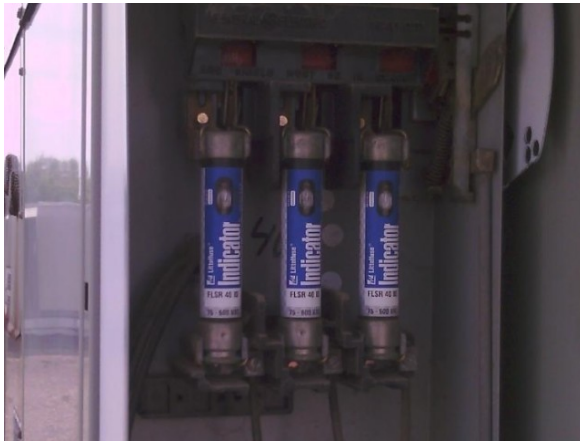
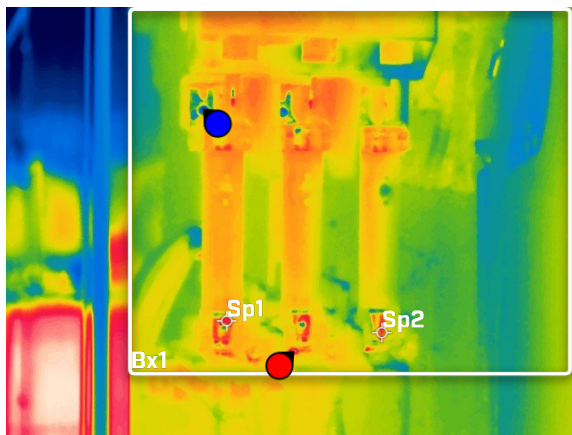
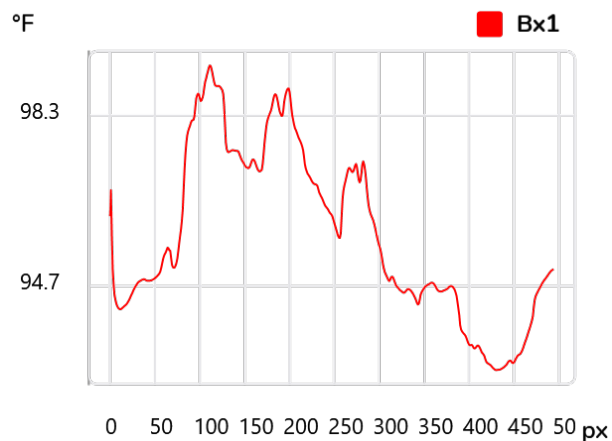
Thermogram 140 Created: 6/2/2026 2:26:49 PM

Equipment name : RTU #14  
Device name : Roof Top Units  
Measurement Point : #14  
Status OK

Max 115.8 °F  
Min 84.8 °F  
Area 72.872 ft<sup>2</sup>  
Sp1 107.5 °F  
Sp2 103.8 °F

Issue No Issue - Normal operation

Recommended Action No action recommended at this time

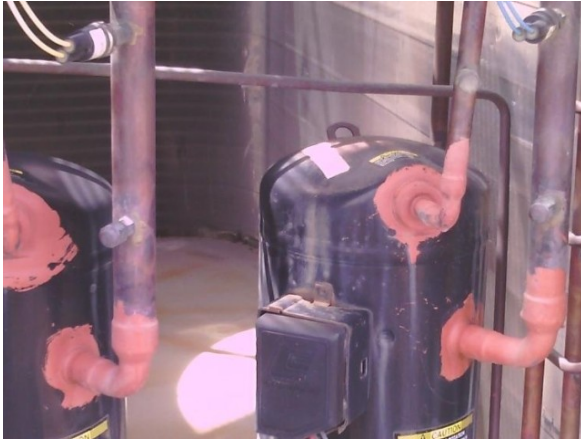
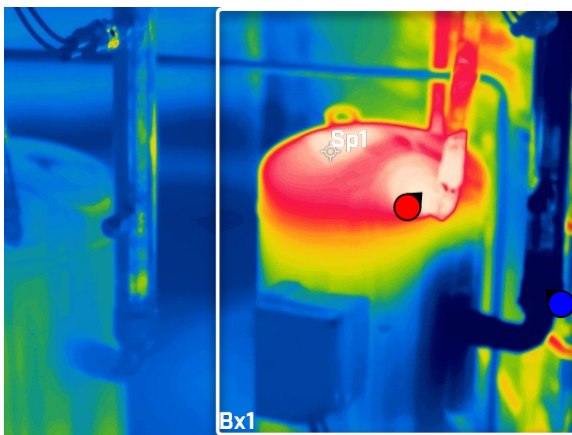
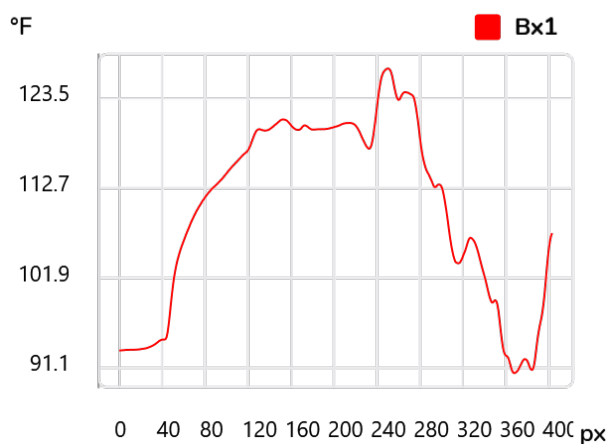
Thermogram 141 Created: 6/2/2026 2:29:04 PM

Equipment name : RTU #14  
Device name : Roof Top Units  
Measurement Point : #14  
Status OK

Sp1 181.7 °F

Issue No Issue - Normal operation

Recommended Action No action recommended at this time

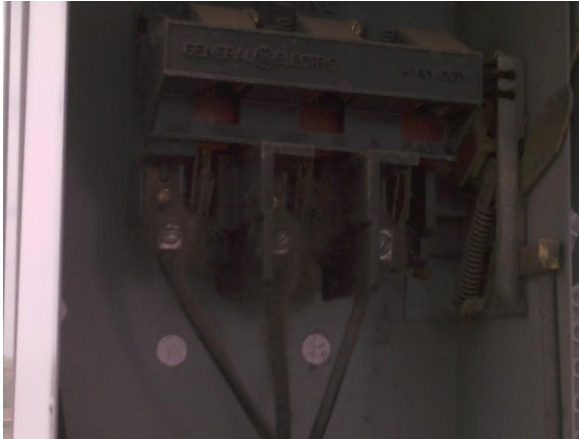
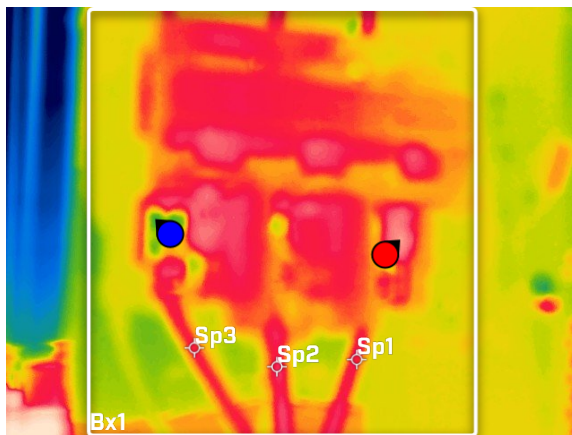
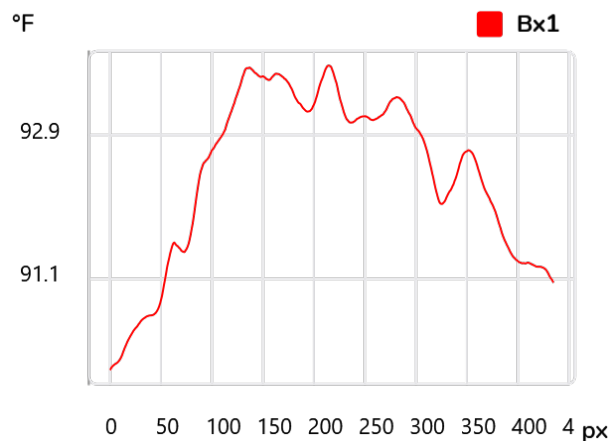
Thermogram 142 Created: 6/2/2026 2:38:02 PM

Equipment name : RTU #20  
Device name : Roof Top Units  
Measurement Point : #20  
Status Note

Sp3 94.1 °F

Issue Dirty/corroded connection(s)

Recommended Action Clean equipment

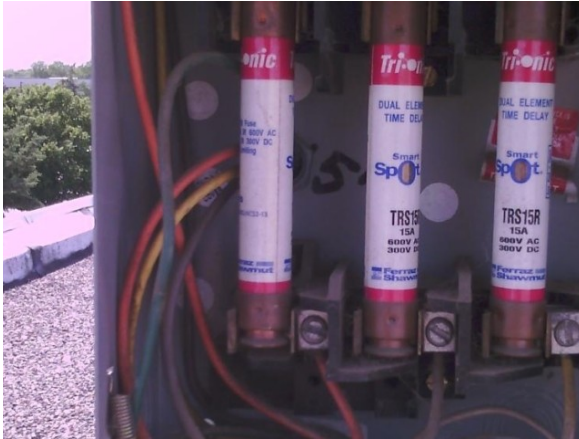
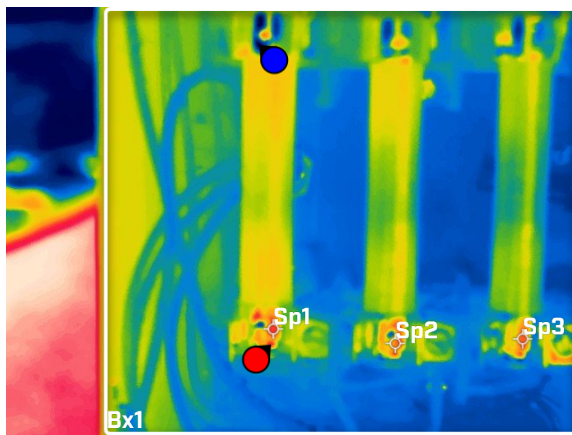
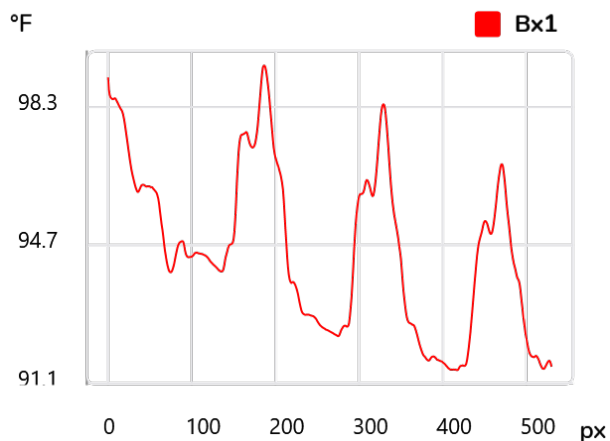
Thermogram 143 Created: 6/3/2026 2:56:12 PM

Equipment name : RTU #22  
Device name : Roof Top Units  
Measurement Point : #22  
Status OK

Sp3 111.8 °F

Issue No Issue - Normal operation

Recommended Action No action recommended at this time

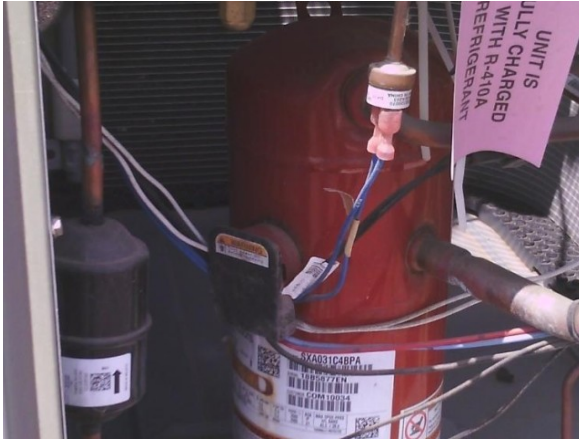
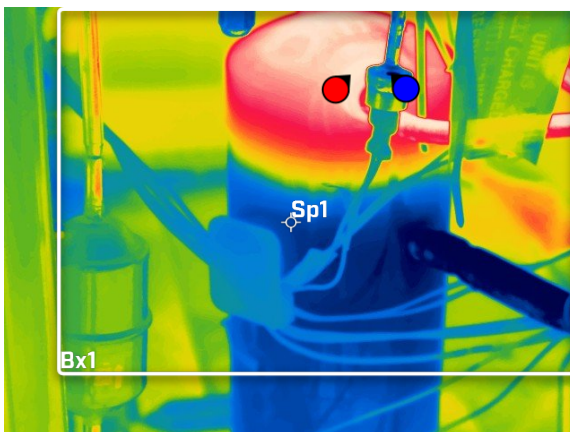
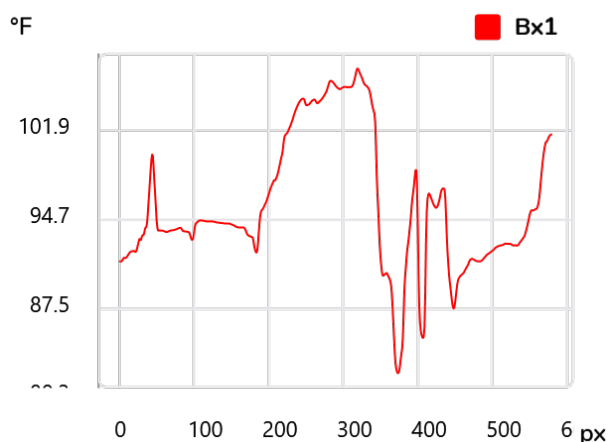
Thermogram 144 Created: 6/3/2026 2:57:39 PM

Equipment name : RTU #22  
Device name : Roof Top Units  
Measurement Point : #22  
Status OK

Sp1 73.3 °F

Issue No Issue - Normal operation

Recommended Action No action recommended at this time

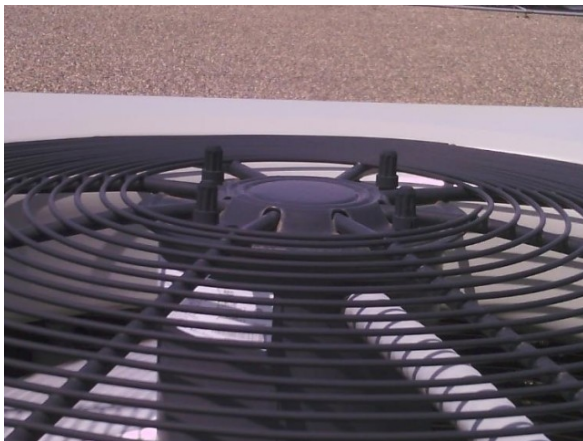
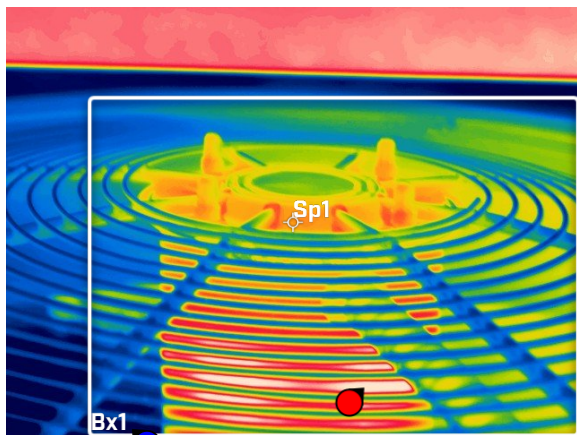
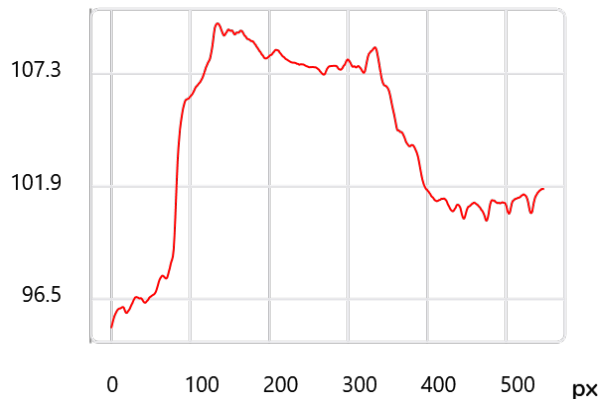
## Thermogram 145

Equipment name : RTU #22  
Device name : Roof Top Units  
Measurement Point : #22  
Status OK

Recommended Action No action recommended at this time

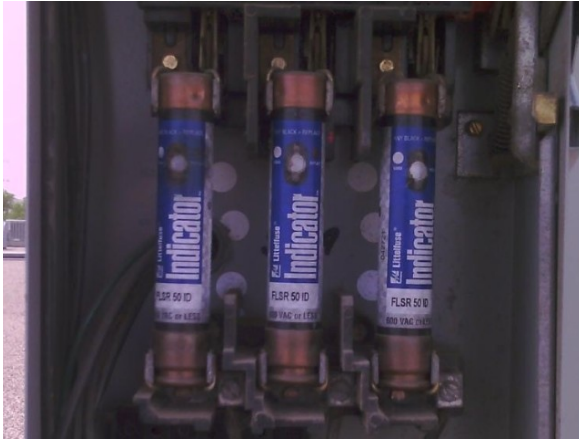
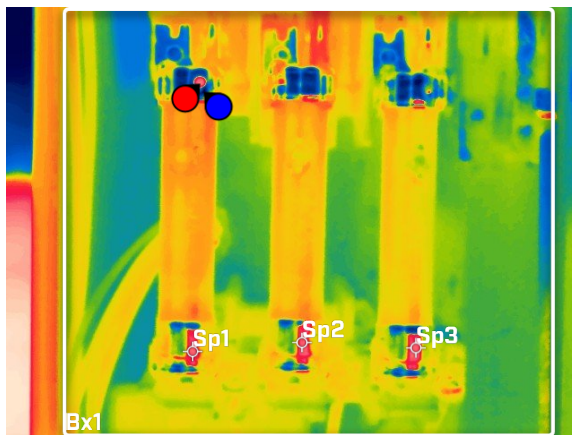
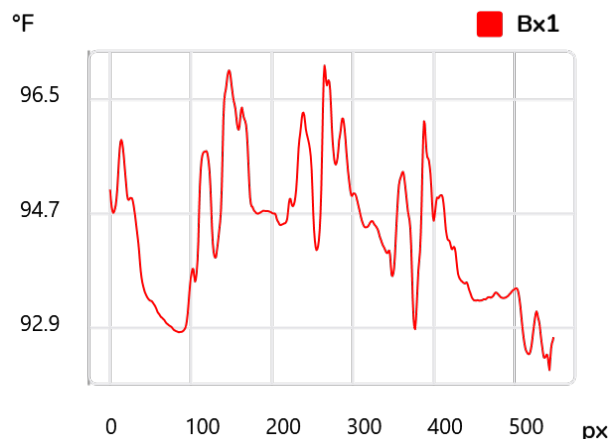
Thermogram 146 Created: 6/3/2026 1:55:18 PM

Equipment name : RTU #23  
Device name : Roof Top Units  
Measurement Point : #23  
Status OK

Max 115.8 °F  
Min 69.4 °F  
Area 0.547 ft<sup>2</sup>  
Sp1 114.5 °F  
Sp2 113.0 °F  
Sp3 112.9 °F

Issue No Issue - Normal operation

Recommended Action No action recommended at this time

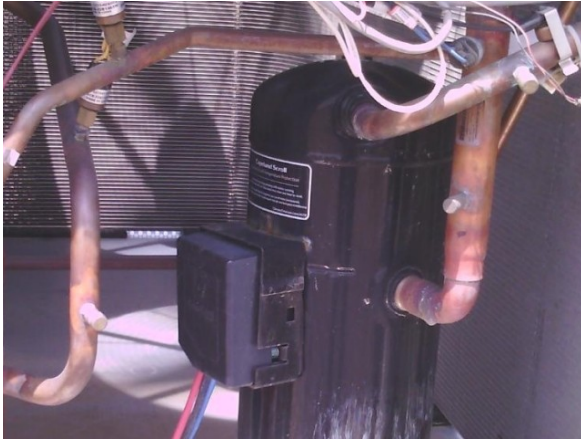
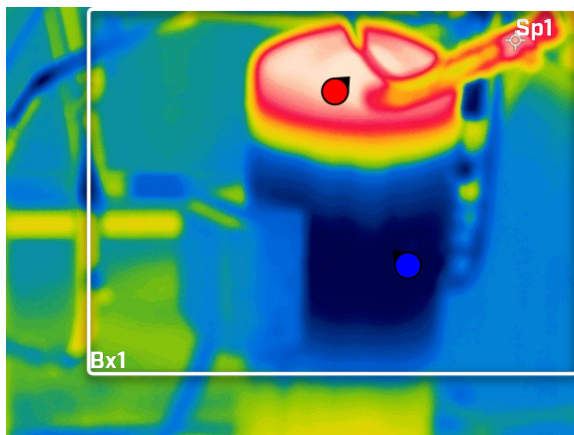
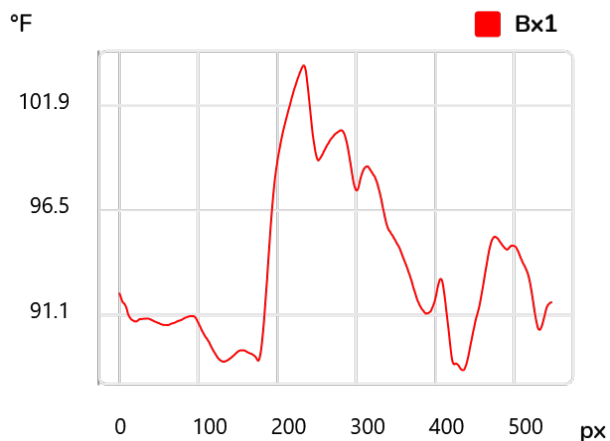
Thermogram 147 Created: 6/3/2026 1:59:45 PM

Equipment name : RTU #23  
Device name : Roof Top Units  
Measurement Point : #23  
Status OK

| <b>Sp1</b> | 161.9 °F |

**Recommended Action** No action recommended at this time

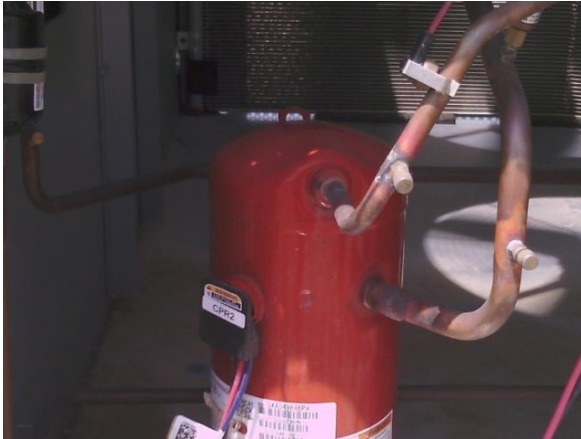
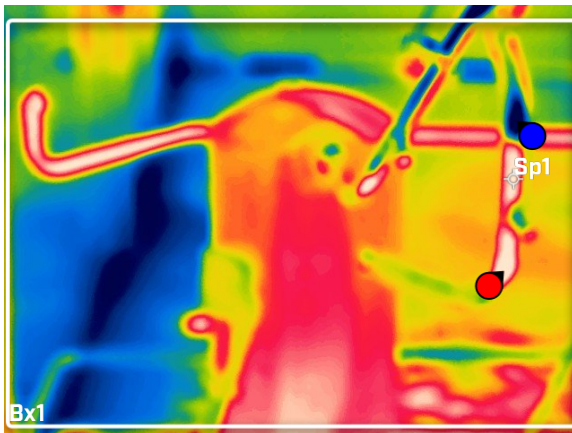
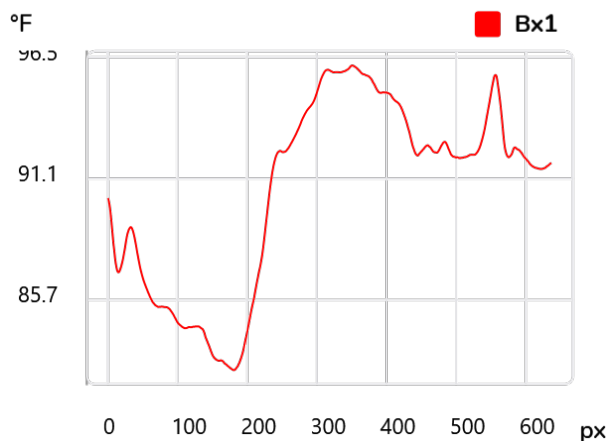
Thermogram 148 Created: 6/3/2026 2:00:18 PM

Equipment name : RTU #23  
Device name : Roof Top Units  
Measurement Point : #23  
Status OK

Sp1 105.8 °F

Recommended Action No action recommended at this time

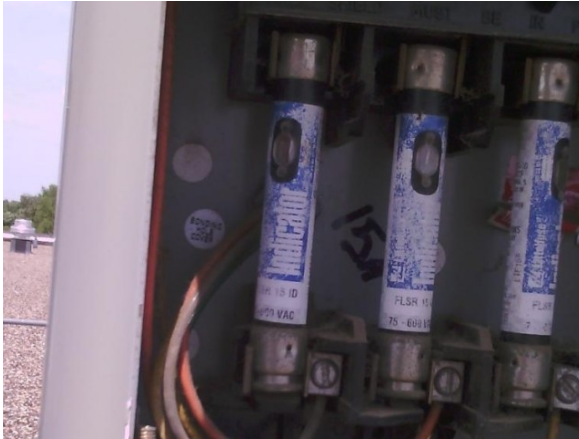
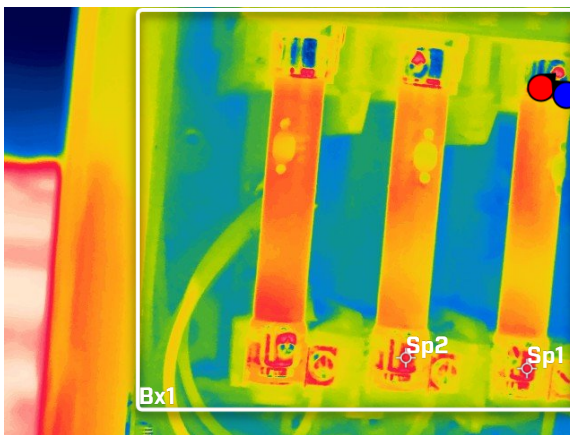
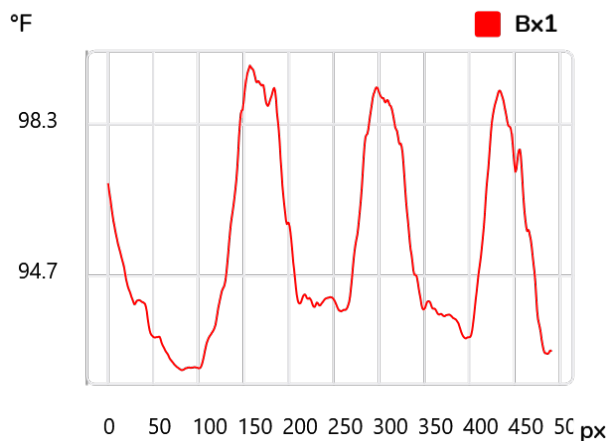
Thermogram 149 Created: 6/3/2026 1:43:42 PM

Equipment name : RTU #24  
Device name : Roof Top Units  
Measurement Point : #24  
Status OK

Sp2 102.3 °F

Recommended Action No action recommended at this time

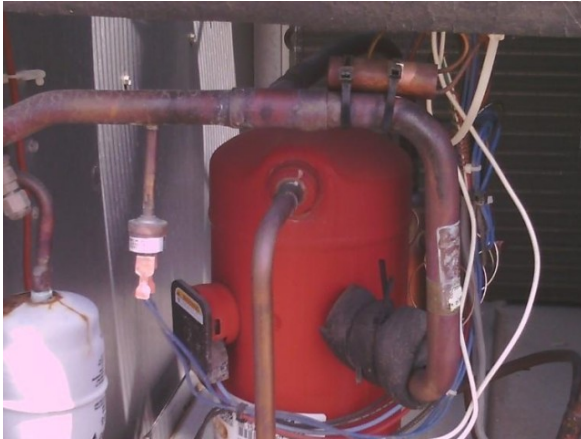
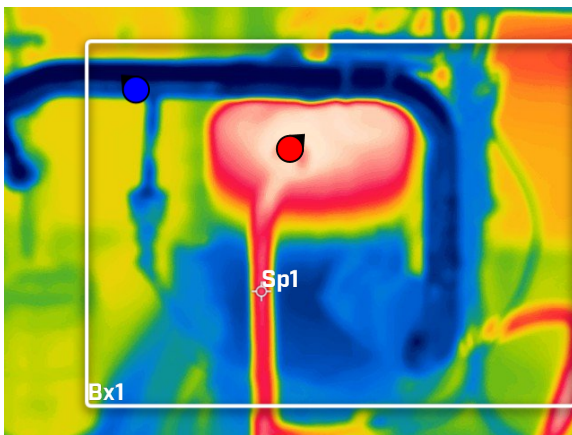
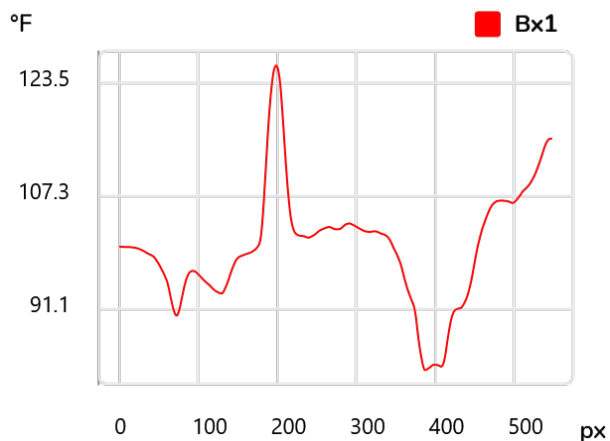
Thermogram 150 Created: 6/3/2026 1:47:43 PM

Equipment name : RTU #24  
Device name : Roof Top Units  
Measurement Point : #24  
Status OK

Sp1 132.7 °F

Recommended Action No action recommended at this time

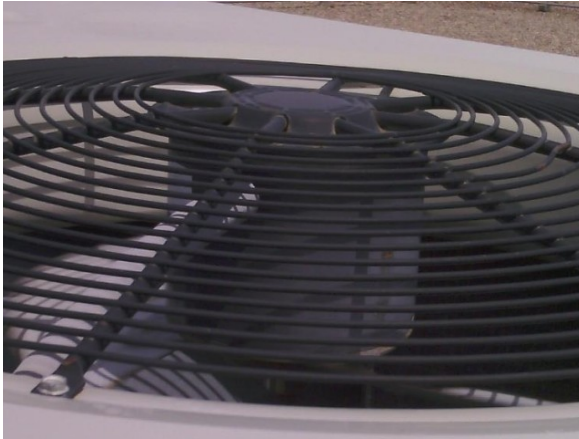
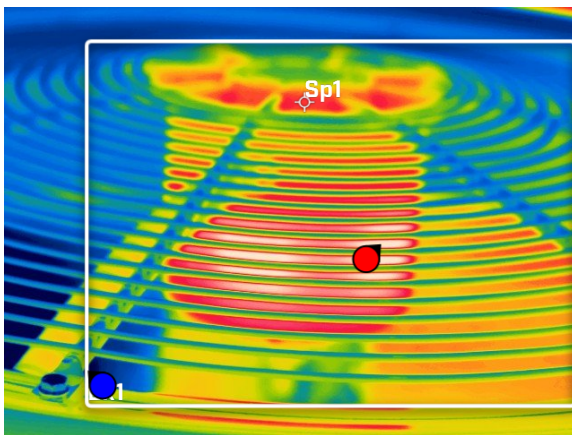
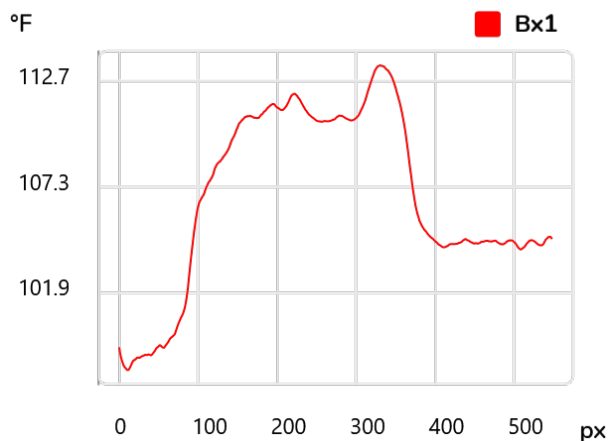
Thermogram 151 Created: 6/3/2026 1:48:20 PM

Equipment name : RTU #24  
Device name : Roof Top Units  
Measurement Point : #24  
Status OK

| <b>Sp1</b> | 119.1 °F |

**Issue** No Issue - Normal operation

**Recommended Action** No action recommended at this time

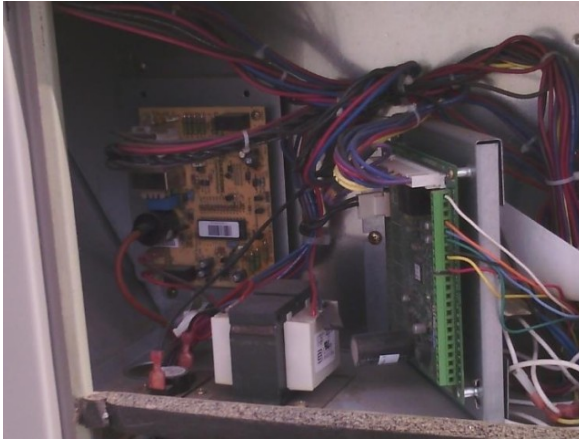
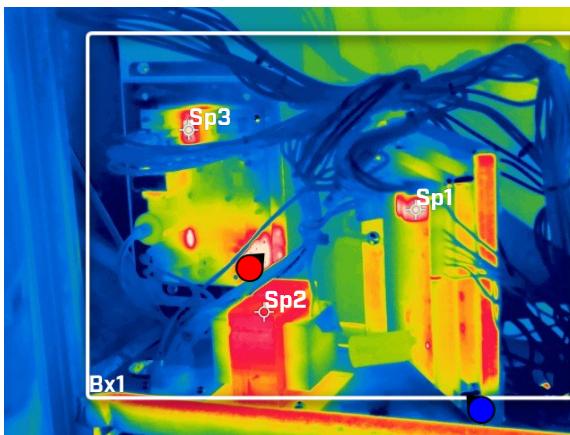
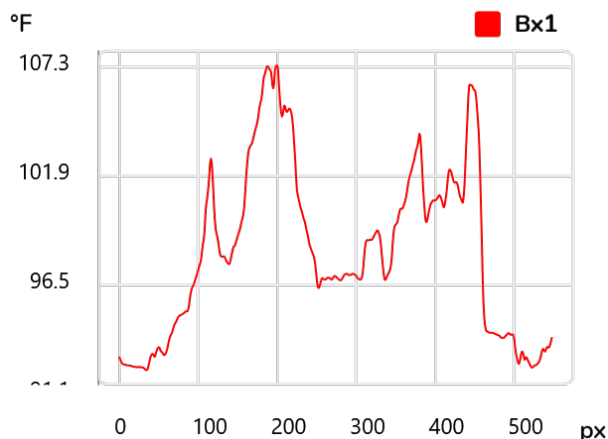
Thermogram 152 Created: 6/3/2026 1:49:14 PM

Equipment name : RTU #24  
Device name : Roof Top Units  
Measurement Point : #24  
Status OK

Sp3 152.2 °F

Issue No Issue - Normal operation

Recommended Action No action recommended at this time

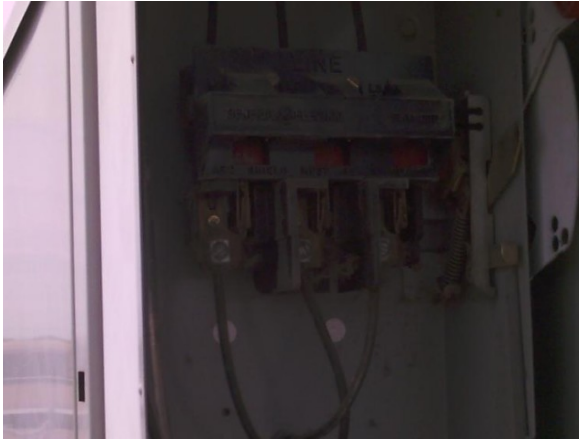
Equipment name : RTU #25  
Device name : Roof Top Units  
Measurement Point : #25  
Status Note

**Issue** Dirty/corroded connection(s)  
**Recommended Action** Inspect connections

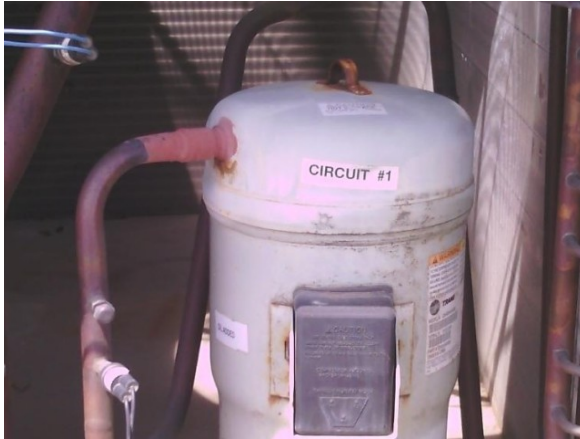
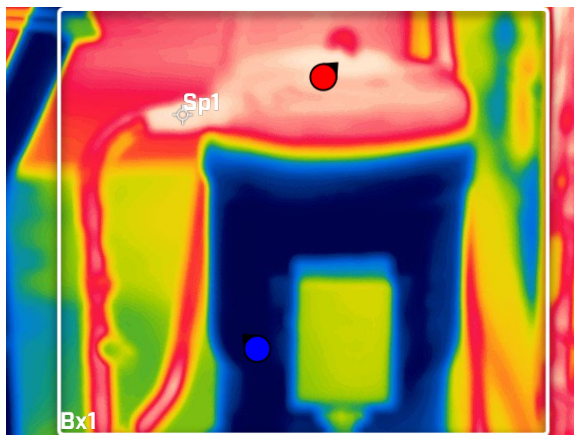
Thermogram 154 Created: 6/3/2026 2:11:44 PM

Equipment name : RTU #25  
Device name : Roof Top Units  
Measurement Point : #25  
Status Note

| <b>Sp1</b> | 130.7 °F |

**Issue** Dirty/corroded connection(s)  
**Recommended Action** Inspect connections

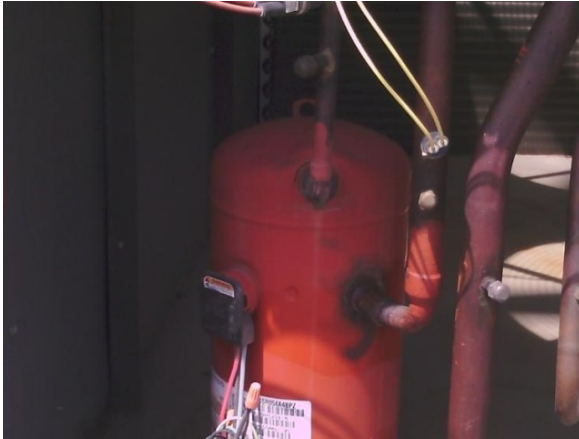
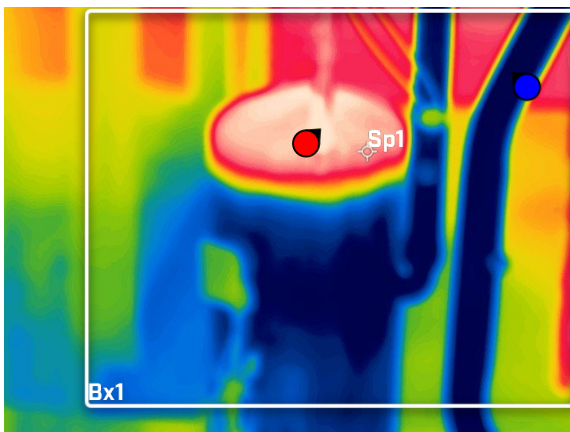
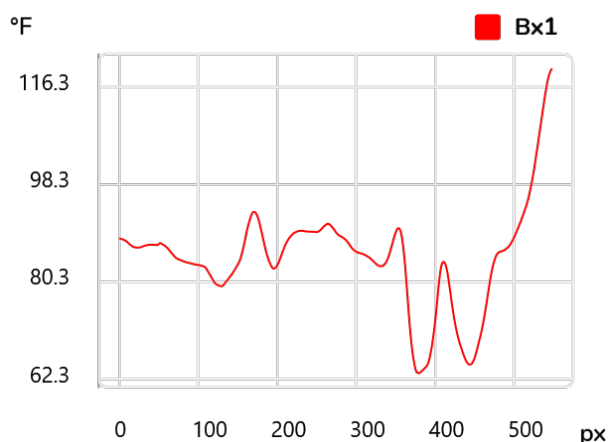
Thermogram 155 Created: 6/3/2026 2:12:09 PM

Equipment name : RTU #25  
Device name : Roof Top Units  
Measurement Point : #25  
Status Note

Sp1 134.5 °F

Issue Dirty/corroded connection(s)

Recommended Action Inspect connections

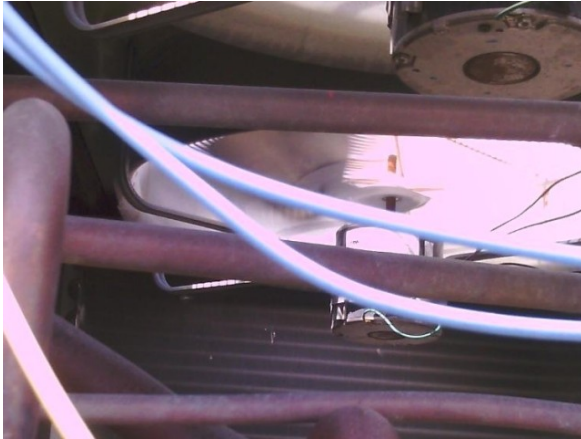
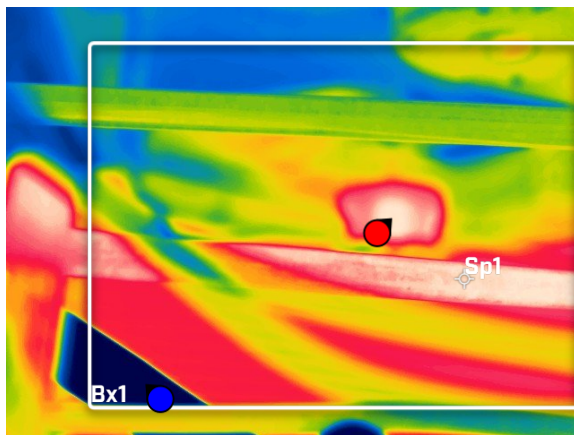
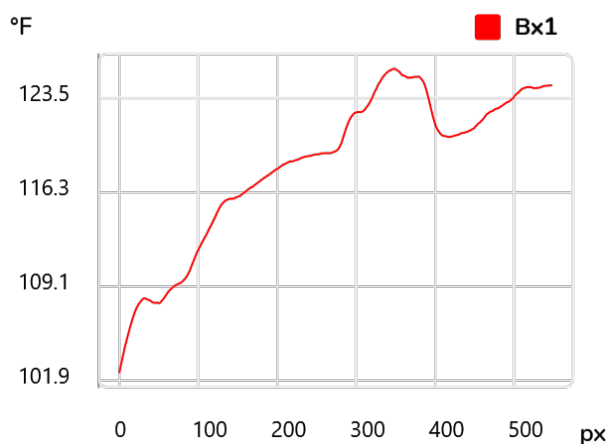
Thermogram 156 Created: 6/3/2026 2:15:28 PM

Equipment name : RTU #25  
Device name : Roof Top Units  
Measurement Point : #25  
Status Note

| <b>Sp1</b> | 152.9 °F |

**Issue** Dirty/corroded connection(s)  
**Recommended Action** Inspect connections

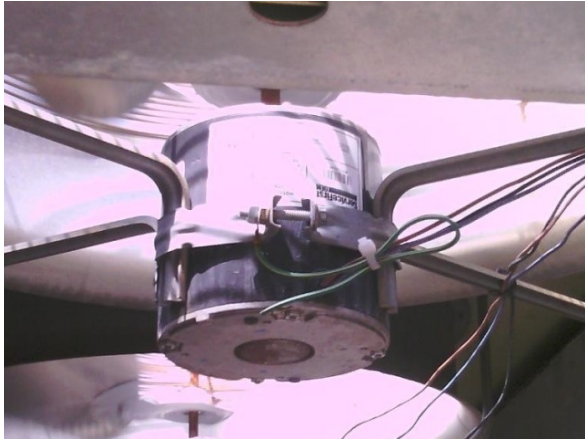
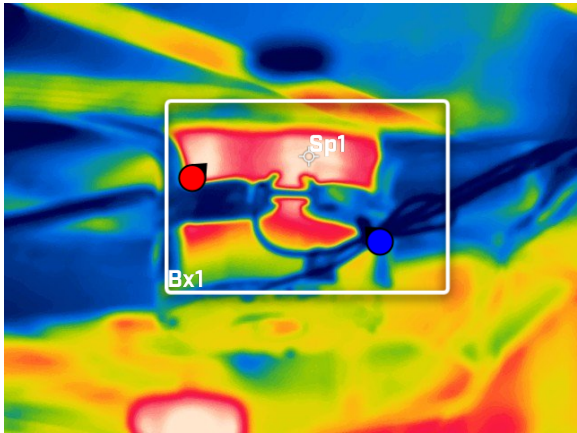
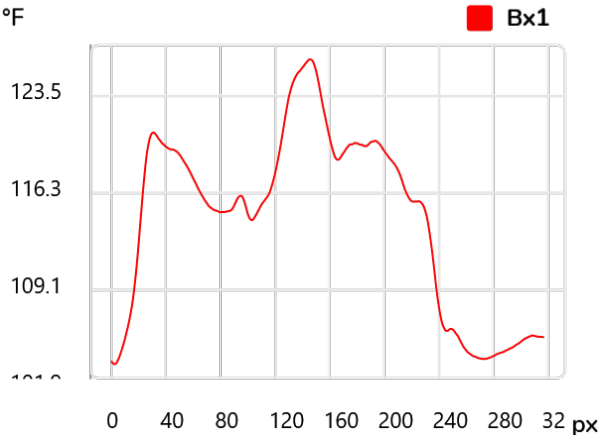
Thermogram 157 Created: 6/3/2026 2:15:55 PM

Equipment name : RTU #25  
Device name : Roof Top Units  
Measurement Point : #25  
Status Note

| Value | |
|---|---|
| Sp1 | 148.0 °F |

Issue Dirty/corroded connection(s)  
Recommended Action Inspect connections  
Comment Check connection on A-phase. Clean with compressed air. 25.8,23.5,24.7amps  
Priority 2-Intermediate/Investigate

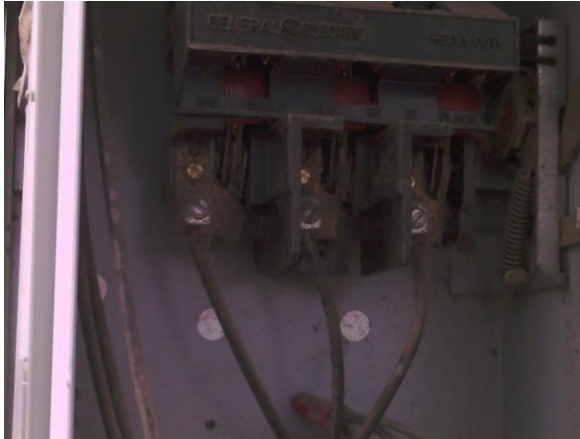
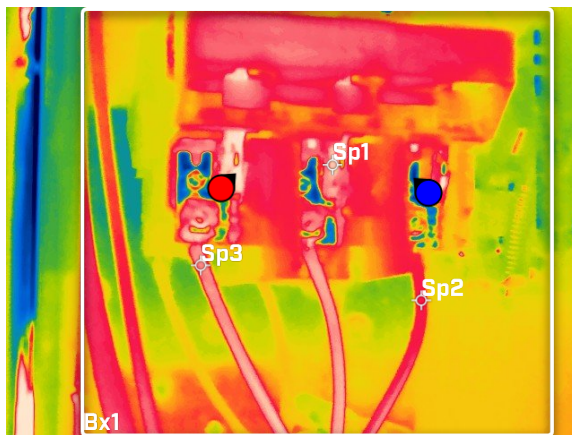
Thermogram 158 Created: 6/3/2026 1:22:55 PM

Equipment name : RTU #26  
Device name : Roof Top Units  
Measurement Point : #26  
Status Note

Max 102.3 °F  
Min 77.2 °F  
Area 1.094 ft<sup>2</sup>  
Sp1 97.8 °F  
Sp2 94.7 °F  
Sp3 96.4 °F

**Issue** Dirty/corroded connection(s)  
**Recommended Action** Clean equipment  
**Comment** Clean with compressed air. 26.3,26.4,23 amps  
**Priority** 2-Intermediate/Investigate

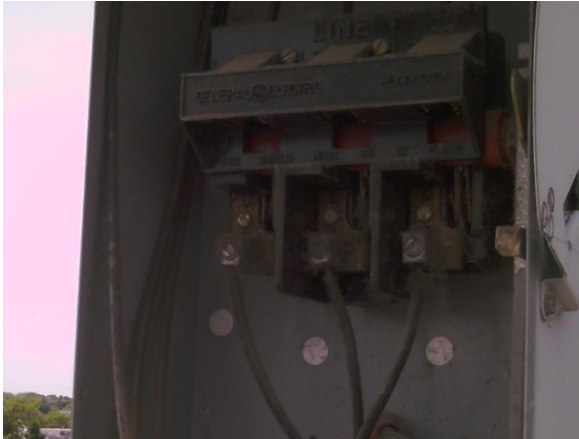
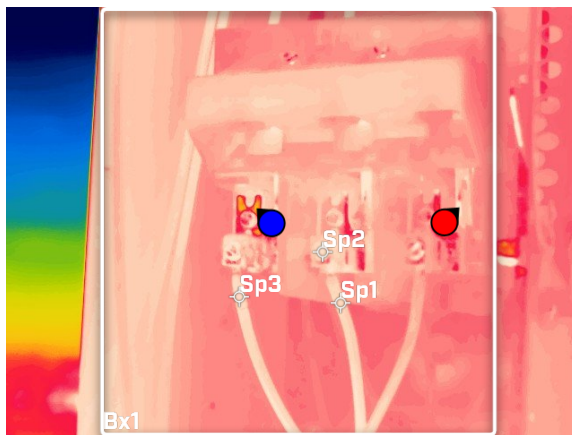
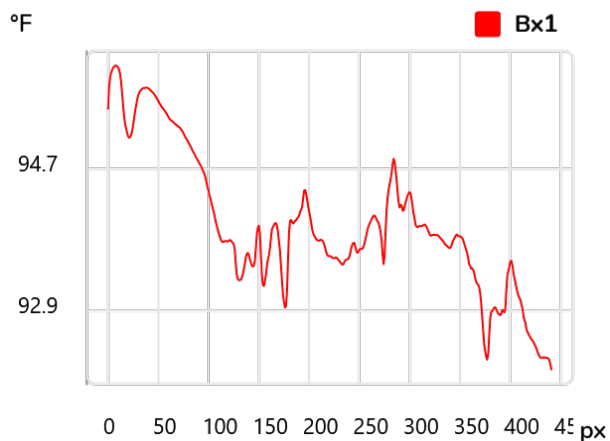
Thermogram 159 Created: 6/3/2026 1:23:52 PM

Equipment name : RTU #26  
Device name : Roof Top Units  
Measurement Point : #26  
Status Note

| <b>Sp3</b> | 97.0 °F |

**Issue** Dirty/corroded connection(s)  
**Recommended Action** Clean equipment  
**Comment** Clean with compressed air. 26.3,26.4,23 amps  
**Priority** 2-Intermediate/Investigate

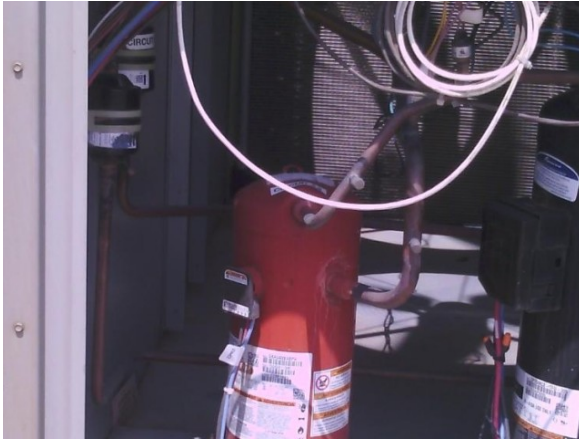
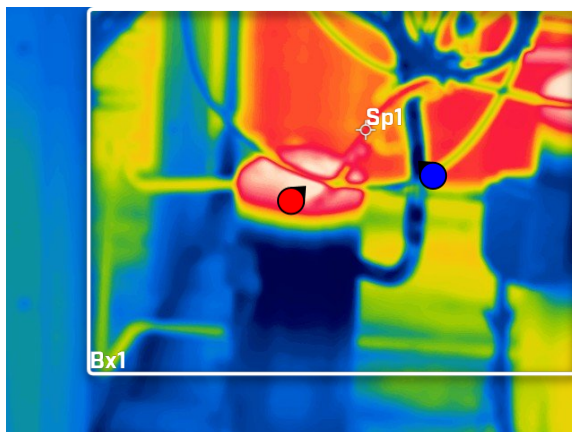
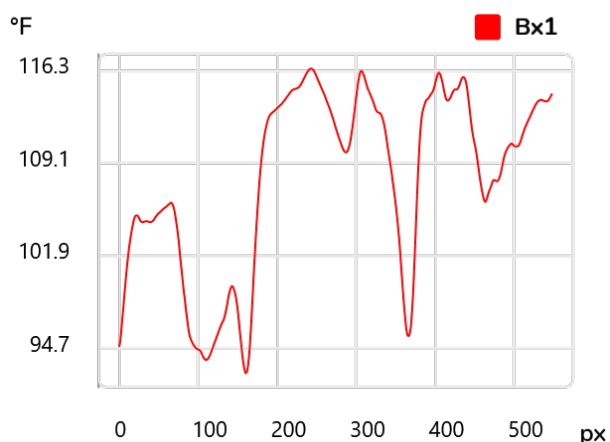
Thermogram 160 Created: 6/3/2026 1:24:22 PM

Equipment name : RTU #26  
Device name : Roof Top Units  
Measurement Point : #26  
Status Note

| <b>Sp1</b> | 135.5 °F |

**Issue** Dirty/corroded connection(s)  
**Recommended Action** Clean equipment  
**Comment** Clean with compressed air. 26.3,26.4,23 amps  
**Priority** 2-Intermediate/Investigate

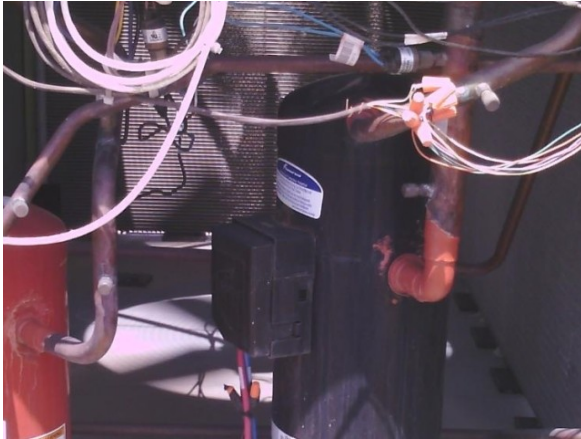
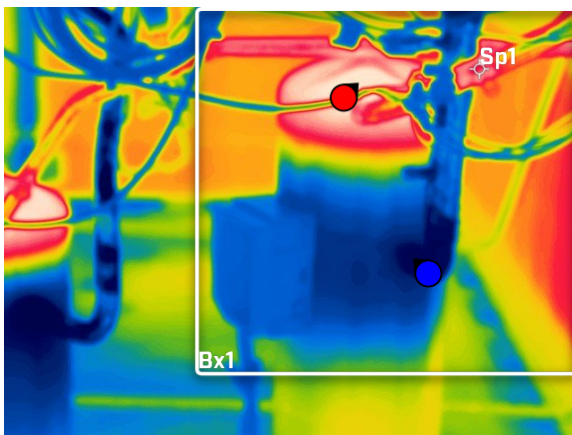
Thermogram 161 Created: 6/3/2026 1:24:55 PM

Equipment name : RTU #26  
Device name : Roof Top Units  
Measurement Point : #26  
Status Note

| <b>Sp1</b> | 148.1 °F |

**Issue** Dirty/corroded connection(s)  
**Recommended Action** Clean equipment  
**Comment** Clean with compressed air. 26.3,26.4,23 amps  
**Priority** 2-Intermediate/Investigate

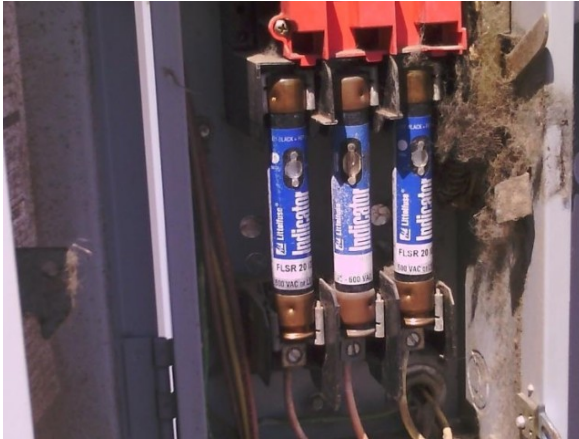
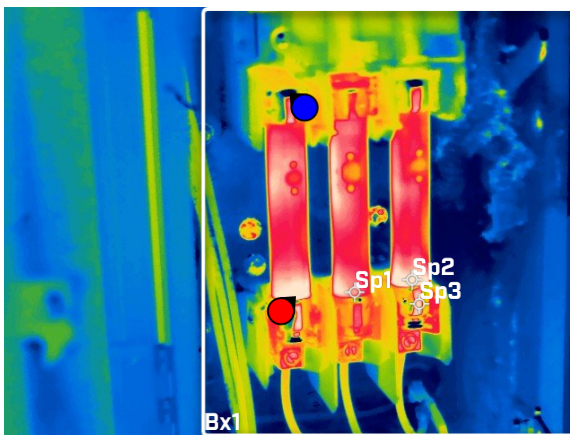
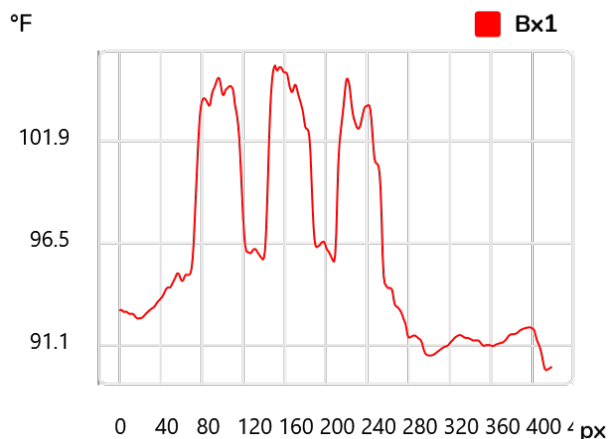
Thermogram 165 Created: 6/3/2026 11:12:02 AM

Equipment name : RTU #29  
Device name : Roof Top Units  
Measurement Point : #29  
Status Note

Max 125.7 °F  
Min 46.0 °F  
Area 0.870 ft²  
Sp1 115.8 °F  
Sp2 122.0 °F  
Sp3 118.0 °F

Issue Dirty/corroded connection(s)  
Recommended Action Clean equipment  
Comment Clean with compressed air. 14.5,13.7,14.3amps  
Priority 2-Intermediate/Investigate

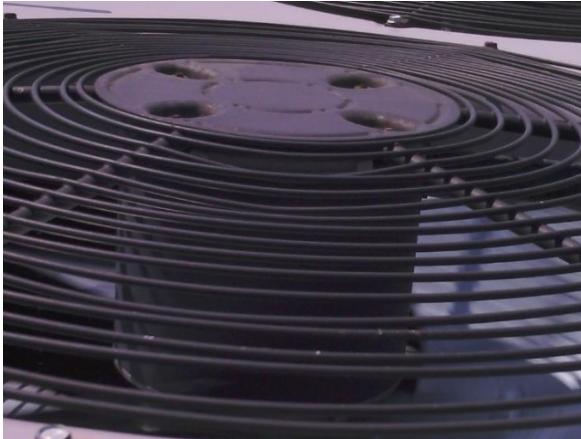
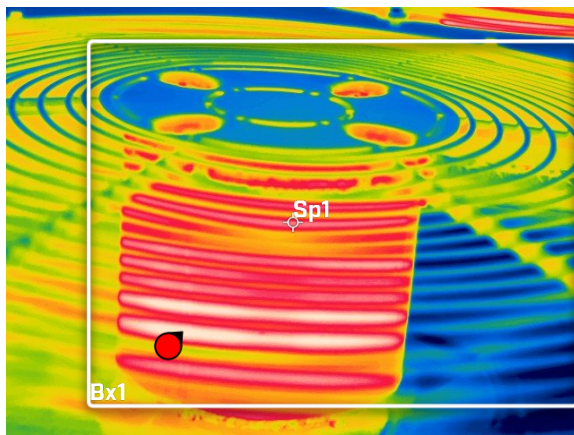
Thermogram 166 Created: 6/3/2026 11:15:02 AM

Equipment name : RTU #29  
Device name : Roof Top Units  
Measurement Point : #29  
Status Note

| <b>Sp1</b> | 113.1 °F |

**Issue** Dirty/corroded connection(s)  
**Recommended Action** Clean equipment  
**Comment** Clean with compressed air. 14.5,13.7,14.3amps  
**Priority** 2-Intermediate/Investigate

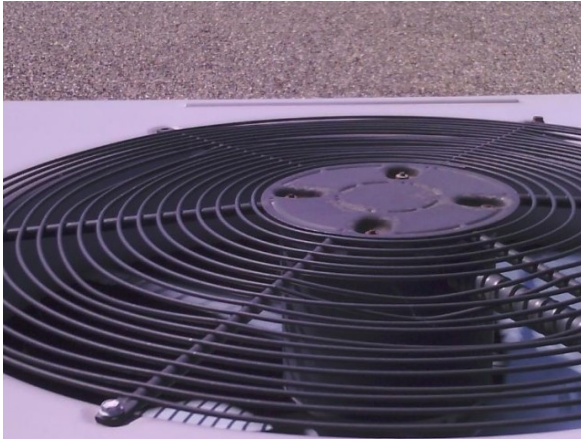
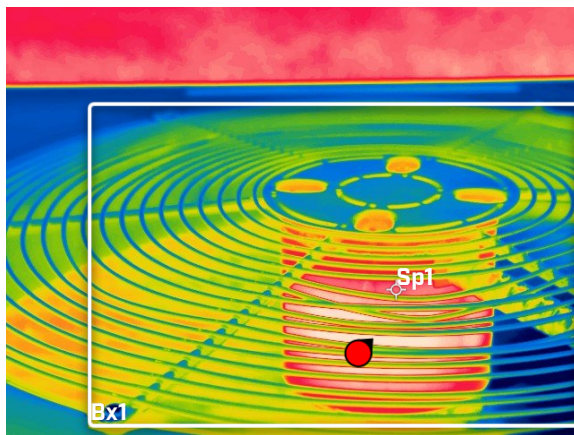
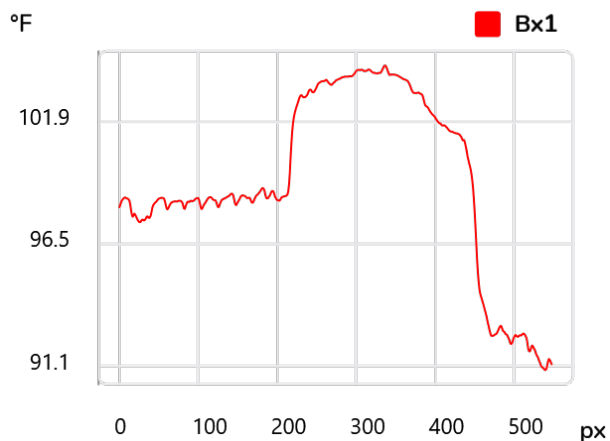
Thermogram 167 Created: 6/3/2026 11:15:21 AM

Equipment name : RTU #29  
Device name : Roof Top Units  
Measurement Point : #29  
Status Note

| <b>Sp1</b> | 118.8 °F |

**Issue** Dirty/corroded connection(s)

**Recommended Action** Clean equipment

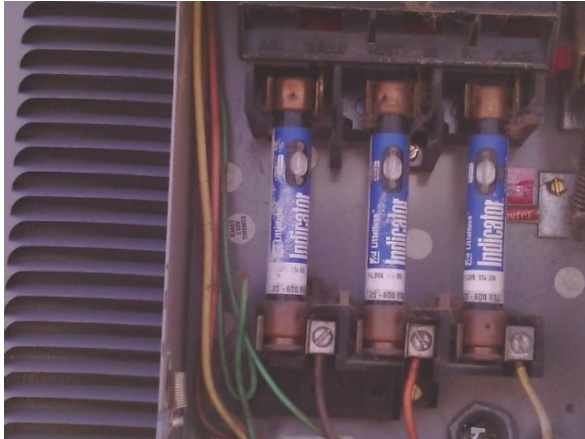
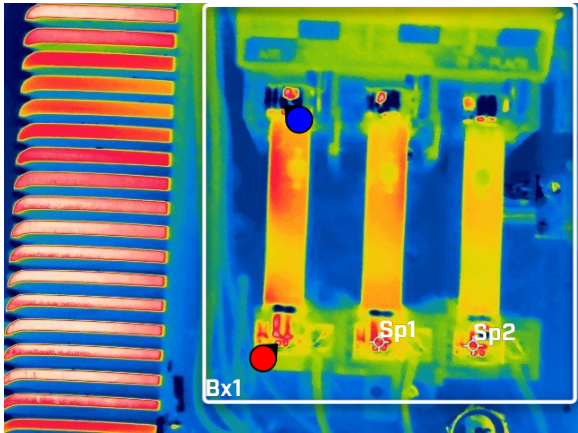
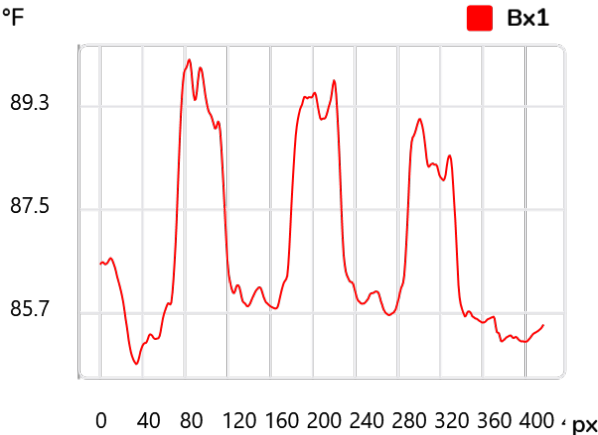
Equipment name : RTU #30  
Device name : Roof Top Units  
Measurement Point : #30  
Status OK

| Value | |
|---|---|
| <b>Sp2</b> | 96.9 °F |

**Issue** No Issue - Normal operation  
**Recommended Action** No action recommended at this time  
**Comment** 4.8,3.8,4.4amps  
**Priority** None

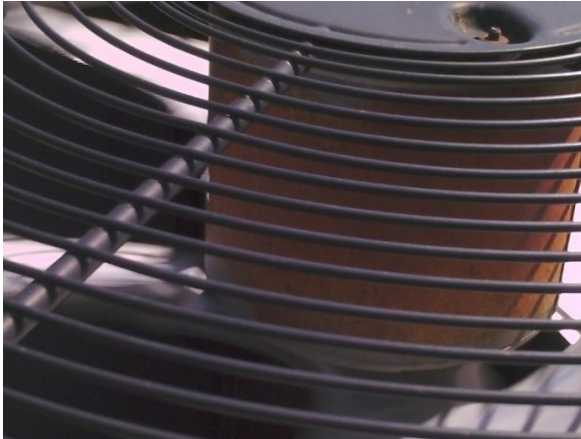
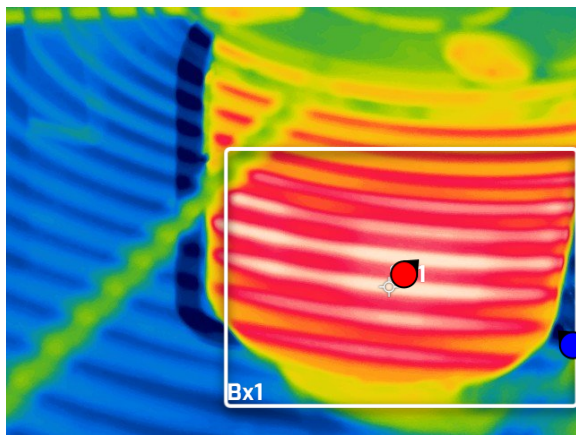
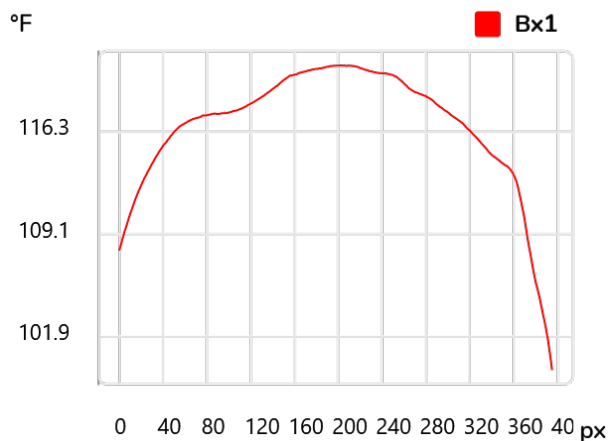
Equipment name : RTU #30  
Device name : Roof Top Units  
Measurement Point : #30  
Status OK

| <b>Sp1</b> | 133.0 °F |

**Recommended Action** No action recommended at this time

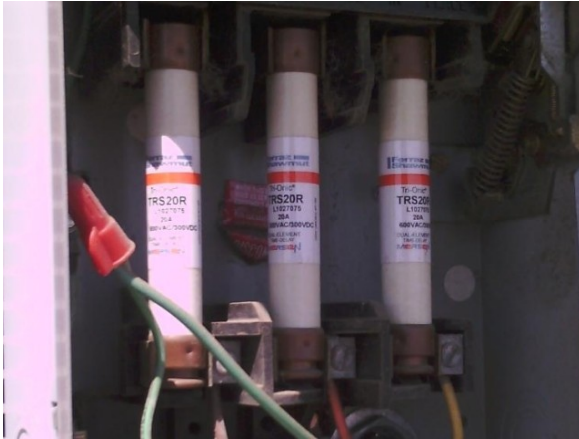
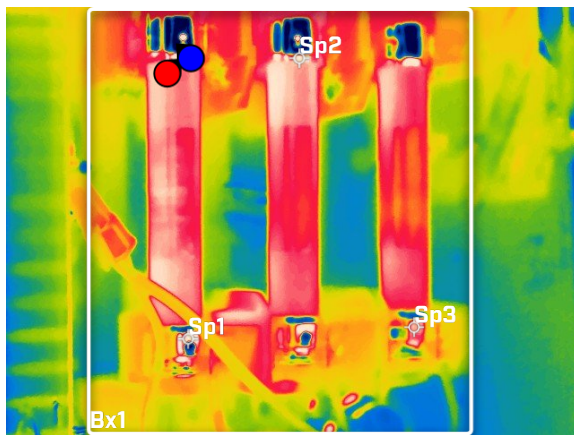
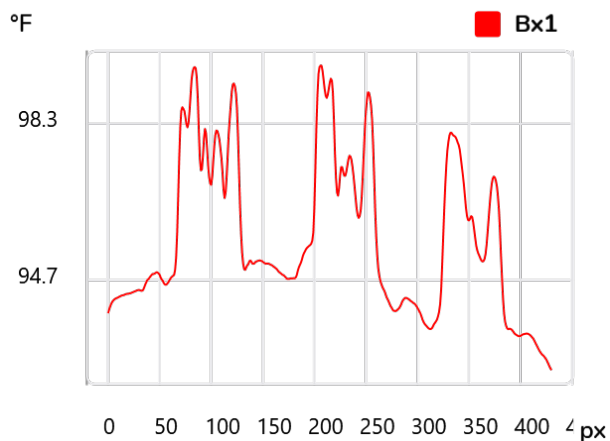
Equipment name : RTU #31  
Device name : Roof Top Units  
Measurement Point : #31  
Status OK

Sp3 102.5 °F

Recommended Action No action recommended at this time

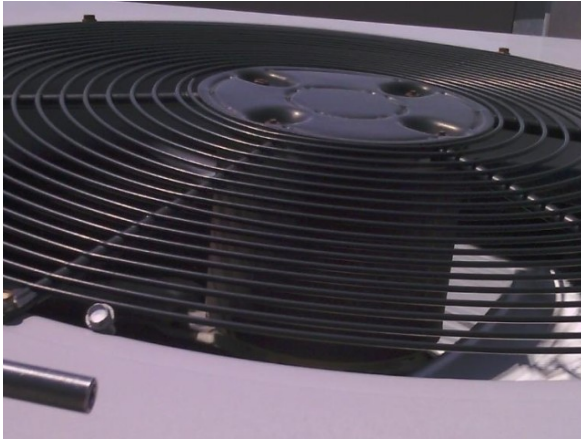
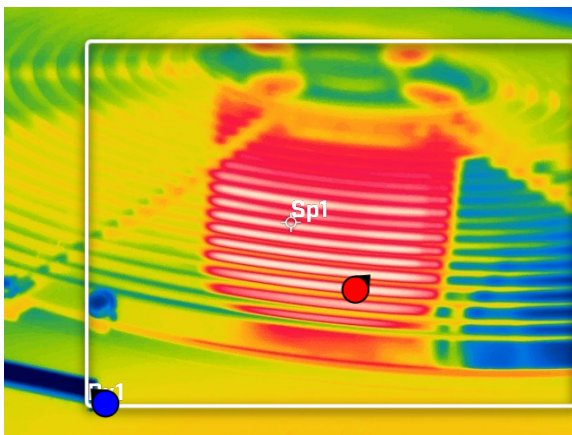
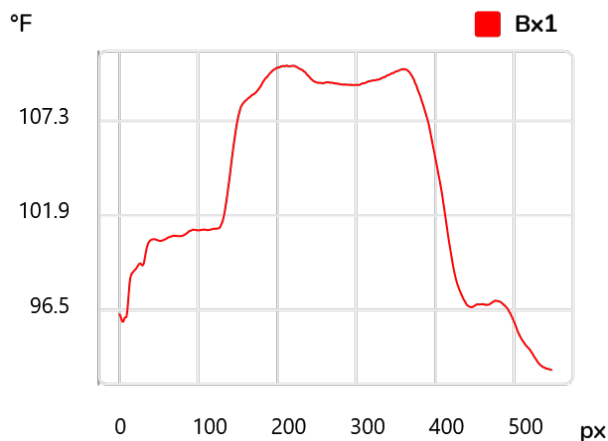
Equipment name : RTU #31  
Device name : Roof Top Units  
Measurement Point : #31  
Status OK

| <b>Sp1</b> | 119.8 °F |

**Recommended Action** No action recommended at this time
