# THERMAL ELECTRICAL INSPECTION

## SAMPLE REPORT

RETROFIT  
ELECTRIC

# Retrofit Electric - Thermal Electrical Inspection

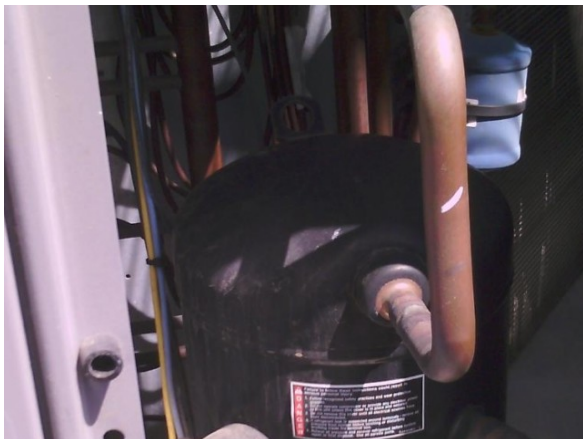
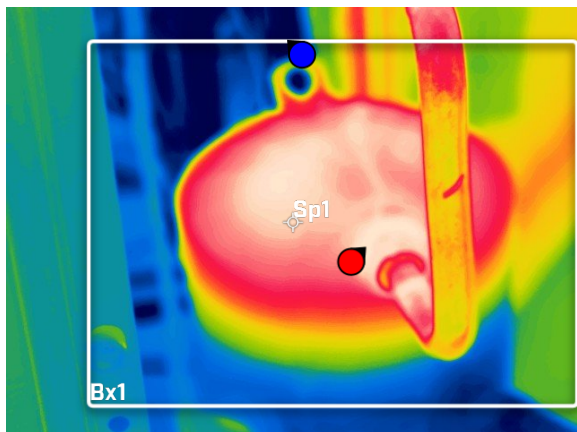
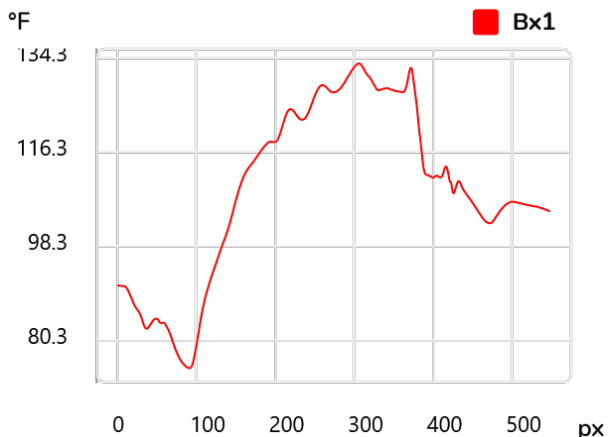
Equipment name : RTU #31  
Device name : Roof Top Units  
Measurement Point : #31  
Status OK

Sp1 152.0 °F

Issue No Issue - Normal operation

Recommended Action No action recommended at this time

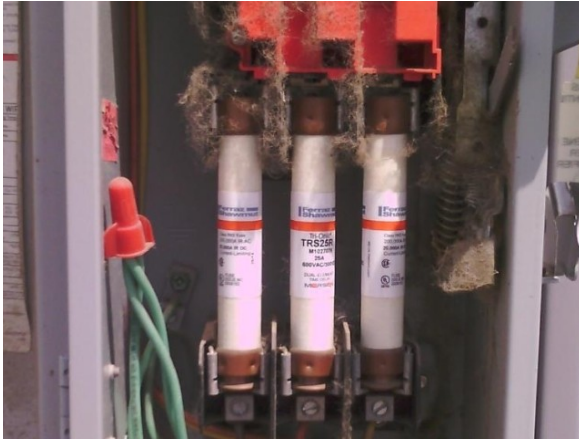
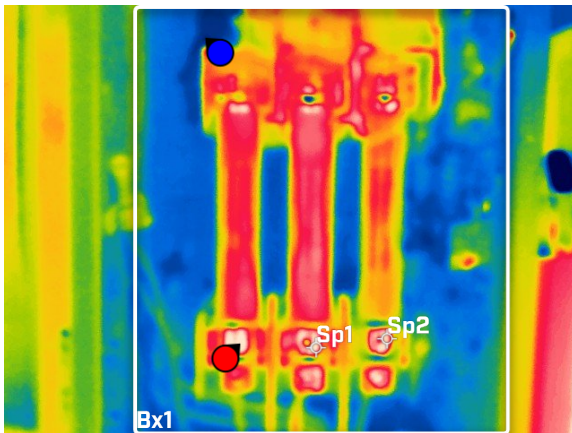
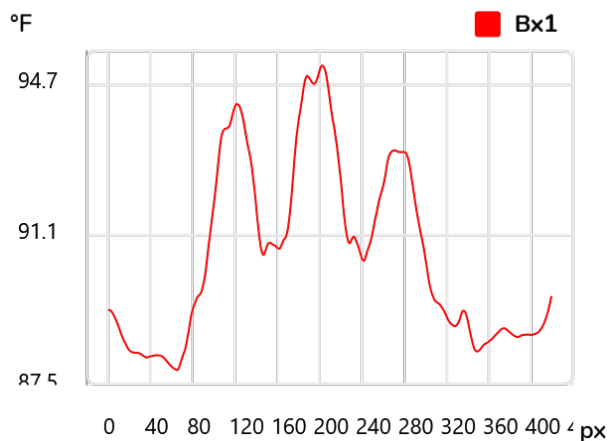
Equipment name : RTU #31  
Device name : Roof Top Units  
Measurement Point : #31  
Status OK

Sp2 99.5 °F

Issue No Issue - Normal operation

Recommended Action No action recommended at this time

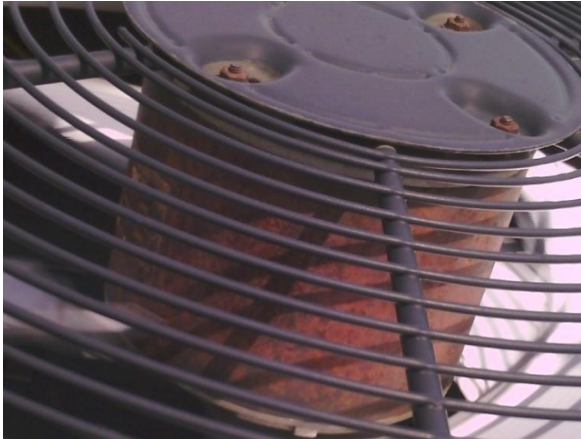
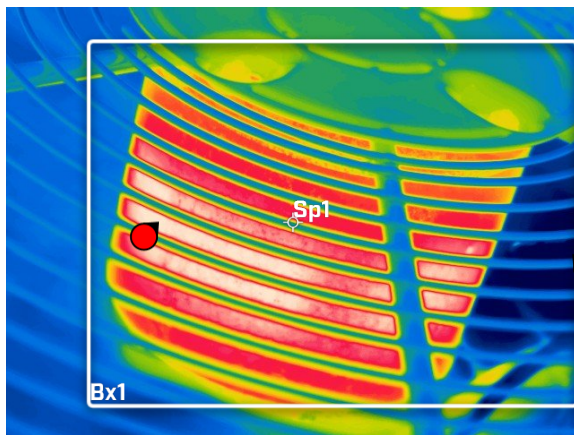
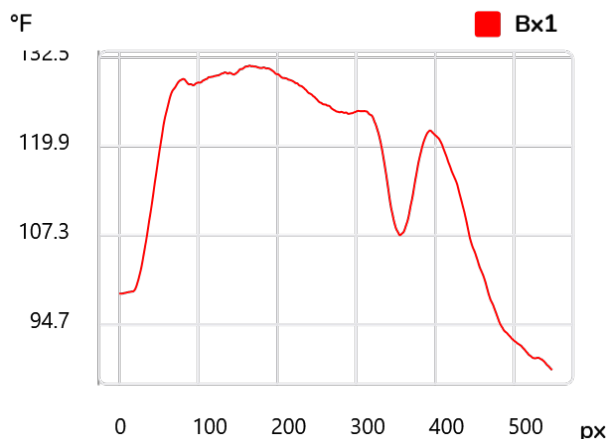
Equipment name : RTU #31  
Device name : Roof Top Units  
Measurement Point : #31  
Status OK

| <b>Sp1</b> | 109.9 °F |

**Issue** No Issue - Normal operation

**Recommended Action** No action recommended at this time

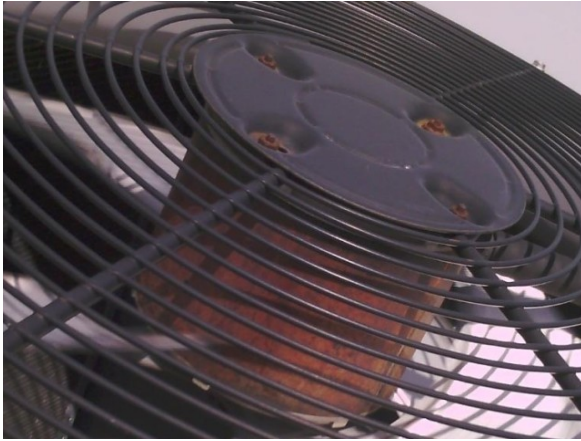
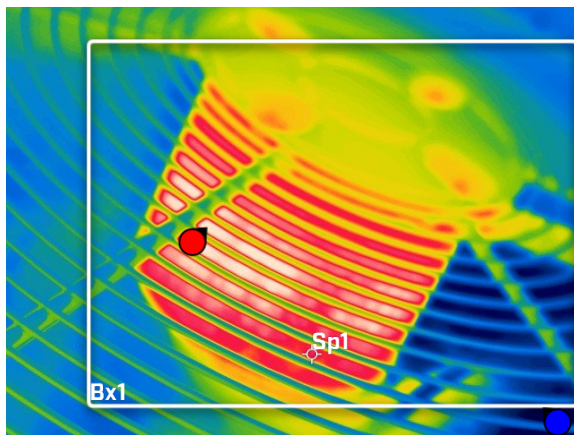
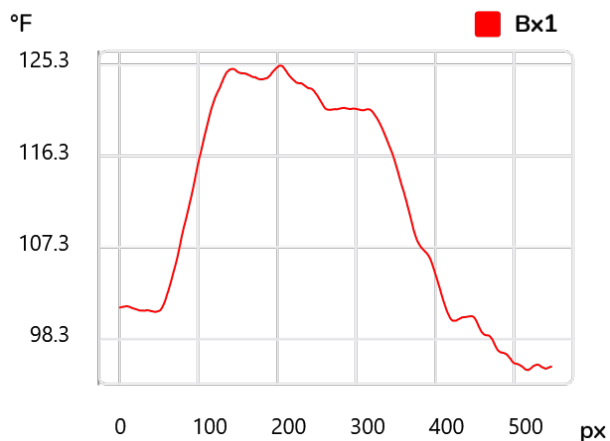
Equipment name : RTU #31  
Device name : Roof Top Units  
Measurement Point : #31  
Status OK

| <b>Sp1</b> | 140.4 °F |

**Issue** No Issue - Normal operation

**Recommended Action** No action recommended at this time

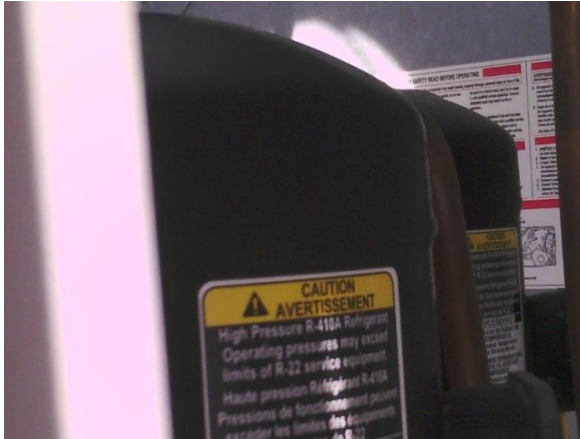
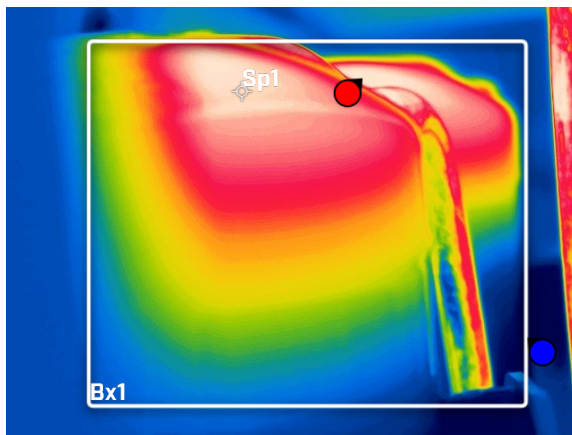
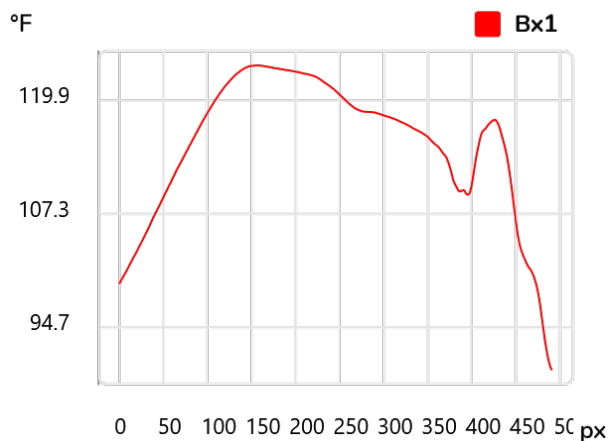
Equipment name : RTU #31  
Device name : Roof Top Units  
Measurement Point : #31  
Status OK

Sp1 141.6 °F

Issue No Issue - Normal operation

Recommended Action No action recommended at this time

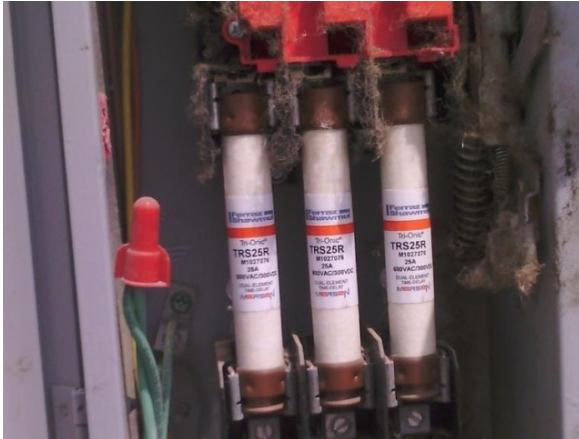
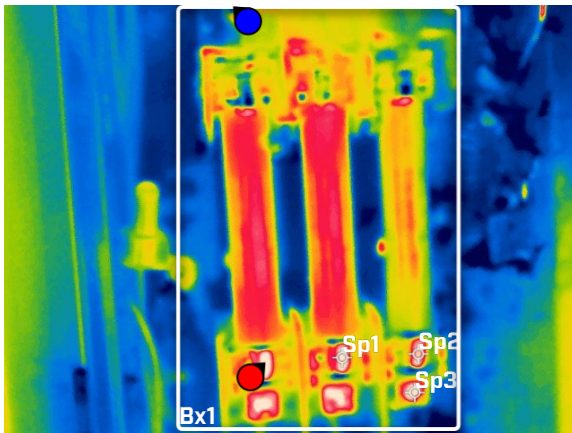
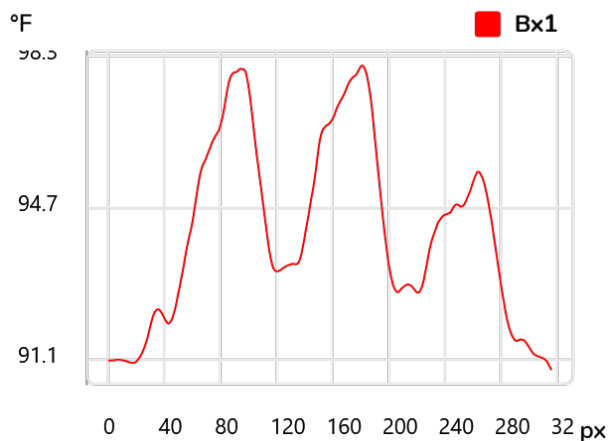
Equipment name : RTU #32  
Device name : Roof Top Units  
Measurement Point : #32  
Status OK

Max 112.5 °F  
Min 88.7 °F  
Area 0.209 ft<sup>2</sup>  
Sp1 109.9 °F  
Sp2 104.8 °F  
Sp3 110.2 °F

Issue No Issue - Normal operation

Recommended Action No action recommended at this time

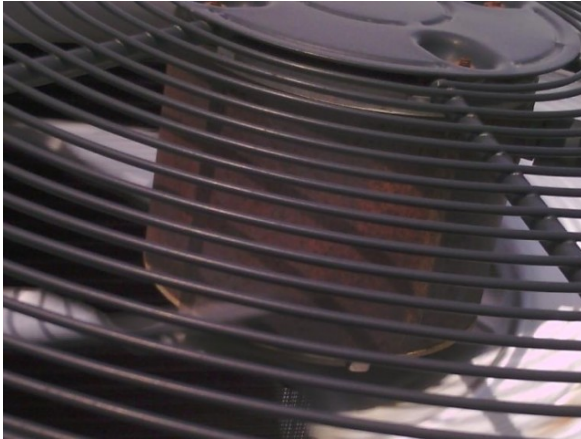
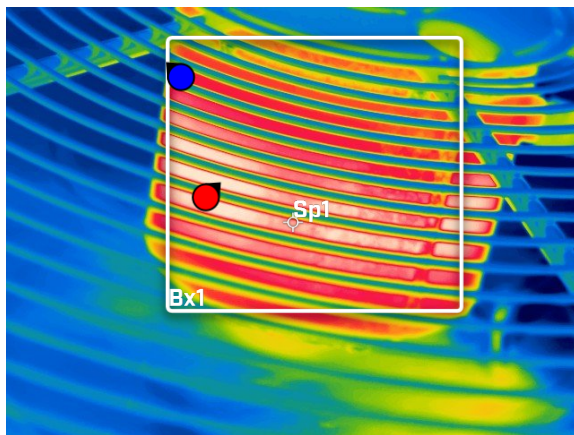
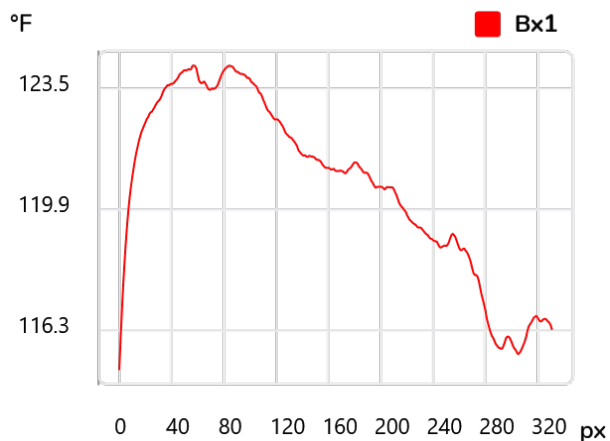
Equipment name : RTU #32  
Device name : Roof Top Units  
Measurement Point : #32  
Status OK

| <b>Sp1</b> | 148.2 °F |

**Recommended Action** No action recommended at this time

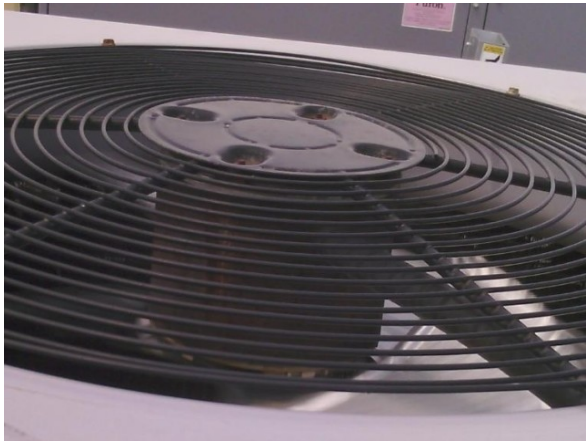
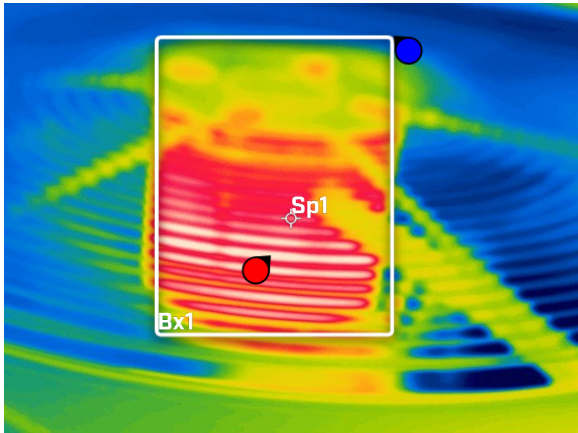
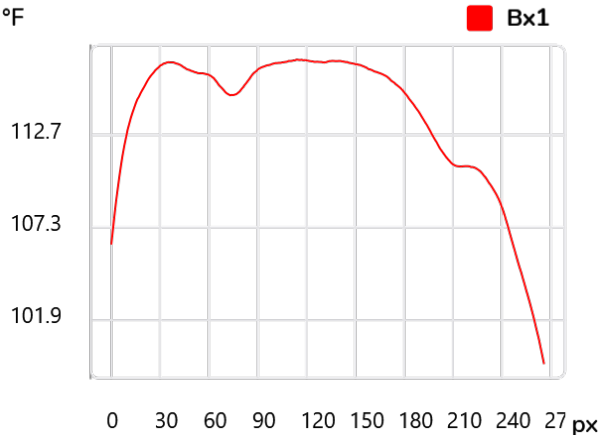
Equipment name : RTU #32  
Device name : Roof Top Units  
Measurement Point : #32  
Status OK

| <b>Sp1</b> | 130.7 °F |

**Issue** No Issue - Normal operation  
**Recommended Action** No action recommended at this time  
**Comment** 7.2,7.6,5.8amps  
**Priority** None

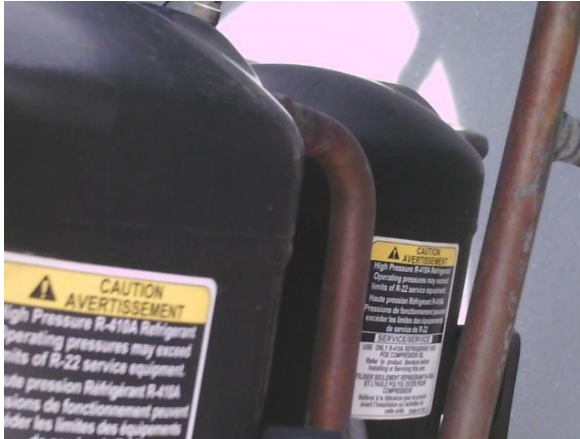
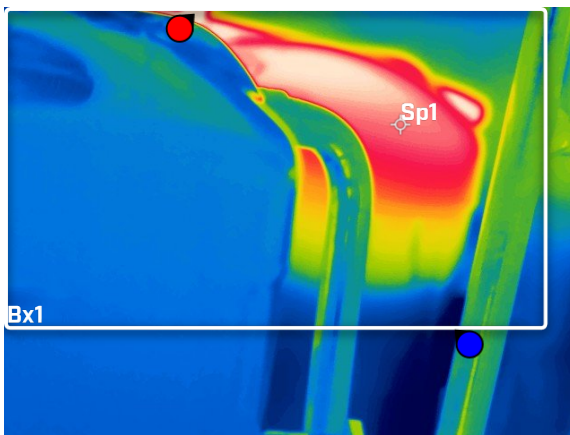
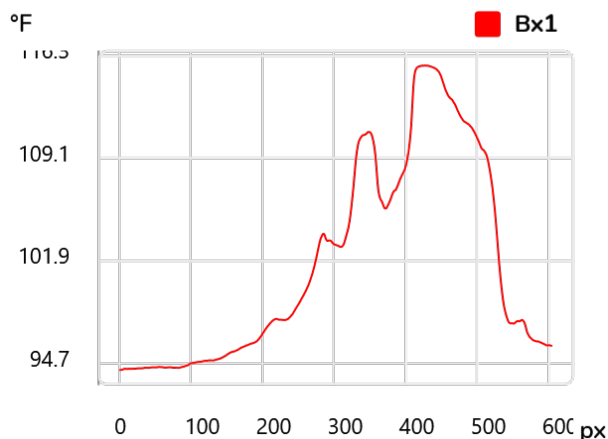
Equipment name : RTU #32  
Device name : Roof Top Units  
Measurement Point : #32  
Status OK

| Value | |
|---|---|
| <b>Sp1</b> | 137.2 °F |

**Issue** No Issue - Normal operation  
**Recommended Action** No action recommended at this time  
**Comment** 7.2,7.6,5.8amps  
**Priority** None

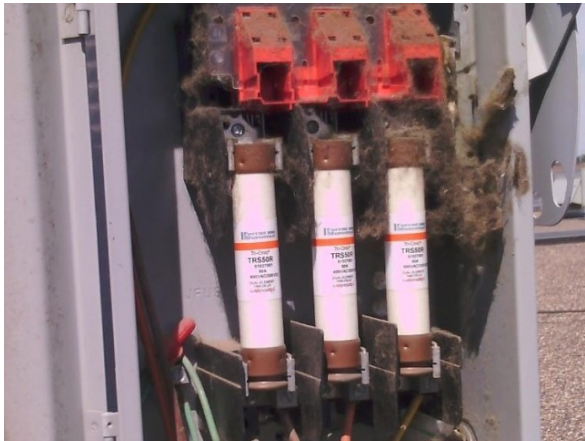
Equipment name : RTU #33  
Device name : Roof Top Units  
Measurement Point : #33  
Status Note

Issue Dirty/corroded connection(s)  
Recommended Action Clean equipment  
Comment Clean with compressed air. 18.4,16.7,16 amps  
Priority 2-Intermediate/Investigate

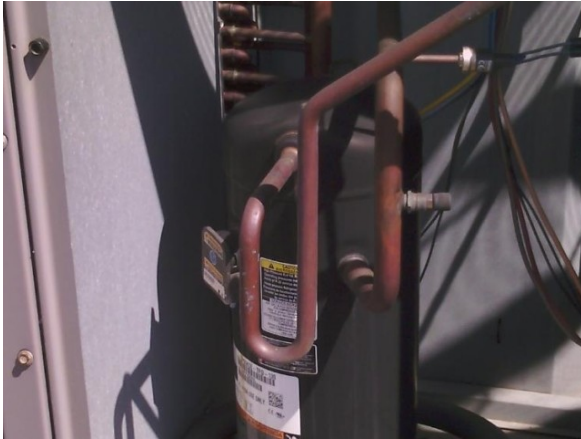
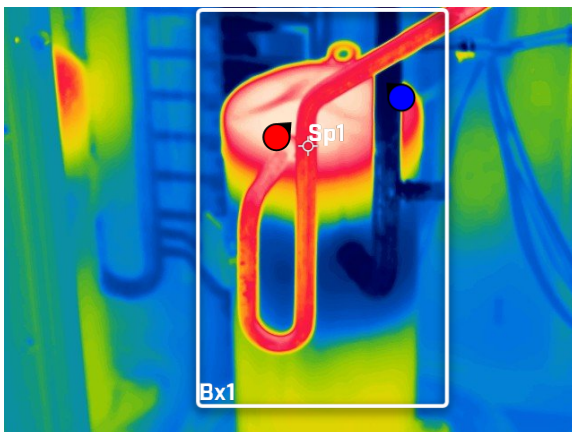
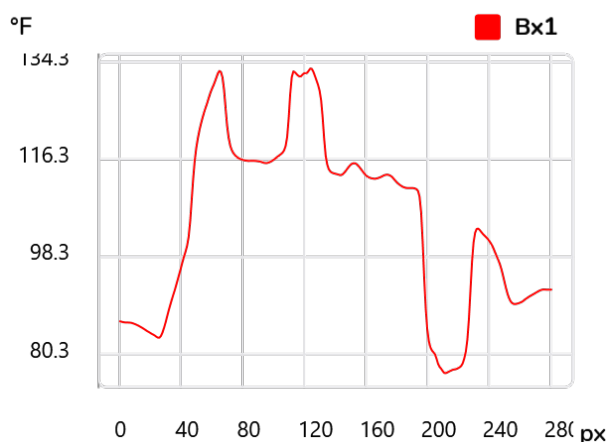
Thermogram 182 Created: 6/3/2026 10:46:45 AM

Equipment name : RTU #33  
Device name : Roof Top Units  
Measurement Point : #33  
Status Note

Sp1 150.9 °F

Issue Dirty/corroded connection(s)  
Recommended Action Clean equipment  
Comment Clean with compressed air. 18.4,16.7,16 amps  
Priority 2-Intermediate/Investigate

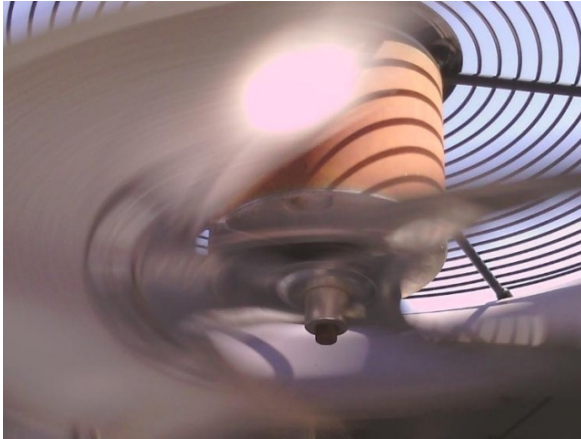
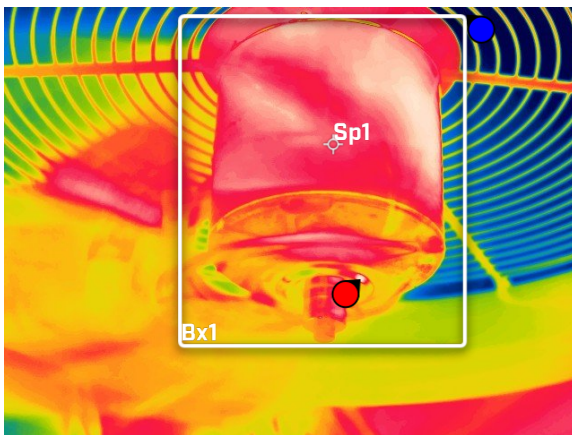
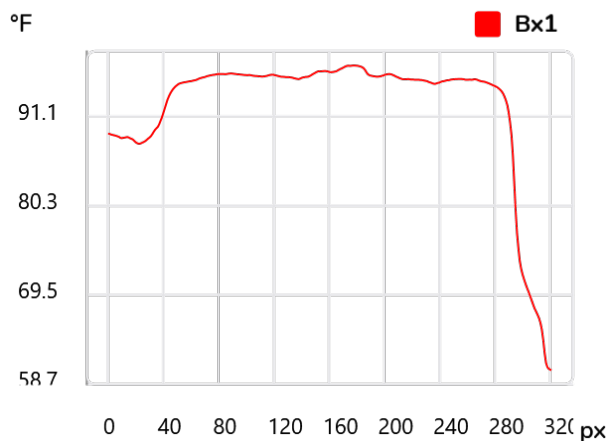
Thermogram 183 Created: 6/3/2026 10:51:29 AM

Equipment name : RTU #33  
Device name : Roof Top Units  
Measurement Point : #33  
Status Note

| <b>Sp1</b> | 99.7 °F |

**Issue** Dirty/corroded connection(s)  
**Recommended Action** Clean equipment  
**Comment** Clean with compressed air. 18.4,16.7,16 amps  
**Priority** 2-Intermediate/Investigate

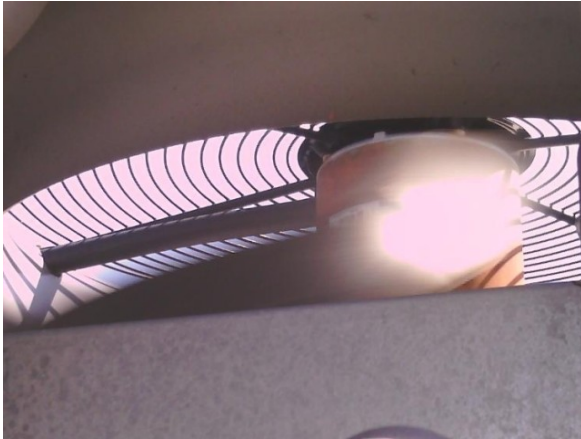
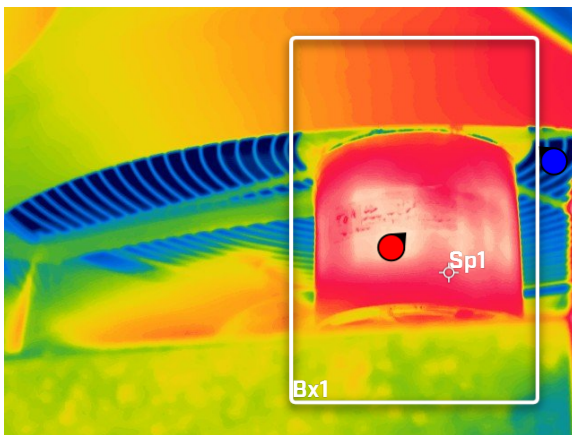
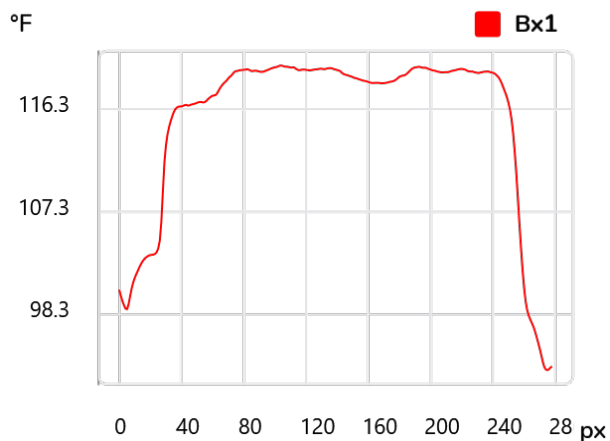
Thermogram 184 Created: 6/3/2026 10:52:00 AM

Equipment name : RTU #33  
Device name : Roof Top Units  
Measurement Point : #33  
Status Note

Sp1 128.9 °F

Issue Dirty/corroded connection(s)

Recommended Action Clean equipment

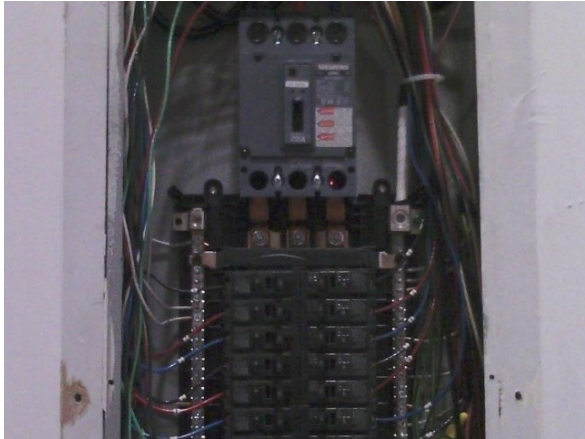
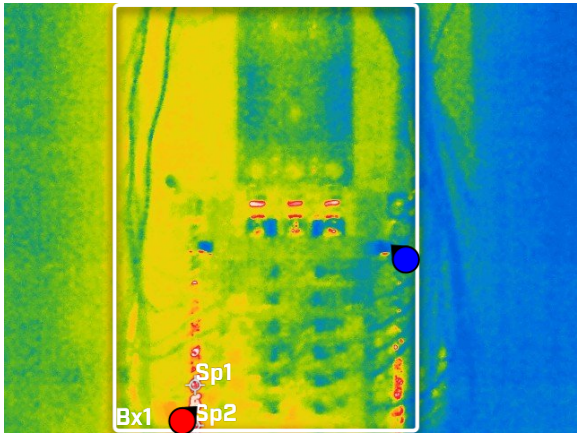
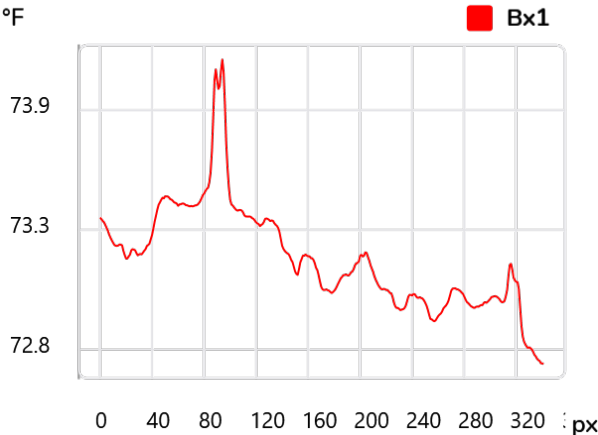
Thermogram 185 Created: 5/18/2026 10:49:04 AM

Equipment name : Sensors 204  
Device name : 1032  
Measurement Point : HZ-1  
Status OK

Issue No Issue - Normal operation  
Recommended Action No action recommended at this time  
Comment No additional comments.  
Priority None

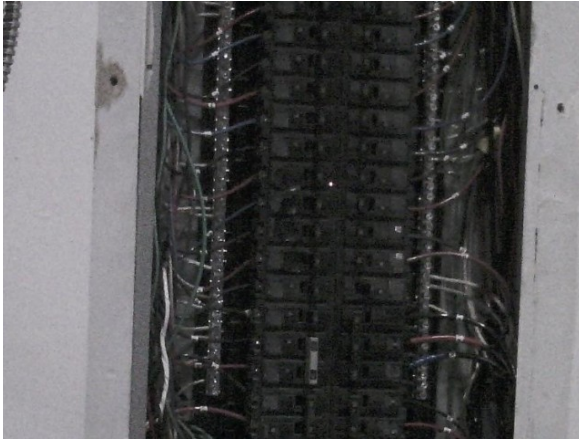
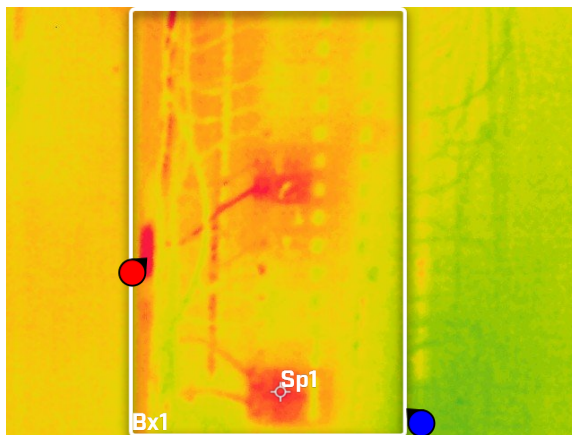
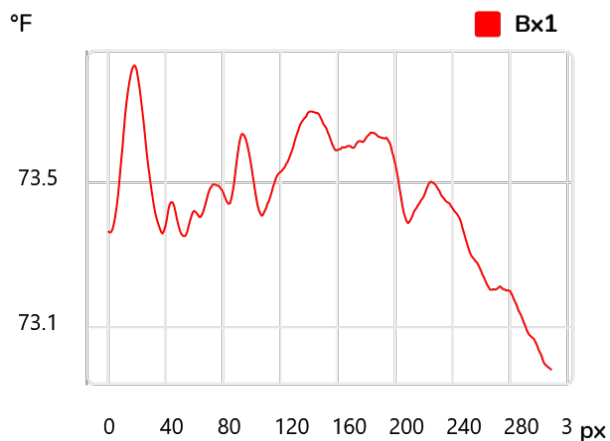
Thermogram 186 Created: 5/18/2026 10:50:09 AM

Equipment name : Sensors 204  
Device name : 1032  
Measurement Point : HZ-1  
Status OK

| <b>Sp1</b> | 74.3 °F |

**Recommended Action** No action recommended at this time

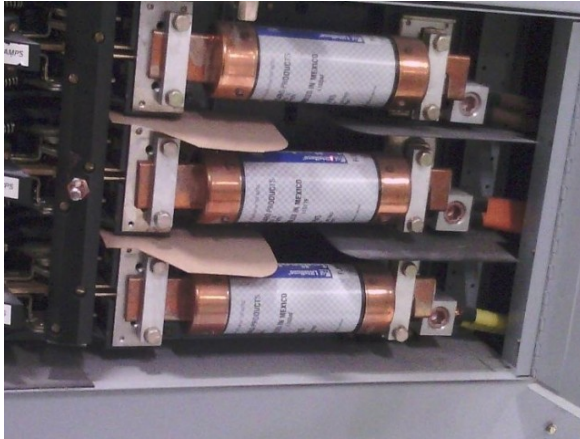
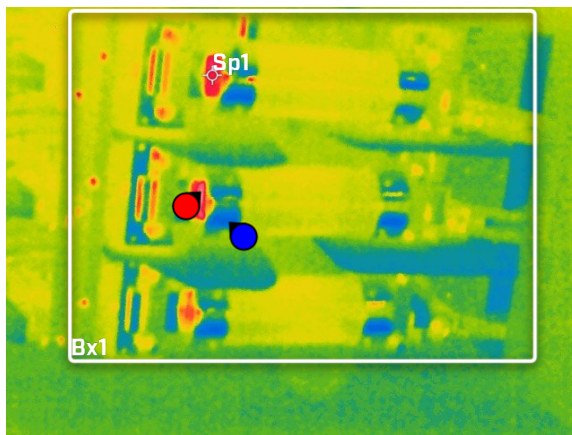
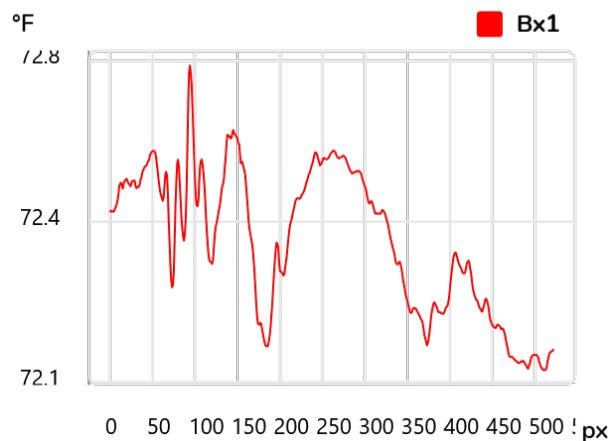
Thermogram 187 Created: 5/18/2026 12:58:41 PM

Equipment name : Sensors 204  
Device name : 1033  
Measurement Point : MM140 Switchboard #1  
Status OK

Max 75.7 °F  
Min 71.1 °F  
Area 1.389 ft<sup>2</sup>  
Sp1 74.6 °F

Issue No Issue - Normal operation  
Recommended Action No action recommended at this time  
Comment No additional comments.  
Priority None

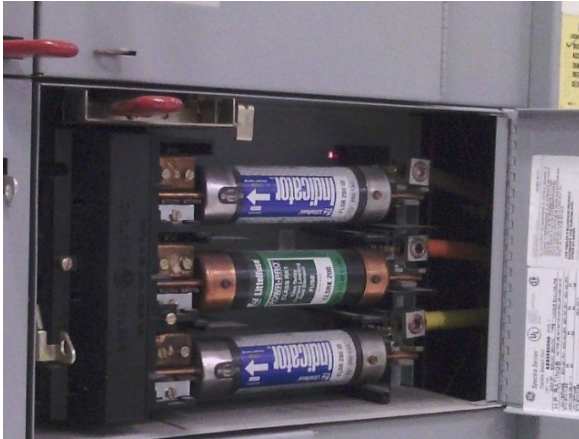
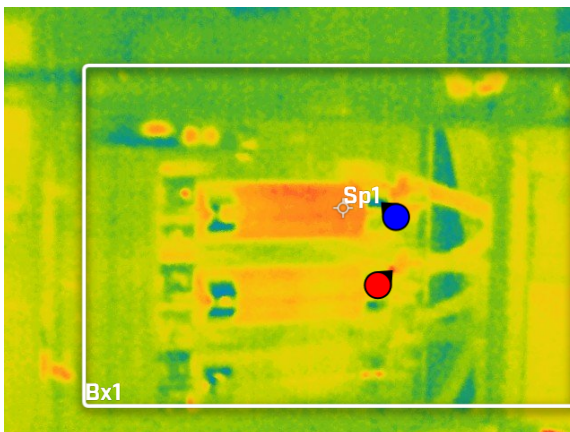
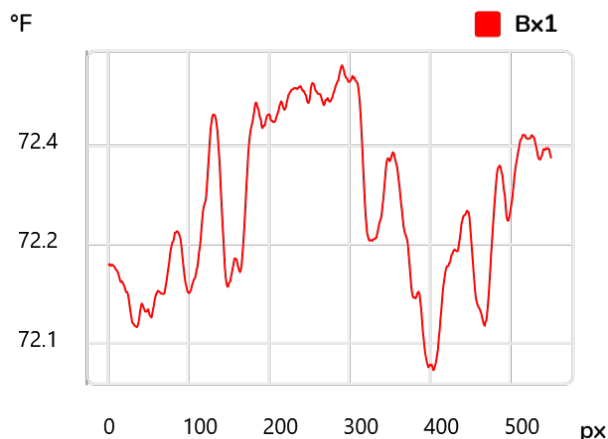
Thermogram 188 Created: 5/18/2026 1:04:54 PM

Equipment name : Sensors 204  
Device name : 1033  
Measurement Point : MM140 Switchboard #1  
Status OK

Max 73.7 °F  
Min 71.4 °F  
Area 1.248 ft<sup>2</sup>  
Sp1 73.4 °F

Issue No Issue - Normal operation

Recommended Action No action recommended at this time

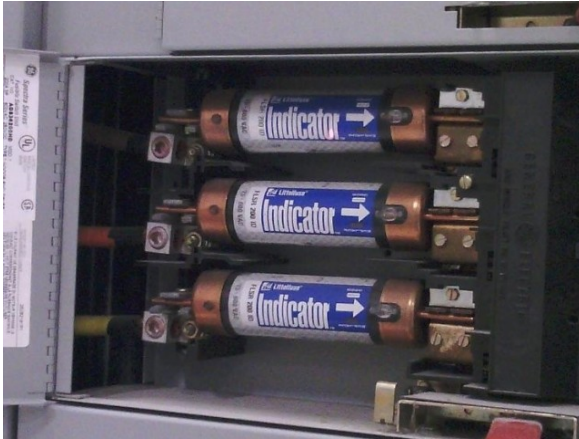
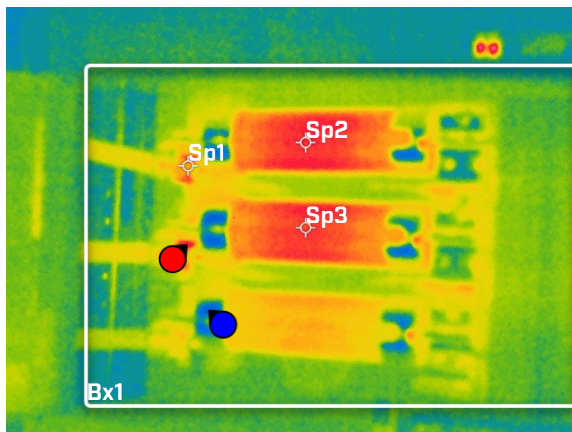
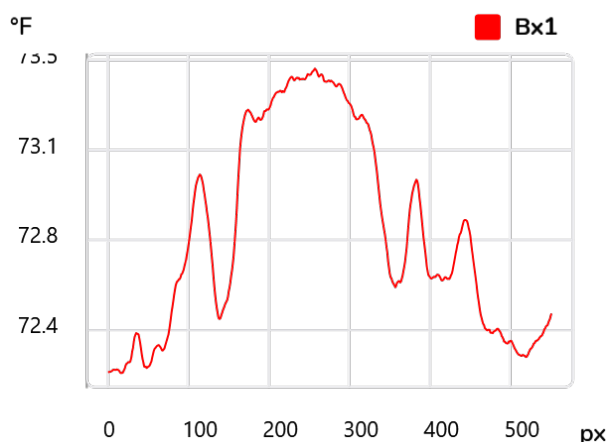
Thermogram 189 Created: 5/18/2026 1:07:22 PM

Equipment name : Sensors 204  
Device name : 1033  
Measurement Point : MM140 Switchboard #1  
Status OK

Max 74.9 °F  
Min 71.2 °F  
Area 0.797 ft<sup>2</sup>  
Sp1 73.8 °F  
Sp2 74.5 °F  
Sp3 74.4 °F

Issue No Issue - Normal operation  
Recommended Action No action recommended at this time  
Comment No additional comments.  
Priority None

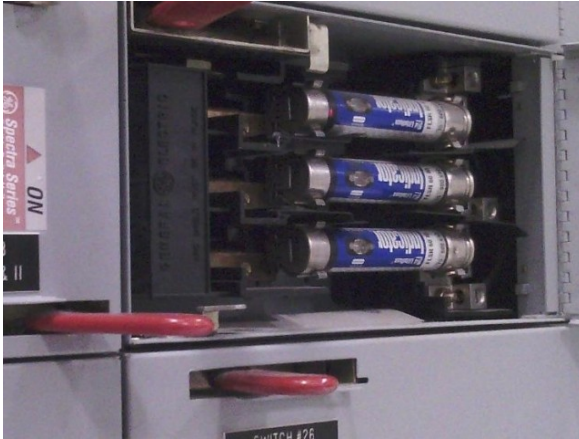
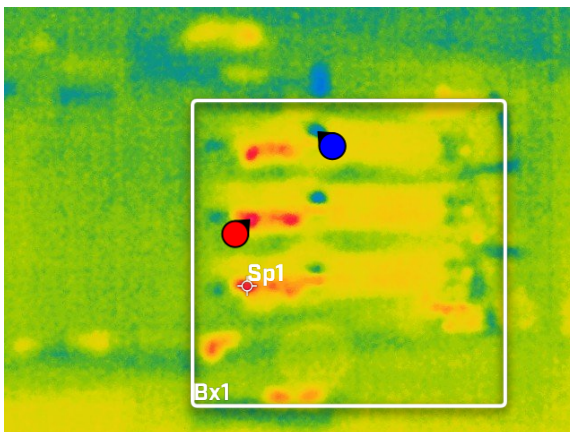
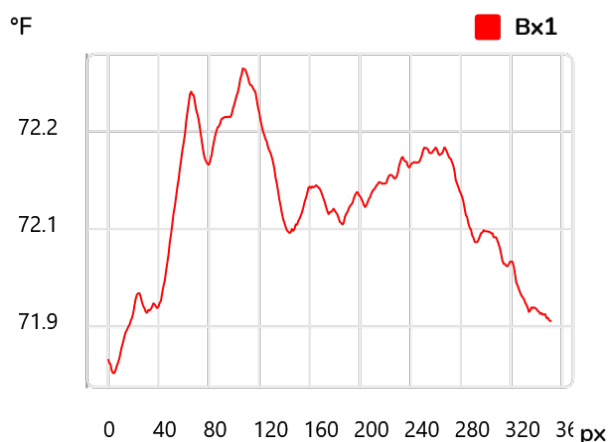
Thermogram 190 Created: 5/18/2026 1:09:59 PM

Equipment name : Sensors 204  
Device name : 1033  
Measurement Point : MM140 Switchboard #1  
Status OK

Max 74.5 °F  
Min 71.1 °F  
Area 0.285 ft²  
Sp1 74.1 °F

Issue No Issue - Normal operation

Recommended Action No action recommended at this time

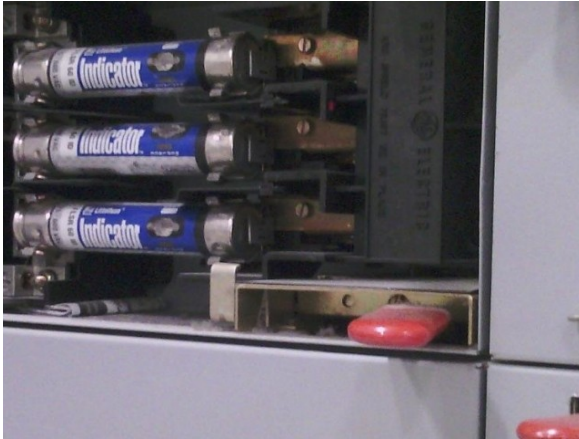
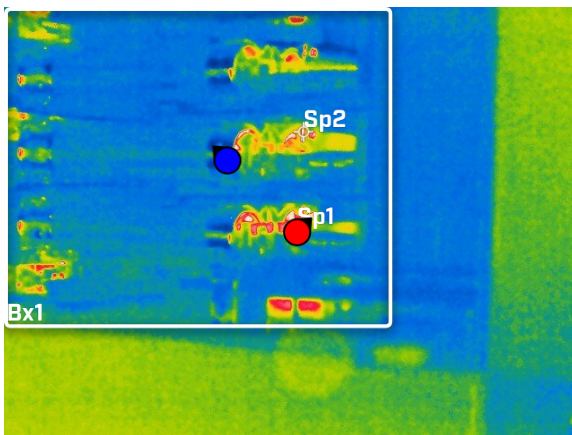
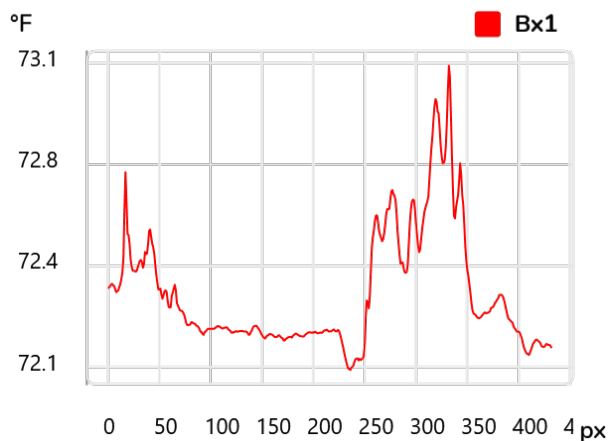
Thermogram 191 Created: 5/18/2026 1:14:12 PM

Equipment name : Sensors 204  
Device name : 1033  
Measurement Point : MM140 Switchboard #1  
Status OK

Sp2 77.1 °F

Issue No Issue - Normal operation

Recommended Action No action recommended at this time

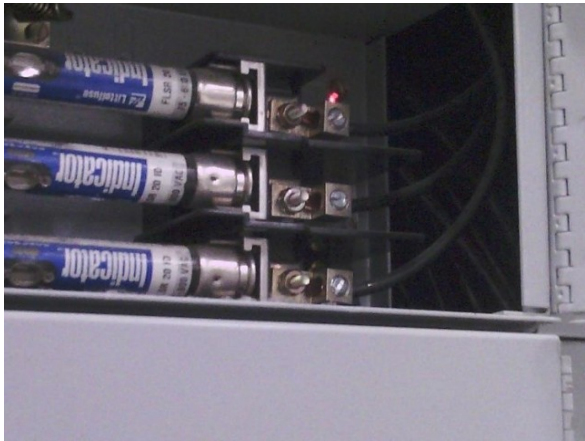
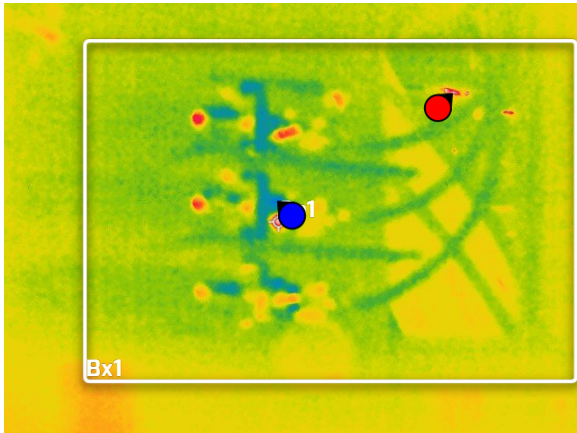
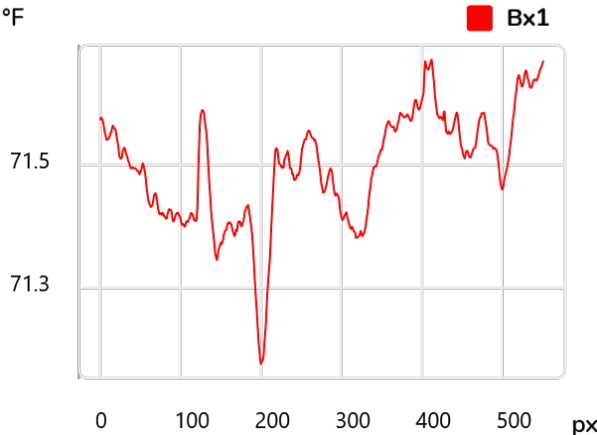
Thermogram 192 Created: 5/18/2026 1:18:04 PM

Equipment name : Sensors 204  
Device name : 1033  
Measurement Point : MM140 Switchboard #1  
Status OK

| Value | |
|---|---|
| Sp1 | 74.9 °F |

Issue No Issue - Normal operation  
Recommended Action No action recommended at this time  
Comment No additional comments.  
Priority None

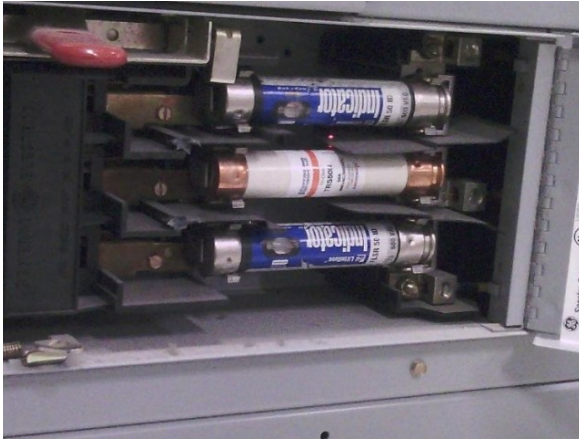
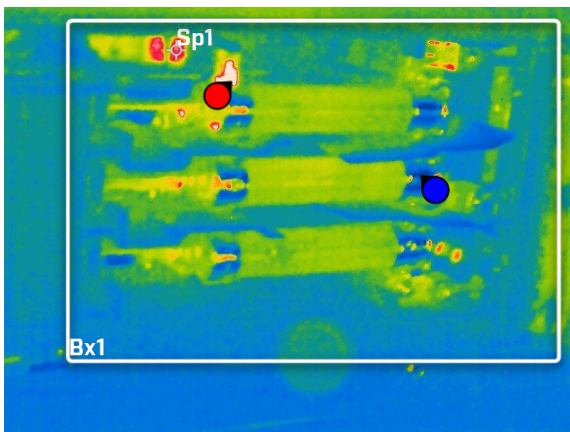
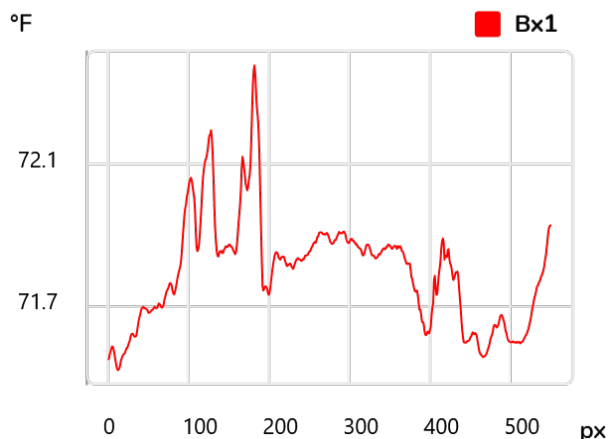
Thermogram 193 Created: 5/18/2026 1:24:23 PM

Equipment name : Sensors 204  
Device name : 1034  
Measurement Point : MM140 Switchboard #2  
Status OK

Max 81.7 °F  
Min 70.4 °F  
Area 0.555 ft<sup>2</sup>  
Sp1 75.4 °F

Issue No Issue - Normal operation  
Recommended Action No action recommended at this time  
Comment No additional comments.  
Priority None

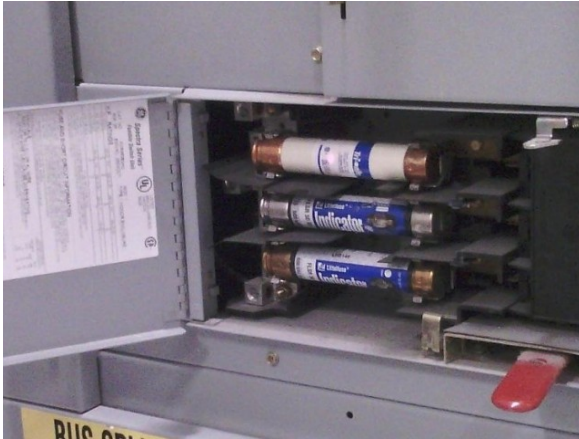
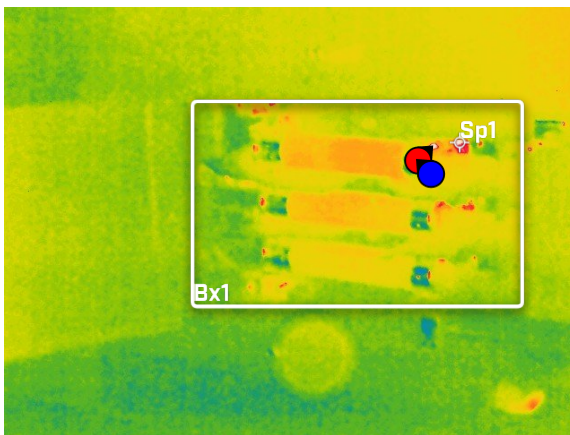
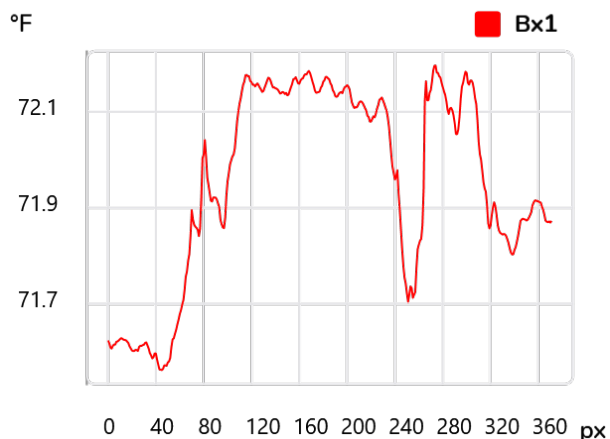
Thermogram 194 Created: 5/18/2026 1:26:49 PM

Equipment name : Sensors 204  
Device name : 1034  
Measurement Point : MM140 Switchboard #2  
Status OK

Max 76.1 °F  
Min 70.9 °F  
Area 0.344 ft²  
Sp1 75.7 °F

Issue No Issue - Normal operation

Recommended Action No action recommended at this time

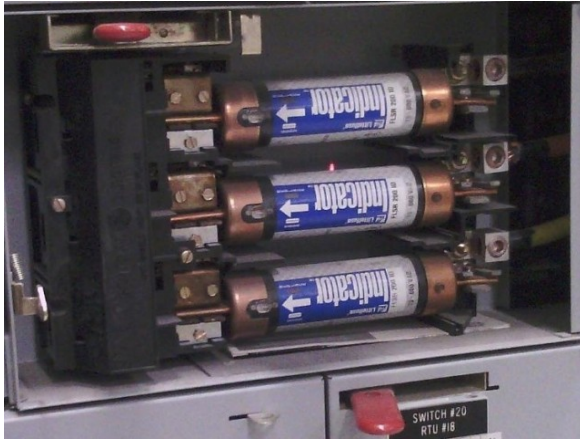
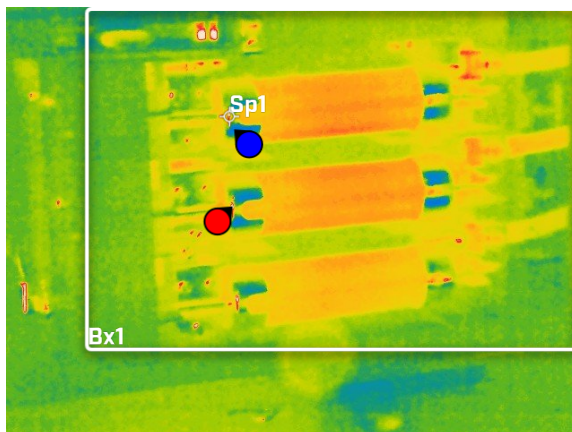
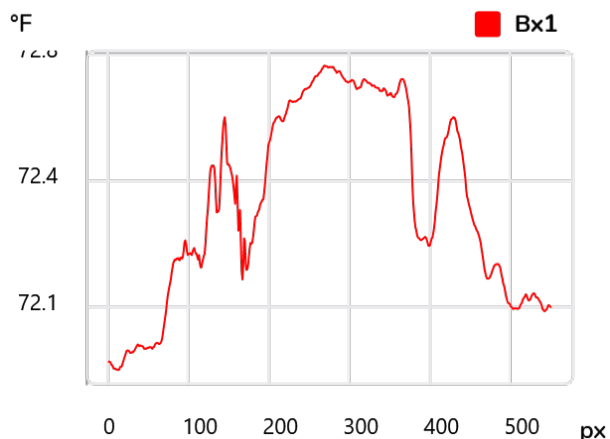
Thermogram 195 Created: 5/18/2026 1:28:53 PM

Equipment name : Sensors 204  
Device name : 1034  
Measurement Point : MM140 Switchboard #2  
Status OK

Max 78.2 °F  
Min 71.1 °F  
Area 0.969 ft²  
Sp1 74.2 °F

Issue No Issue - Normal operation

Recommended Action No action recommended at this time

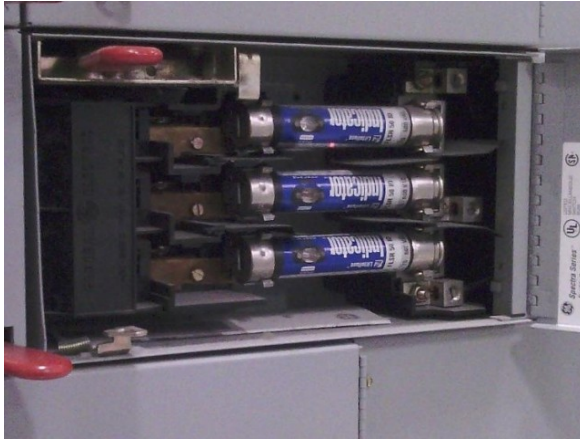
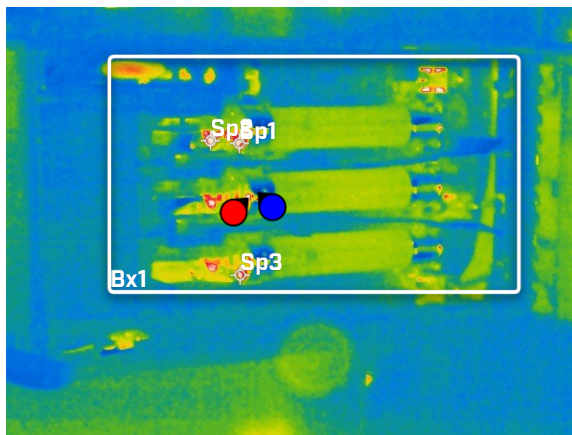
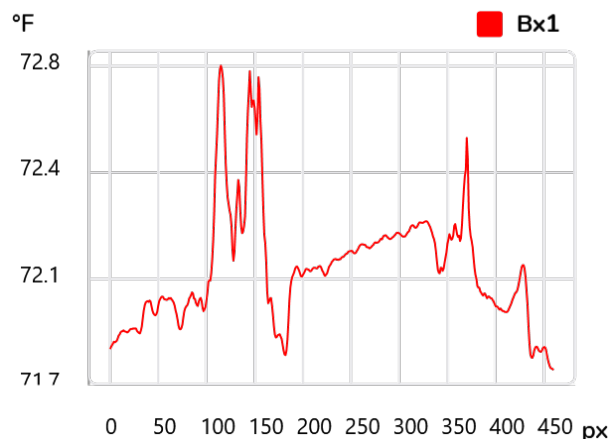
Thermogram 196 Created: 5/18/2026 1:31:22 PM

Equipment name : Sensors 204  
Device name : 1034  
Measurement Point : MM140 Switchboard #2  
Status OK

Issue No Issue - Normal operation  
Recommended Action No action recommended at this time  
Comment No additional comments.  
Priority None

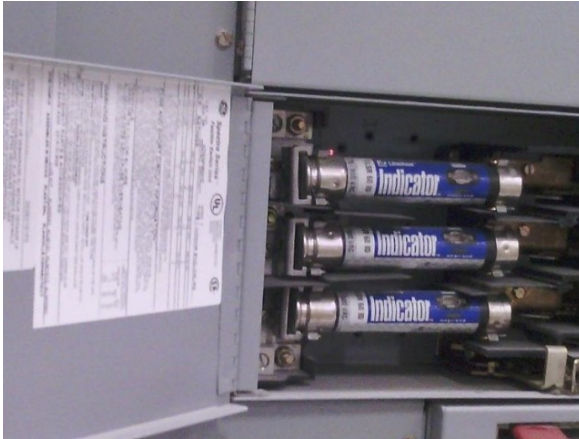
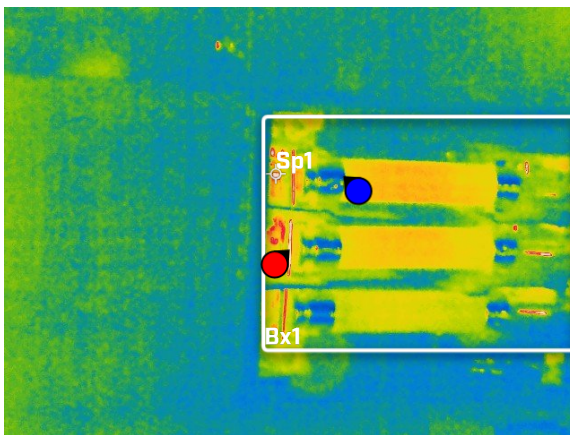
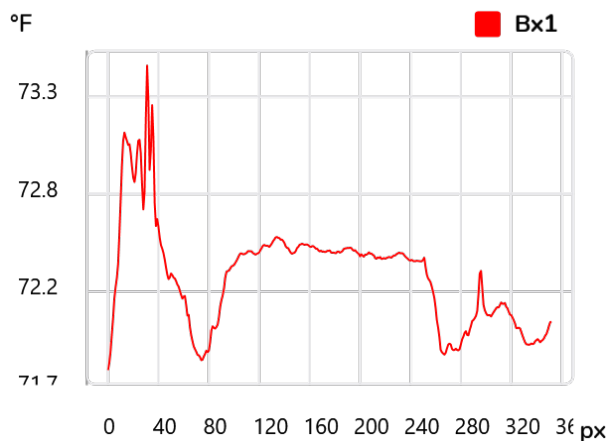
Thermogram 197 Created: 5/18/2026 1:33:48 PM

Equipment name : Sensors 204  
Device name : 1034  
Measurement Point : MM140 Switchboard #2  
Status OK

Max 78.9 °F  
Min 70.4 °F  
Area 0.331 ft²  
Sp1 76.1 °F

Issue No Issue - Normal operation

Recommended Action No action recommended at this time

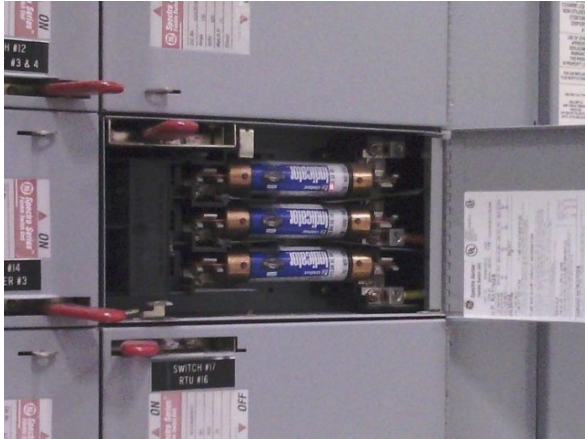
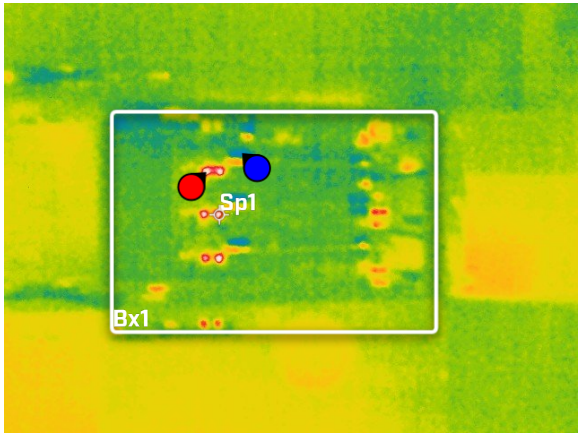
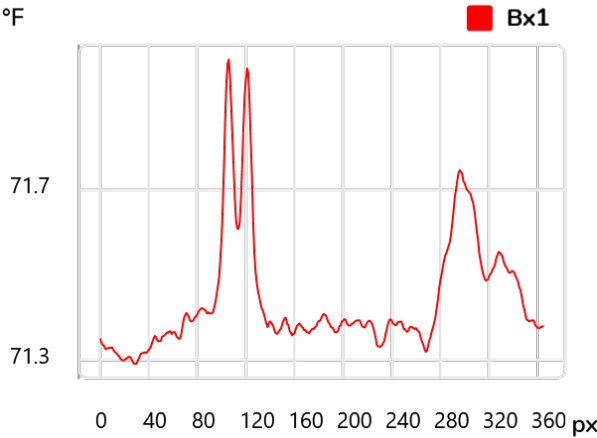
Thermogram 198 Created: 5/18/2026 1:36:28 PM

Equipment name : Sensors 204  
Device name : 1034  
Measurement Point : MM140 Switchboard #2  
Status OK

Issue No Issue - Normal operation  
Recommended Action No action recommended at this time  
Comment No additional comments.  
Priority None
