# THERMAL ELECTRICAL INSPECTION

## SAMPLE REPORT

RETROFIT  
ELECTRIC

# Retrofit Electric - Thermal Electrical Inspection

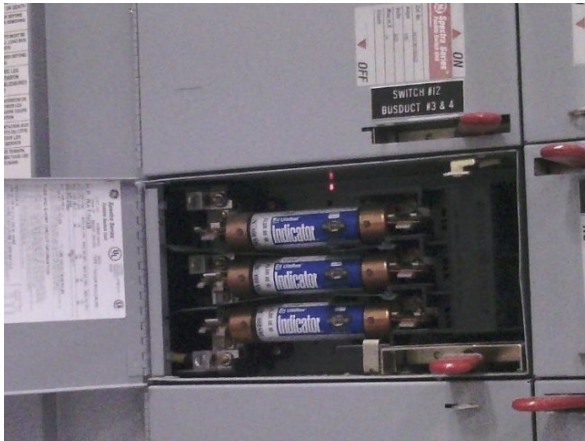
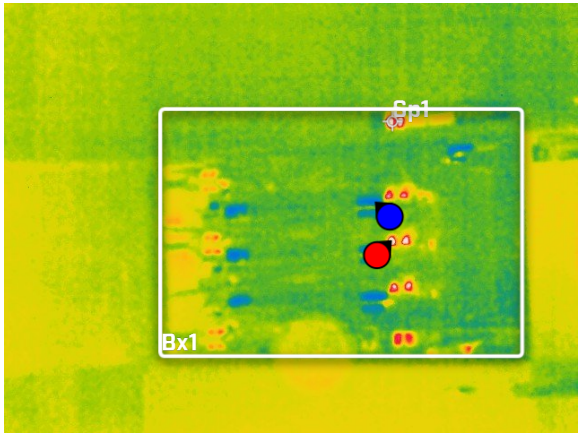
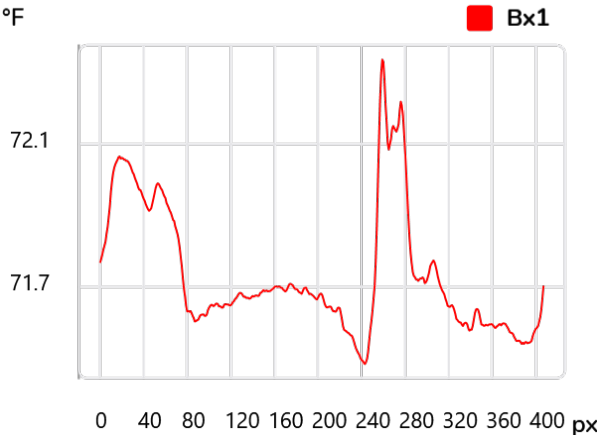
Thermogram 199 Created: 5/18/2026 1:38:34 PM

Equipment name : Sensors 204  
Device name : 1034  
Measurement Point : MM140 Switchboard #2  
Status OK

Issue No Issue - Normal operation  
Recommended Action No action recommended at this time  
Comment No additional comments.  
Priority None

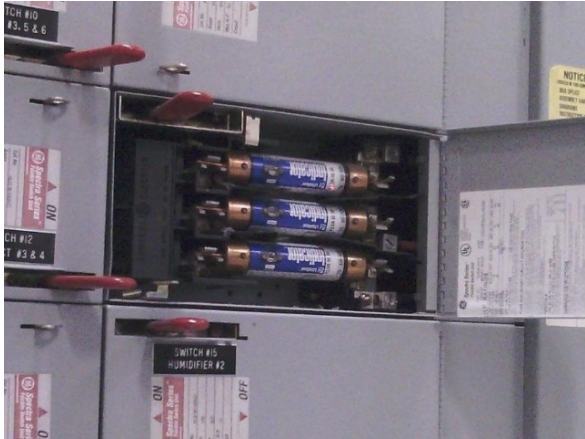
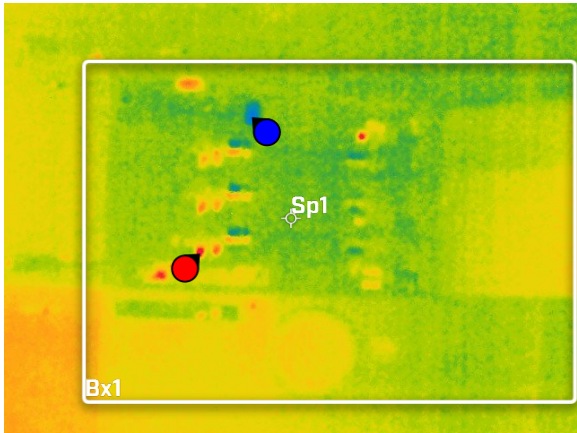
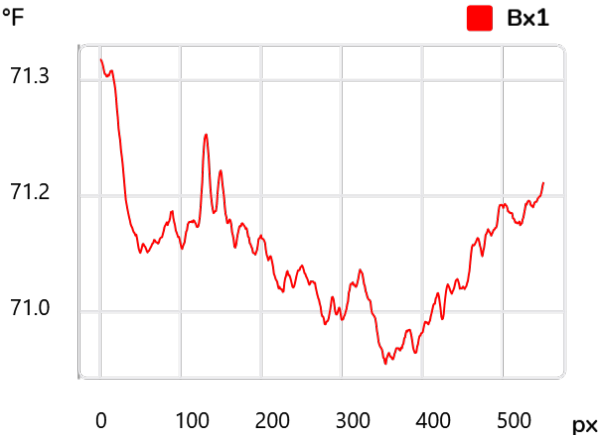
Thermogram 200 Created: 5/18/2026 1:40:37 PM

Equipment name : Sensors 204  
Device name : 1034  
Measurement Point : MM140 Switchboard #2  
Status OK

Issue No Issue - Normal operation  
Recommended Action No action recommended at this time  
Comment No additional comments.  
Priority None

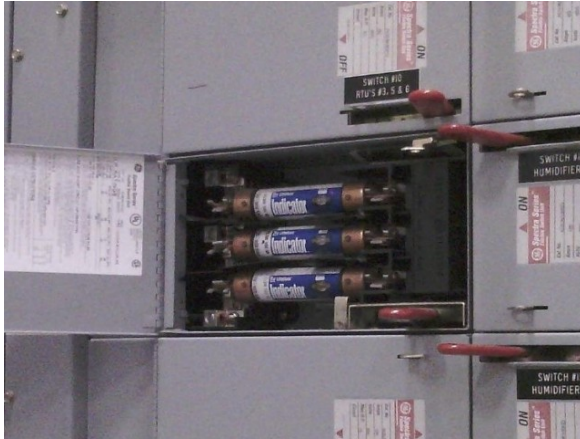
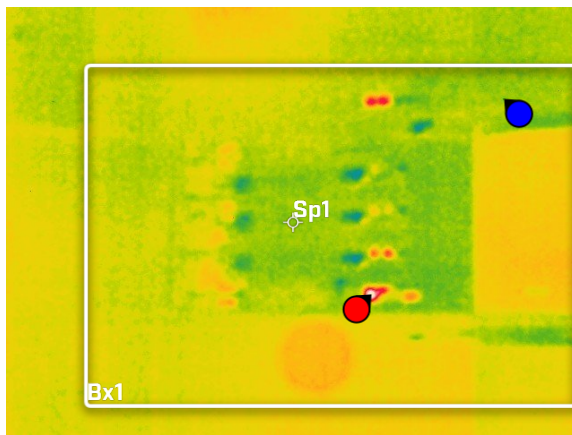
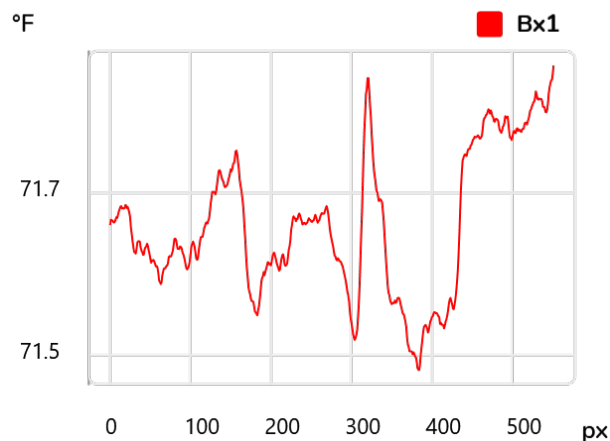
Thermogram 201 Created: 5/18/2026 1:43:02 PM

Equipment name : Sensors 204  
Device name : 1034  
Measurement Point : MM140 Switchboard #2  
Status OK

Max 76.2 °F  
Min 70.7 °F  
Area 1.471 ft<sup>2</sup>  
Sp1 71.4 °F

Issue No Issue - Normal operation  
Recommended Action No action recommended at this time  
Comment No additional comments.  
Priority None

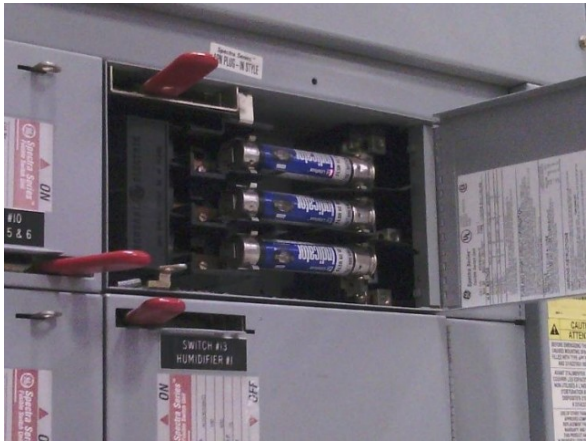
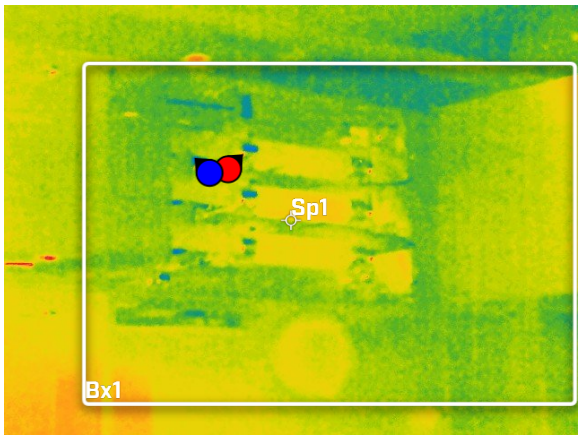
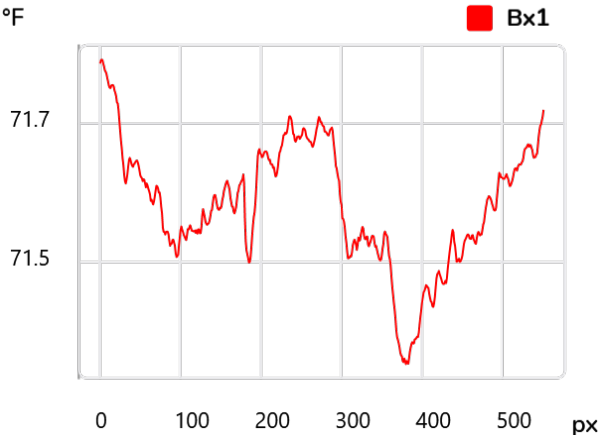
Thermogram 202 Created: 5/18/2026 1:45:06 PM

Equipment name : Sensors 204  
Device name : 1034  
Measurement Point : MM140 Switchboard #2  
Status OK

Issue No Issue - Normal operation  
Recommended Action No action recommended at this time  
Comment No additional comments.  
Priority None

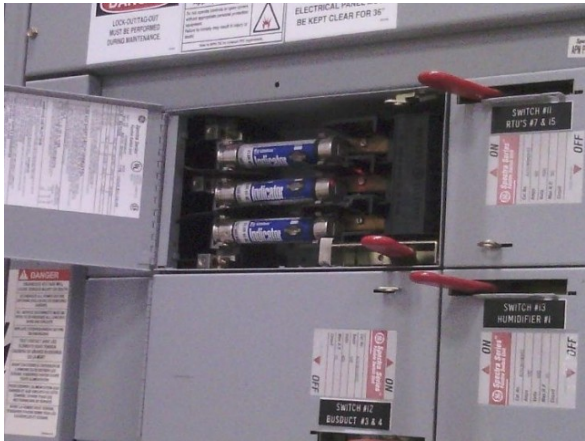
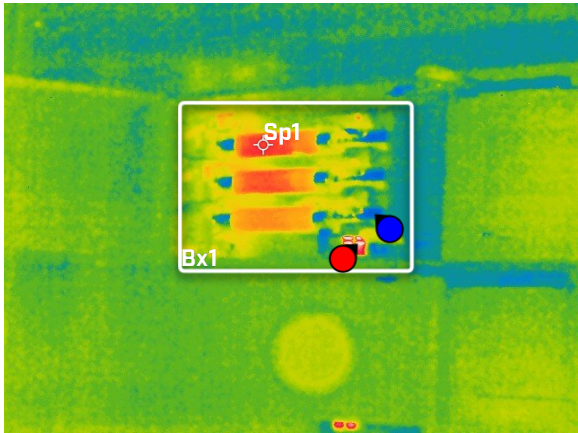
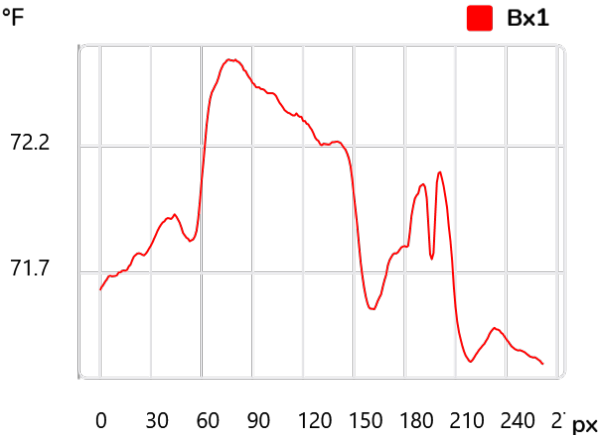
Thermogram 203 Created: 5/18/2026 1:47:15 PM

Equipment name : Sensors 204  
Device name : 1034  
Measurement Point : MM140 Switchboard #2  
Status OK

Issue No Issue - Normal operation  
Recommended Action No action recommended at this time  
Comment No additional comments.  
Priority None

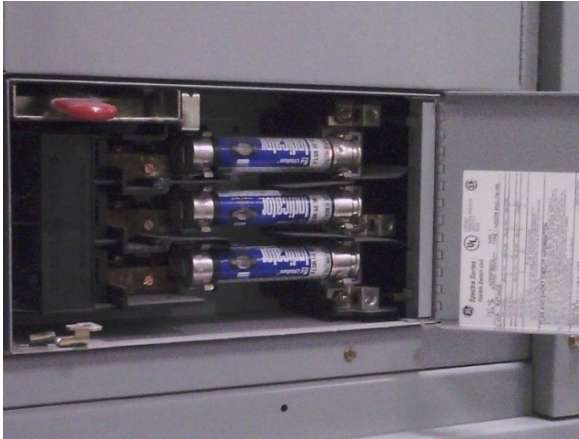
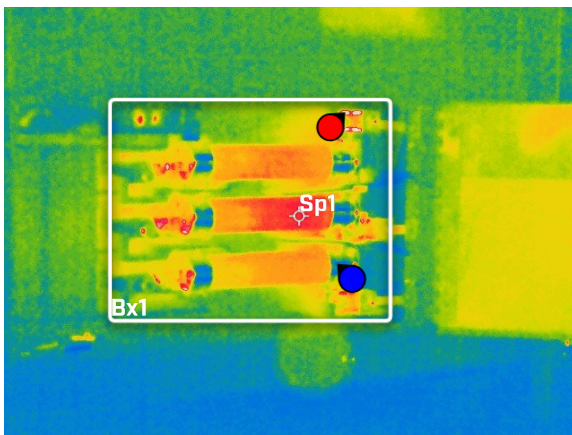
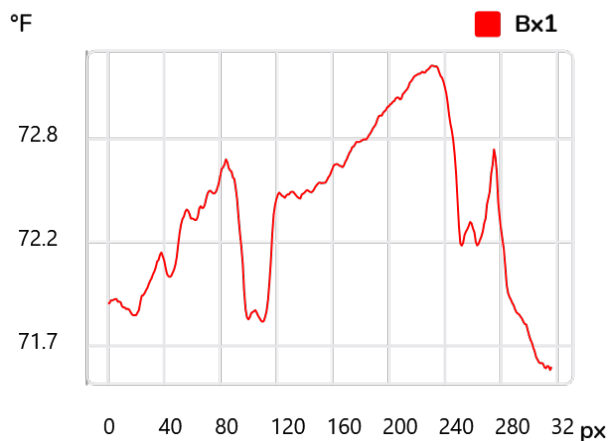
Thermogram 204 Created: 5/18/2026 1:51:26 PM

Equipment name : Sensors 204  
Device name : 1035  
Measurement Point : MM140 Switchboard #3  
Status OK

Max 78.9 °F  
Min 70.7 °F  
Area 0.353 ft<sup>2</sup>  
Sp1 74.1 °F

Recommended Action No action recommended at this time

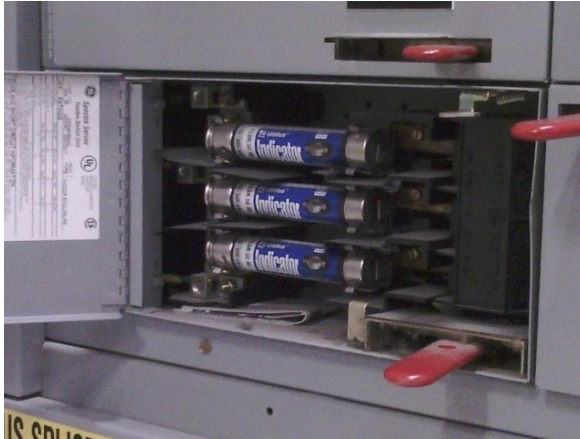
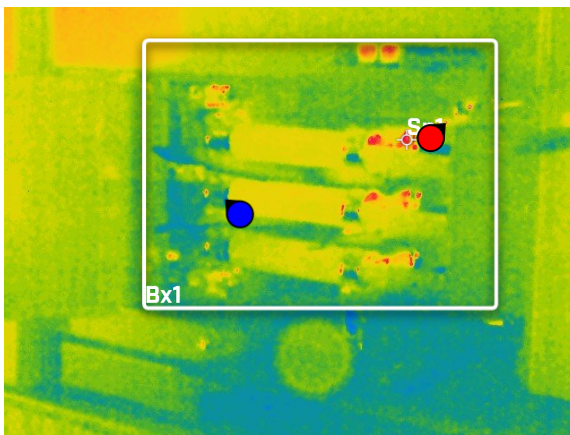
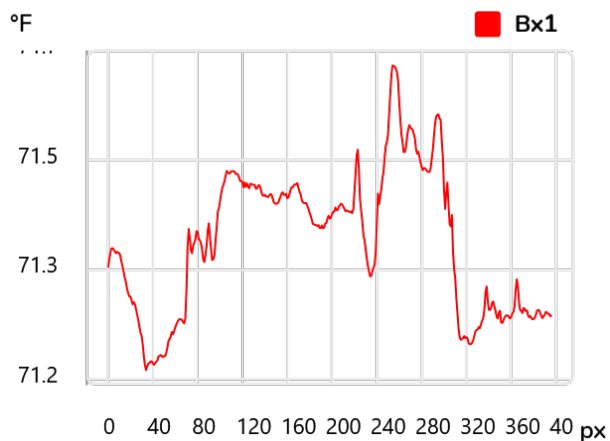
Thermogram 205 Created: 5/18/2026 1:54:46 PM

Equipment name : Sensors 204  
Device name : 1035  
Measurement Point : MM140 Switchboard #3  
Status OK

Max 76.5 °F  
Min 70.5 °F  
Area 0.433 ft<sup>2</sup>  
Sp1 74.1 °F

Recommended Action No action recommended at this time

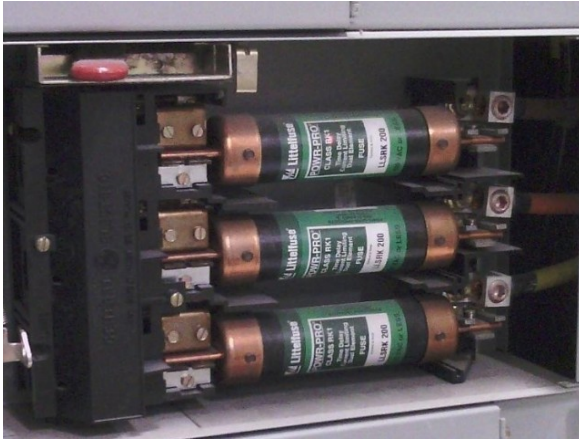
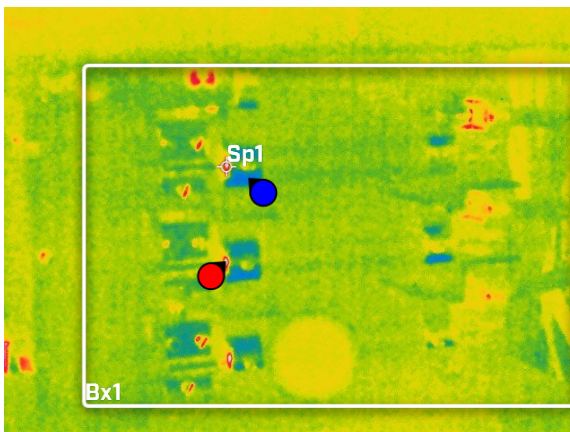
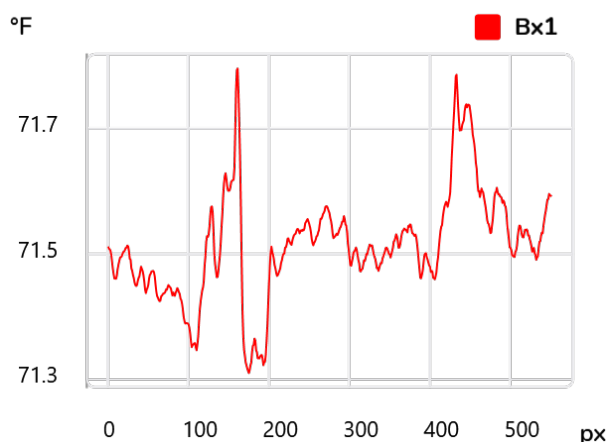
Thermogram 206 Created: 5/18/2026 1:57:09 PM

Equipment name : Sensors 204  
Device name : 1035  
Measurement Point : MM140 Switchboard #3  
Status OK

Max 76.0 °F  
Min 70.4 °F  
Area 0.734 ft²  
Sp1 75.1 °F

Issue No Issue - Normal operation  
Recommended Action No action recommended at this time  
Comment No additional comments.  
Priority None

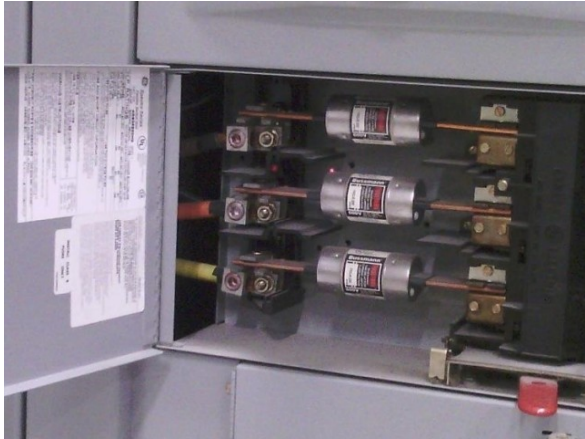
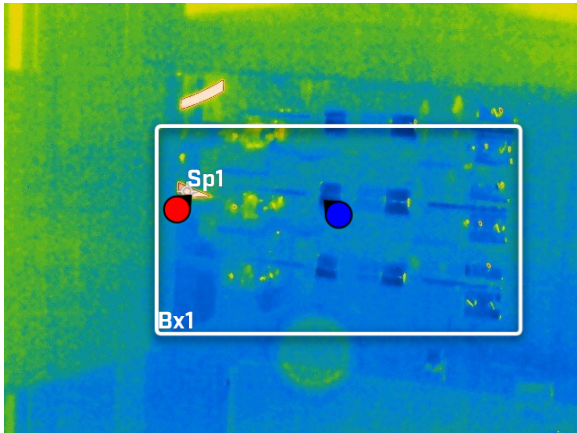
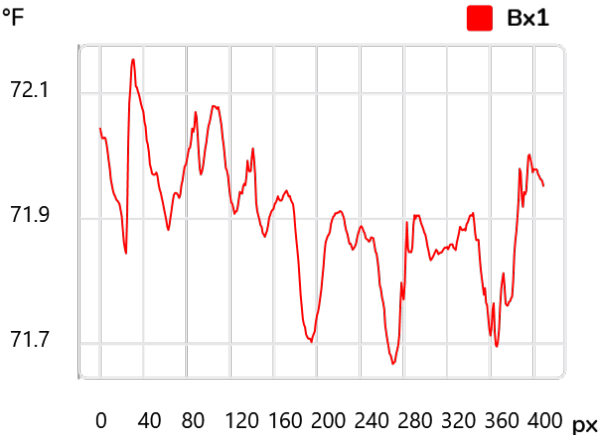
Thermogram 207 Created: 5/18/2026 1:59:32 PM

Equipment name : Sensors 204  
Device name : 1035  
Measurement Point : MM140 Switchboard #3  
Status OK

Issue No Issue - Normal operation  
Recommended Action No action recommended at this time  
Comment No additional comments.  
Priority None

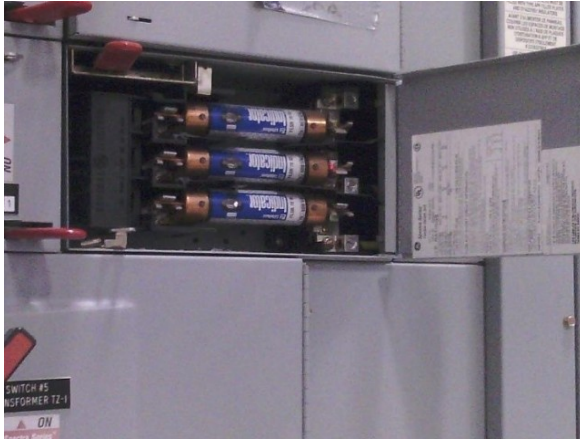
Equipment name : Sensors 204  
Device name : 1035  
Measurement Point : MM140 Switchboard #3  
Status OK

Recommended Action No action recommended at this time

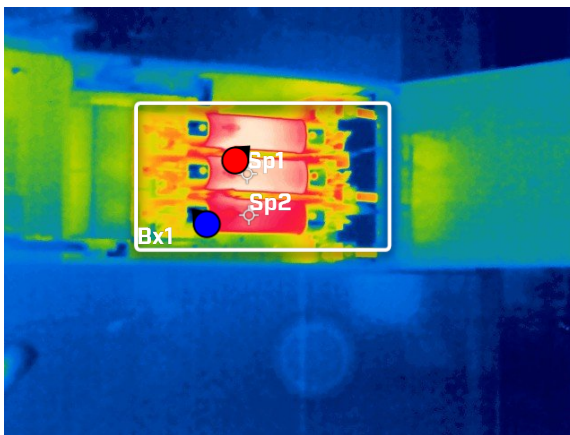
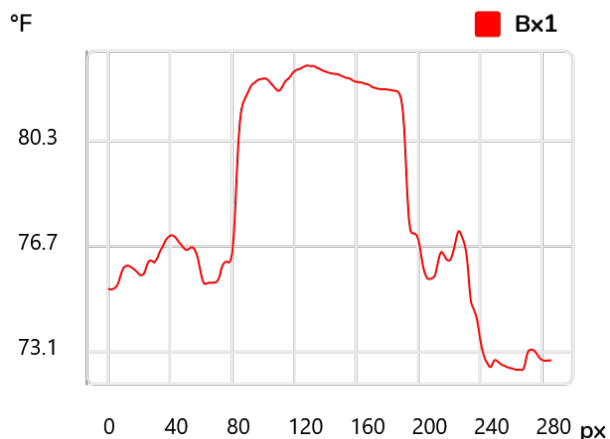
Thermogram 208 Created: 5/18/2026 2:17:07 PM

Max 89.6 °F  
Min 71.3 °F  
Area 0.355 ft<sup>2</sup>  
Sp1 87.5 °F  
Sp2 84.5 °F

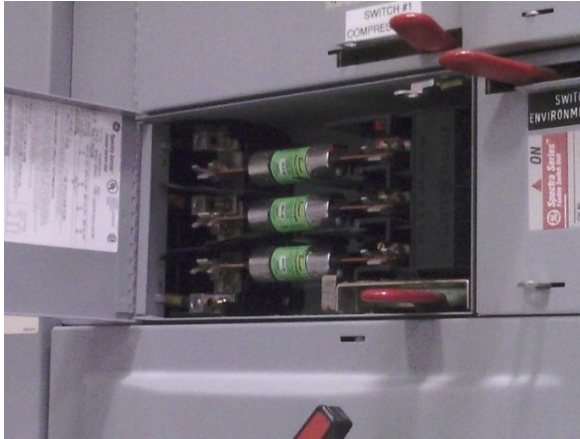
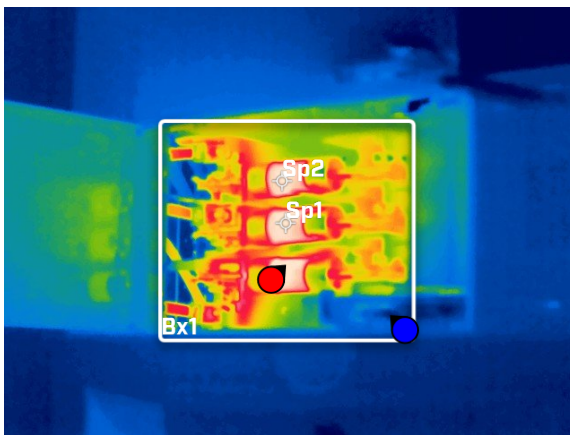
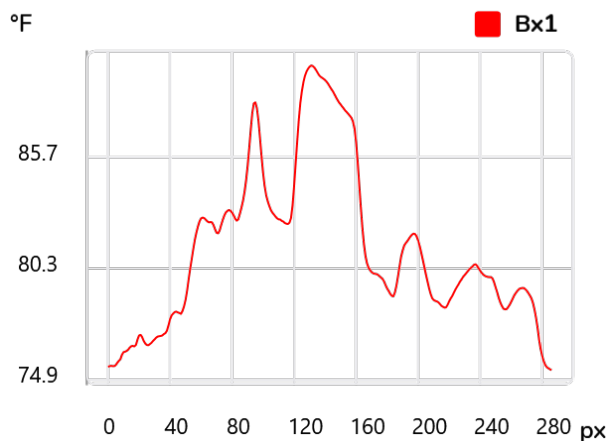
Thermogram 209 Created: 5/18/2026 2:19:49 PM

Equipment name : Sensors 204  
Device name : 1035  
Measurement Point : MM140 Switchboard #3  
Status OK

Sp2 102.9 °F

Recommended Action No action recommended at this time

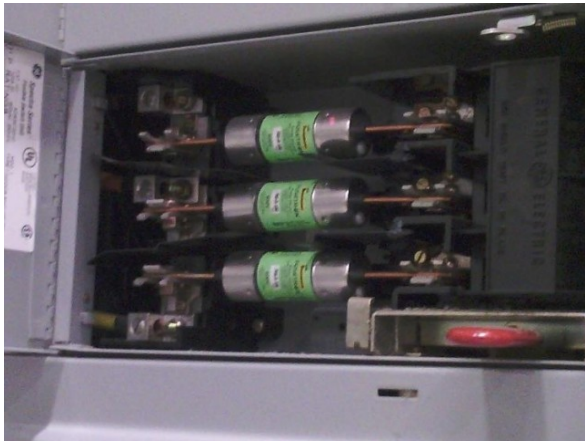
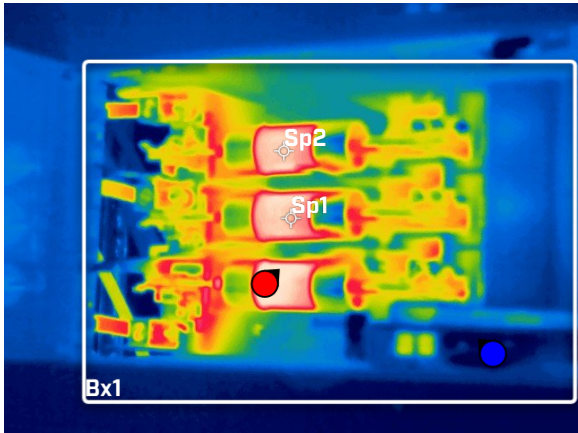
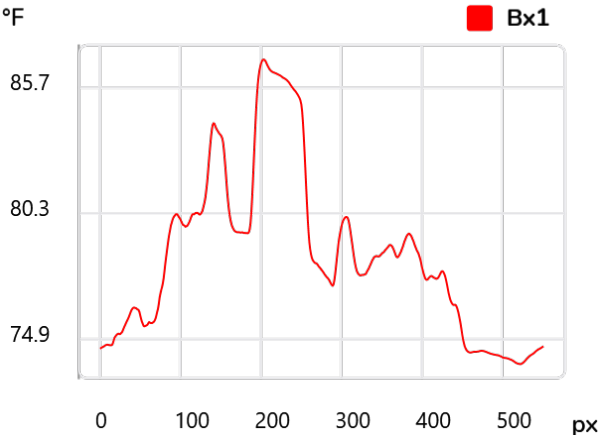
Thermogram 210 Created: 5/18/2026 2:25:19 PM

Equipment name : Sensors 204  
Device name : 1035  
Measurement Point : MM140 Switchboard #3  
Status OK

| Value | |
|---|---|
| Sp2 | 100.4 °F |

Issue No Issue - Normal operation  
Recommended Action No action recommended at this time  
Comment No additional comments.  
Priority None

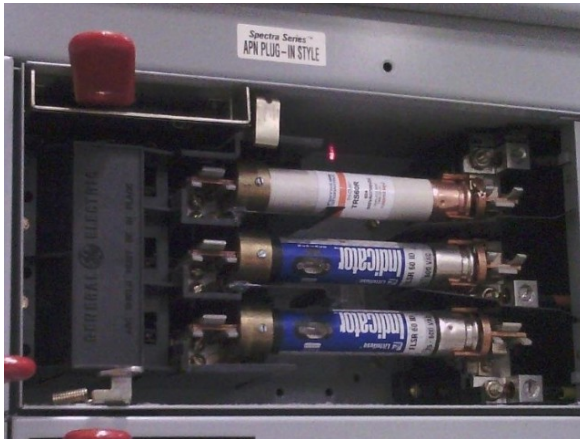
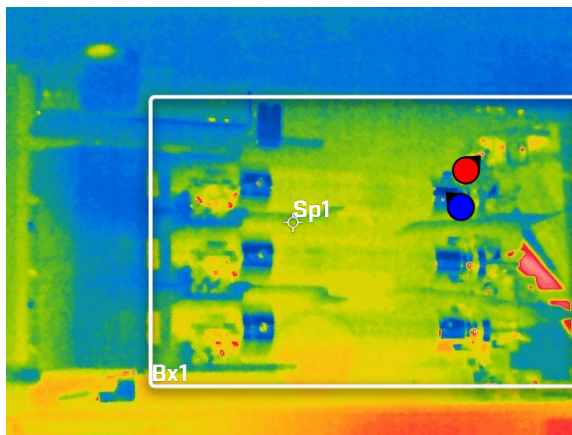
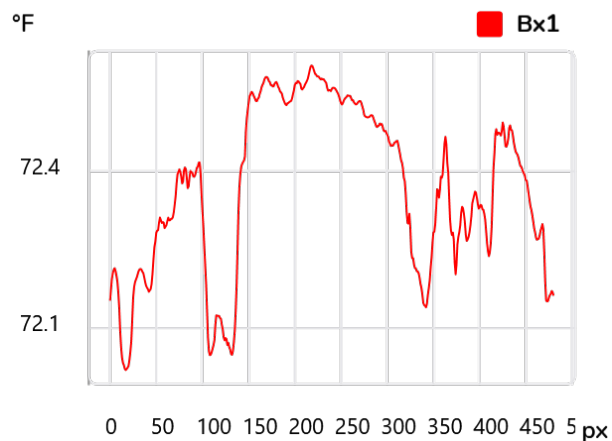
Thermogram 211 Created: 5/18/2026 2:26:46 PM

Equipment name : Sensors 204  
Device name : 1035  
Measurement Point : MM140 Switchboard #3  
Status OK

Max 78.0 °F  
Min 70.6 °F  
Area 0.523 ft²  
Sp1 72.5 °F

Issue No Issue - Normal operation  
Recommended Action No action recommended at this time  
Comment No additional comments.  
Priority None

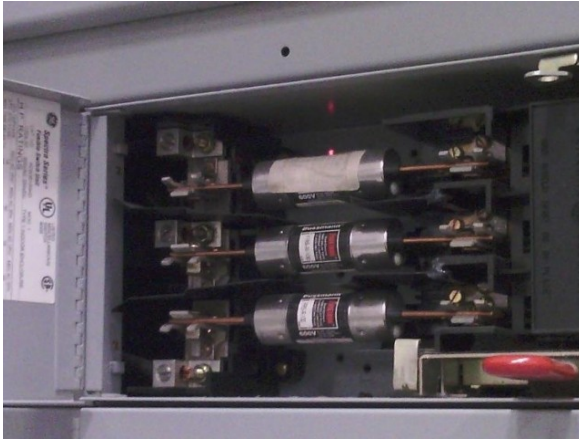
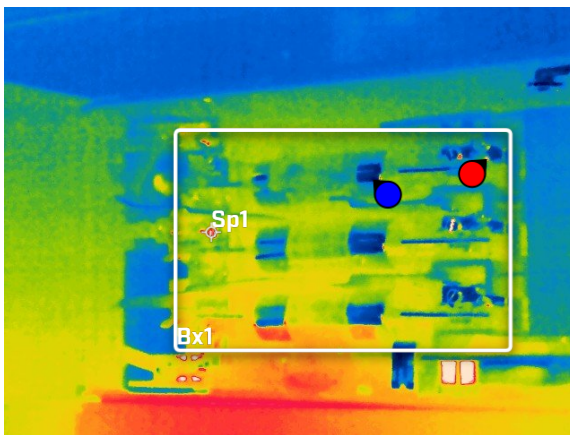
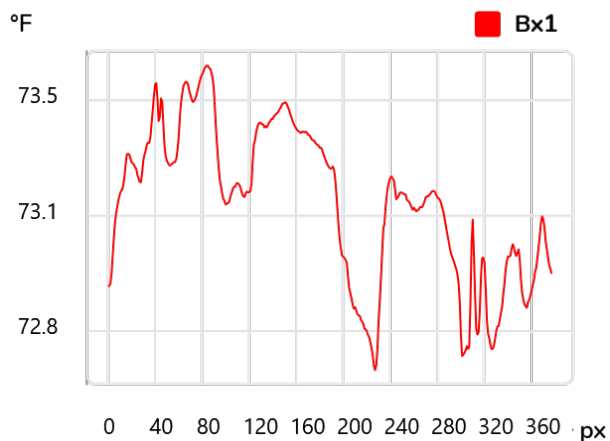
Thermogram 212 Created: 5/18/2026 2:28:53 PM

Equipment name : Sensors 204  
Device name : 1035  
Measurement Point : MM140 Switchboard #3  
Status OK

Max 81.0 °F  
Min 70.8 °F  
Area 0.317 ft<sup>2</sup>  
Sp1 76.6 °F

Issue No Issue - Normal operation

Recommended Action No action recommended at this time

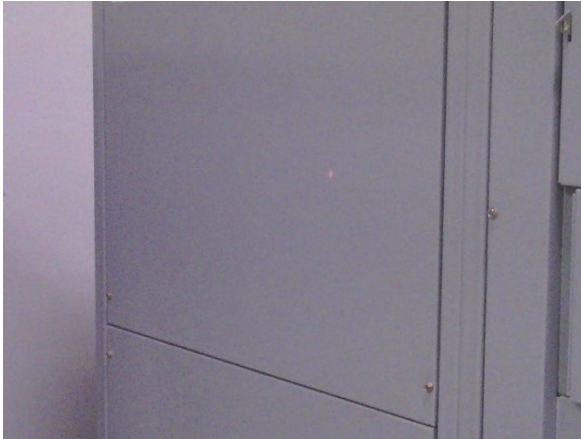
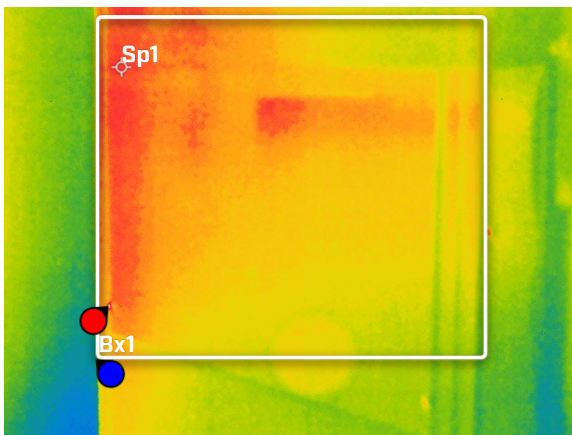
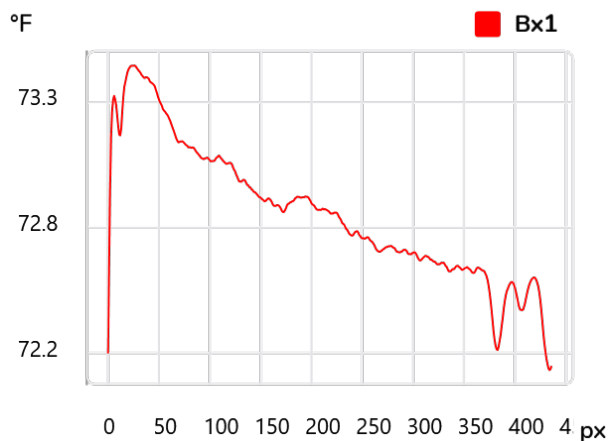
Thermogram 213 Created: 5/18/2026 2:34:40 PM

Equipment name : Sensors 204  
Device name : 1036  
Measurement Point : MM140 Switchboard #4

Status Note

Max 75.7 °F  
Min 71.4 °F  
Area 2.541 ft<sup>2</sup>  
Sp1 73.6 °F

Issue Unbalanced electrical loads

Recommended Action Monitor changes

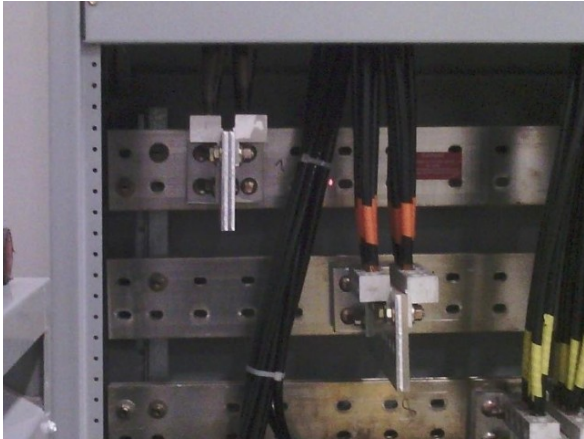
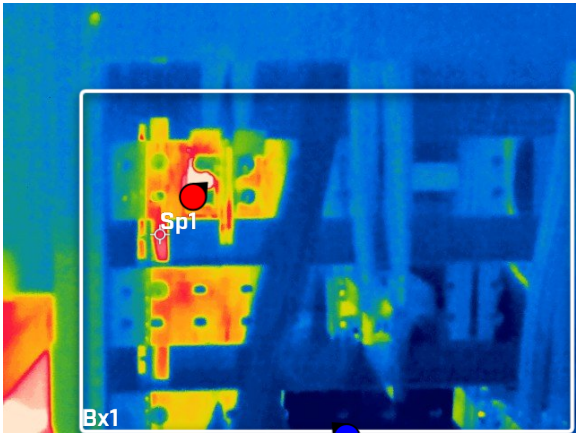
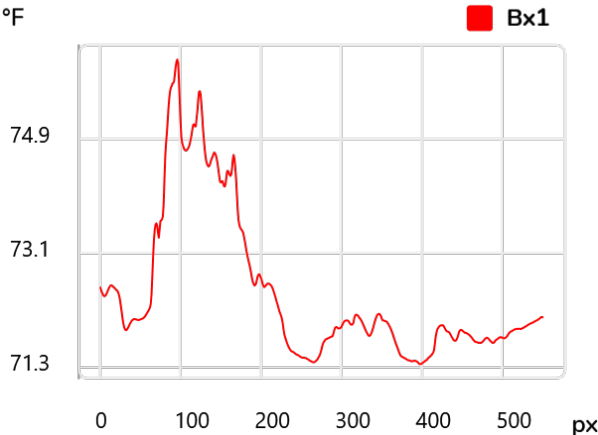
Thermogram 214 Created: 5/18/2026 2:36:57 PM

Equipment name : Sensors 204

Device name : 1036

| Value | |
|---|---|
| Sp1 | 80.3 °F |

Issue Unbalanced electrical loads

Recommended Action Monitor changes

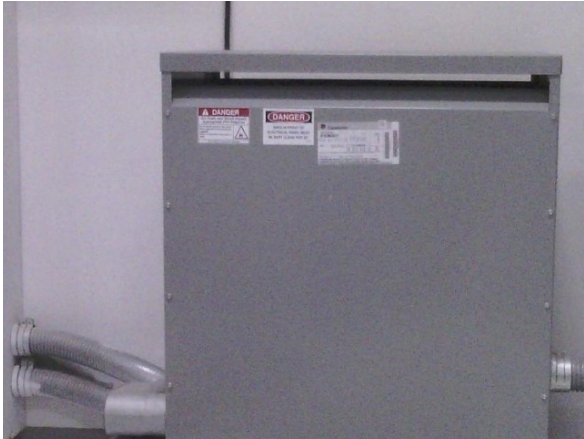
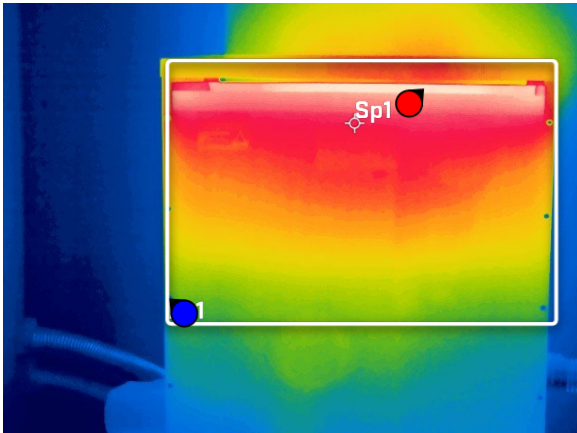
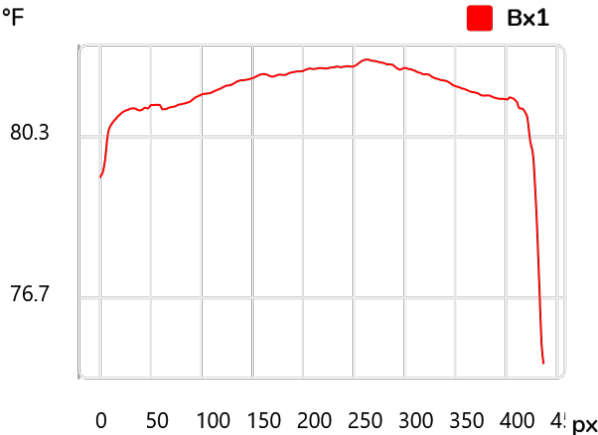
Thermogram 215 Created: 5/18/2026 2:40:12 PM

Equipment name : Sensors 204  
Device name : 1037  
Measurement Point : Transformer #1  
Status OK

| Value | |
|---|---|
| Sp1 | 84.1 °F |

Issue No Issue - Normal operation

Recommended Action No action recommended at this time

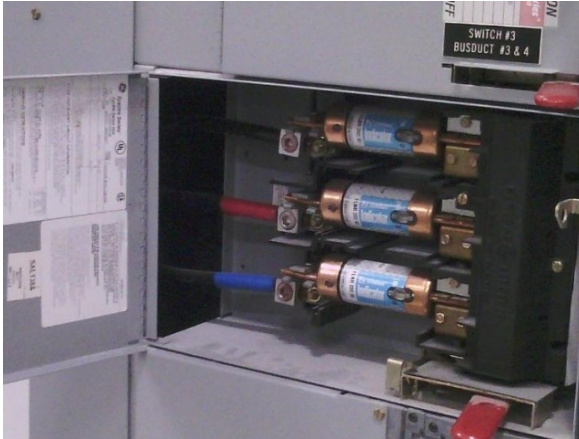
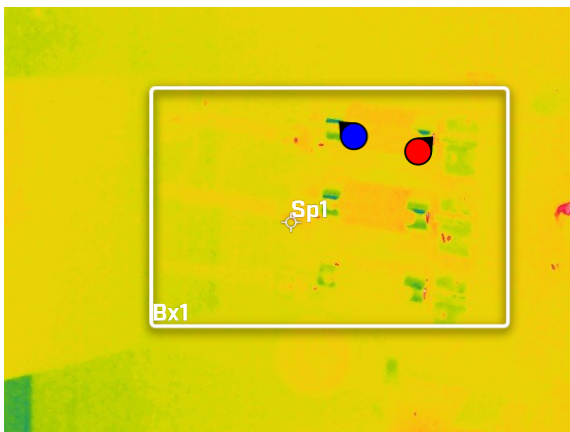
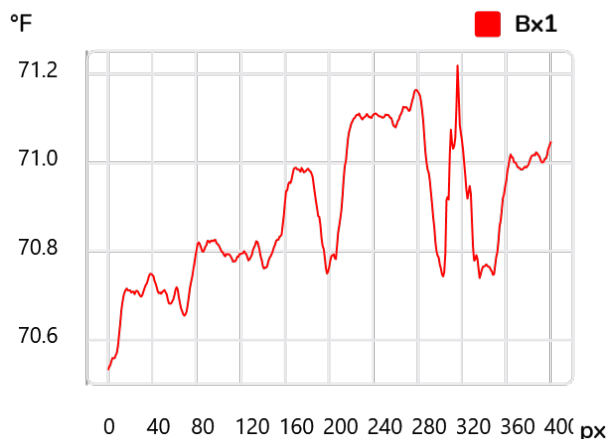
Thermogram 216 Created: 5/18/2026 2:45:26 PM

Equipment name : Sensors 204  
Device name : 1038  
Measurement Point : LZ1  
Status OK

Max 74.9 °F  
Min 68.8 °F  
Area 0.626 ft²  
Sp1 71.1 °F

Issue No Issue - Normal operation

Recommended Action No action recommended at this time

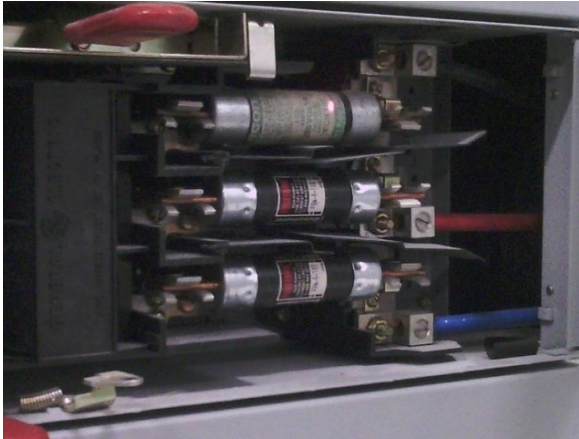
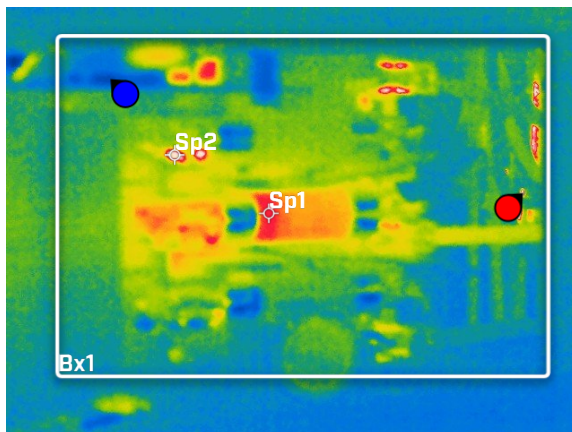
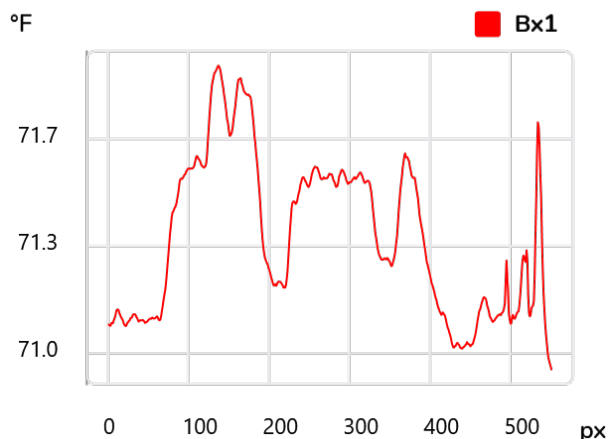
Thermogram 217 Created: 5/18/2026 2:48:03 PM

Equipment name : Sensors 204  
Device name : 1038  
Measurement Point : LZ1  
Status OK

Max 81.1 °F  
Min 69.9 °F  
Area 0.416 ft²  
Sp1 73.8 °F  
Sp2 77.3 °F

Recommended Action No action recommended at this time

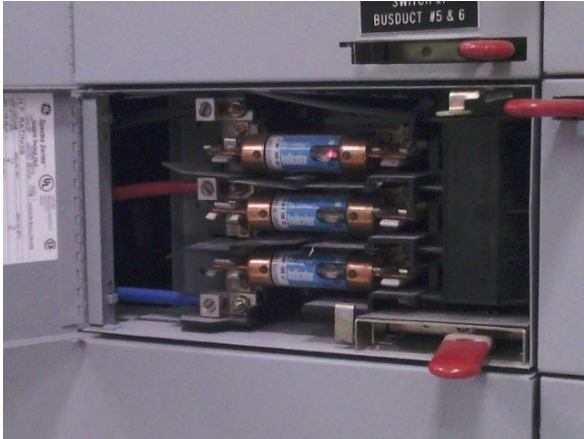
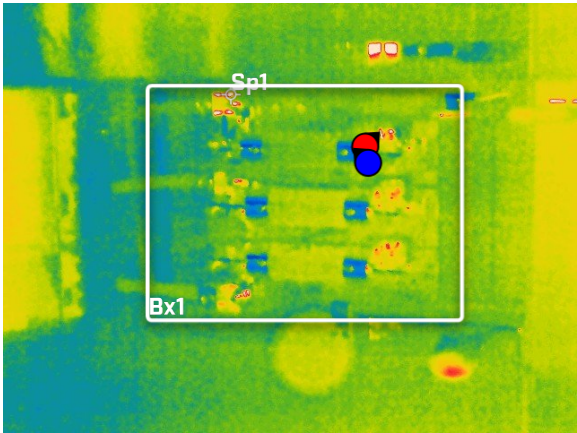
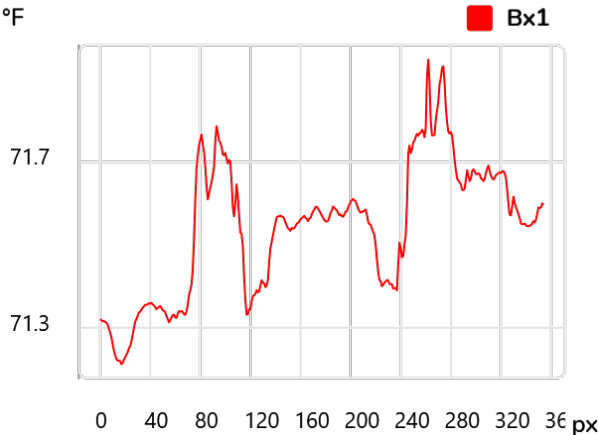
Thermogram 218 Created: 5/18/2026 2:50:14 PM

Equipment name : Sensors 204  
Device name : 1038  
Measurement Point : LZ1  
Status OK

| Value | |
|---|---|
| Sp1 | 77.0 °F |

Issue No Issue - Normal operation  
Recommended Action No action recommended at this time  
Comment No additional comments.  
Priority None

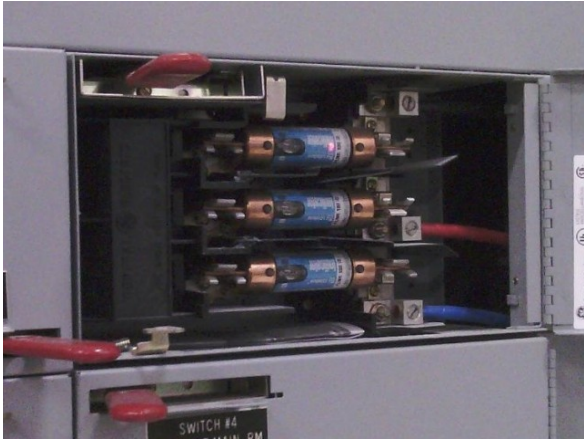
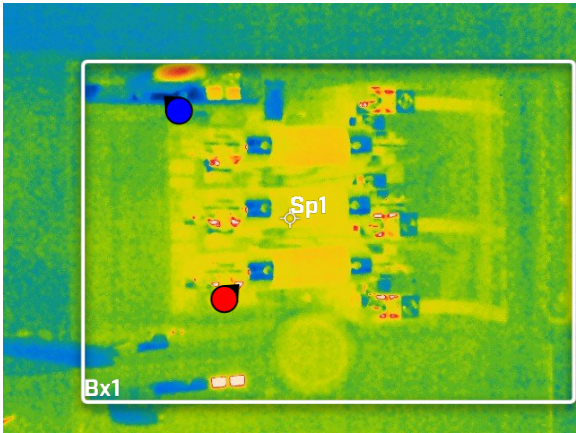
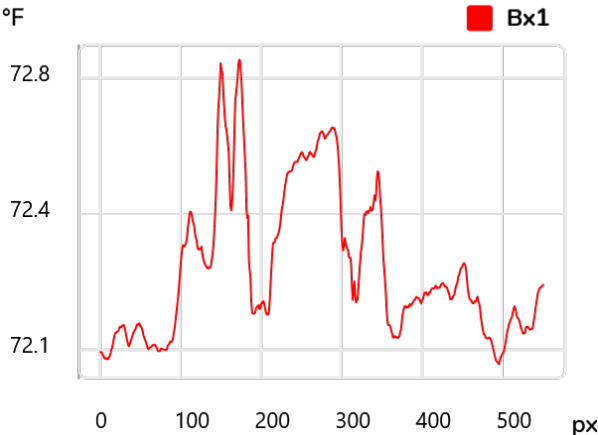
Thermogram 219 Created: 5/18/2026 2:52:17 PM

Equipment name : Sensors 204  
Device name : 1038  
Measurement Point : LZ1  
Status OK

| Value | |
|---|---|
| Sp1 | 72.8 °F |

Issue No Issue - Normal operation  
Recommended Action No action recommended at this time  
Comment No additional comments.  
Priority None

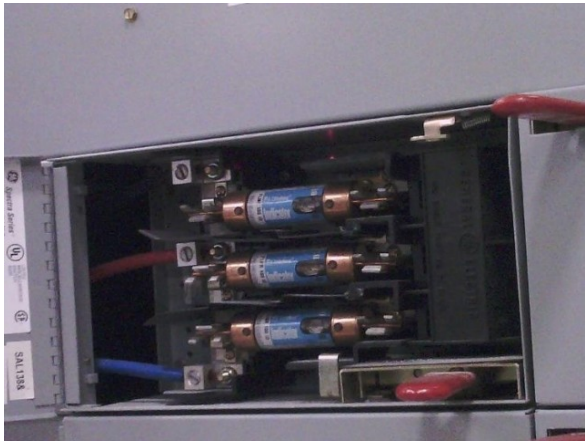
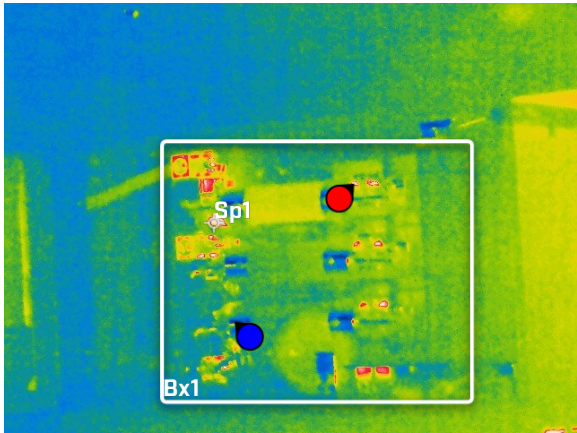
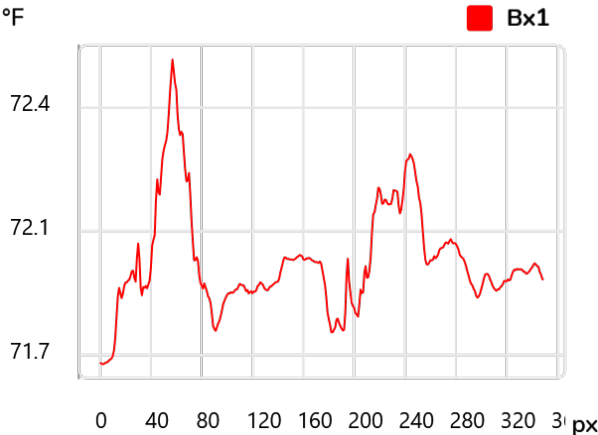
Thermogram 220 Created: 5/18/2026 2:54:29 PM

Equipment name : Sensors 204  
Device name : 1038  
Measurement Point : LZ1  
Status OK

| Value | |
|---|---|
| Sp1 | 77.2 °F |

Issue No Issue - Normal operation  
Recommended Action No action recommended at this time  
Comment No additional comments.  
Priority None

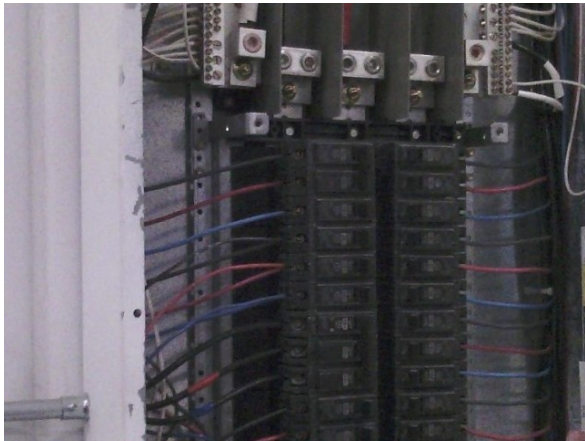
Equipment name : Sensors 204  
Device name : 1039  
Measurement Point : LZ1A  
Status OK

**Issue** No Issue - Normal operation  
**Recommended Action** No action recommended at this time  
**Comment** No additional comments.  
**Priority** None

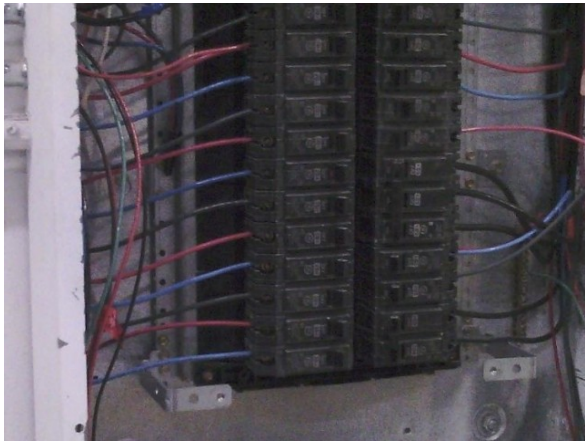
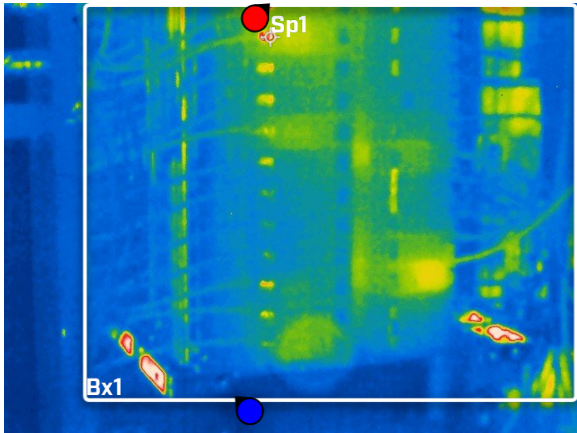
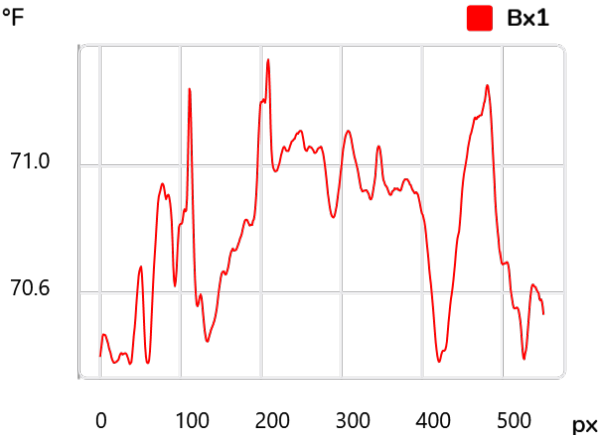
Thermogram 222 Created: 5/18/2026 3:02:30 PM

Equipment name : Sensors 204  
Device name : 1039  
Measurement Point : LZ1A  
Status OK

Issue No Issue - Normal operation  
Recommended Action No action recommended at this time  
Comment No additional comments.  
Priority None

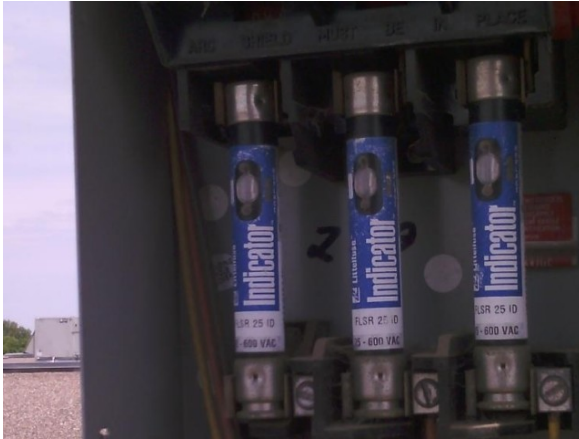
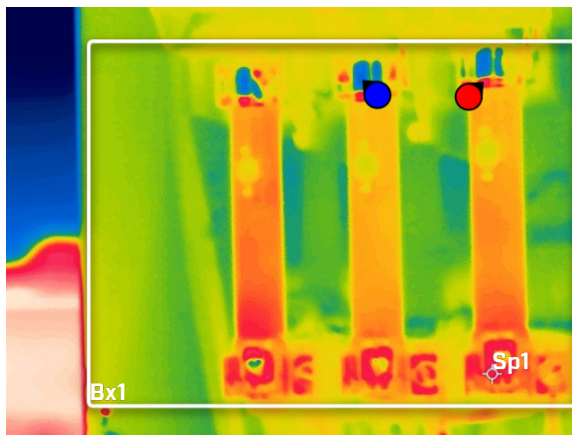
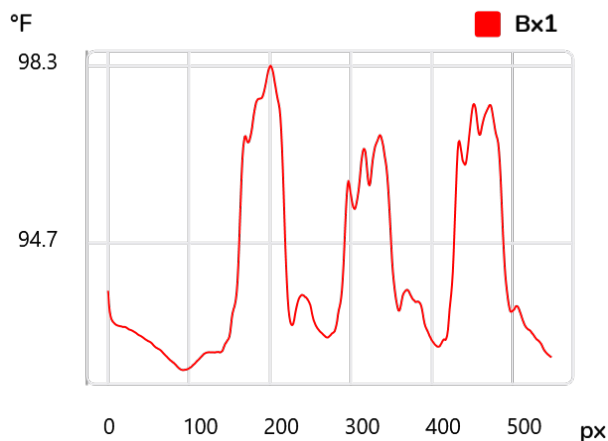
Thermogram 223 Created: 6/3/2026 2:36:06 PM

Equipment name : Quality Lab 205  
Device name : 1045  
Measurement Point : Compressor #2  
Status OK

Issue No Issue - Normal operation

Recommended Action No action recommended at this time

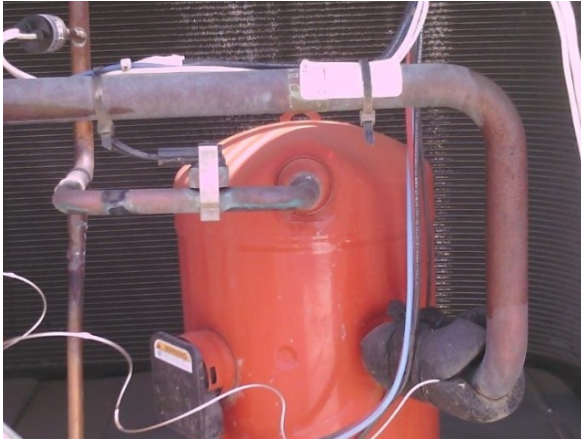
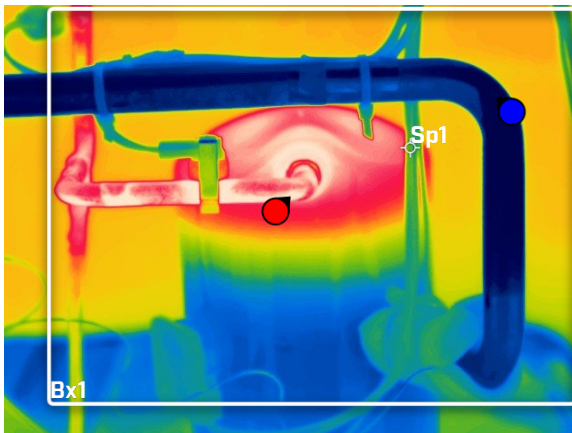
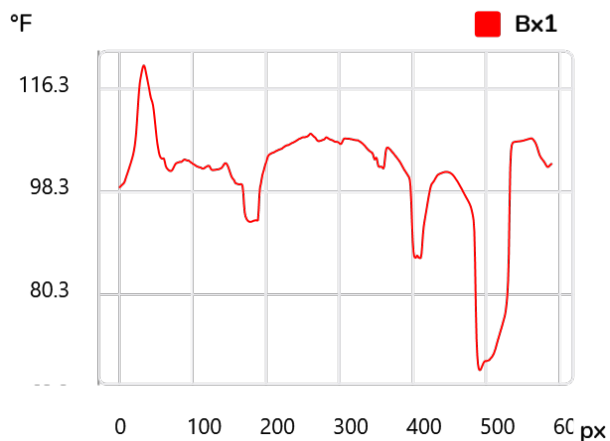
Thermogram 224 Created: 6/3/2026 2:37:02 PM

Equipment name : Quality Lab 205  
Device name : 1045  
Measurement Point : Compressor #2  
Status OK

Issue No Issue - Normal operation

Recommended Action No action recommended at this time

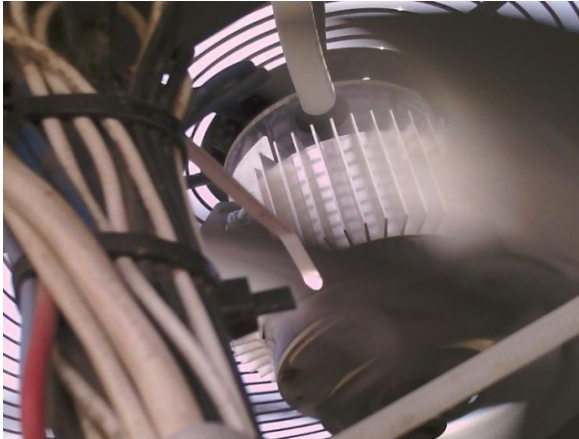
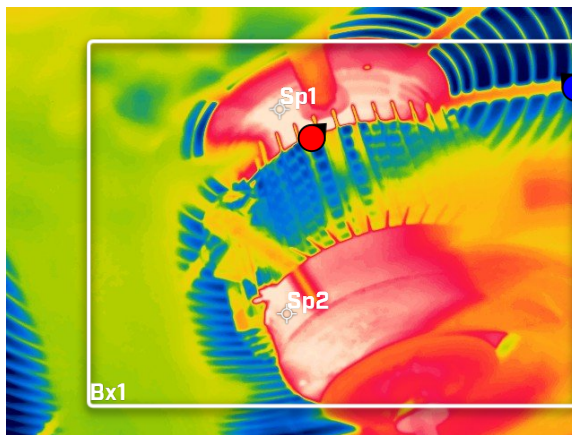
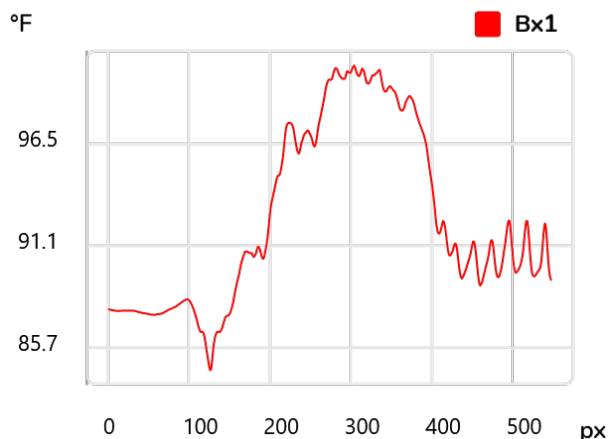
Thermogram 225 Created: 6/3/2026 2:37:40 PM

Equipment name : Quality Lab 205  
Device name : 1045  
Measurement Point : Compressor #2  
Status OK

**Recommended Action** No action recommended at this time
