# THERMAL ELECTRICAL INSPECTION

## SAMPLE REPORT

RETROFIT  
ELECTRIC

# Retrofit Electric - Thermal Electrical Inspection

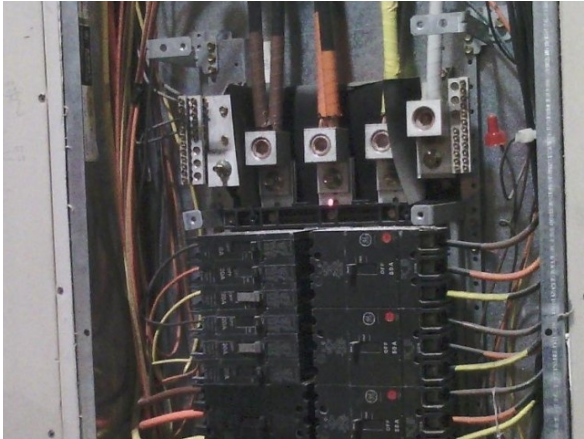
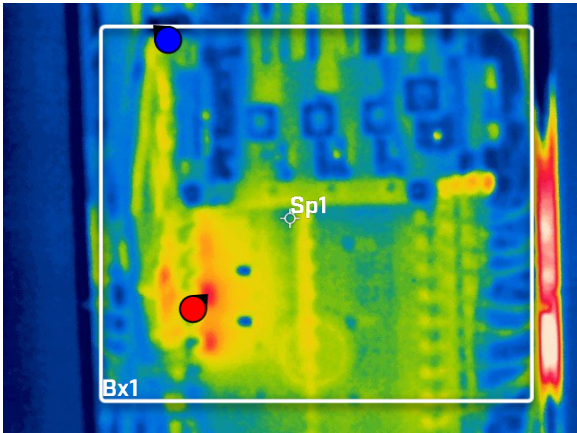
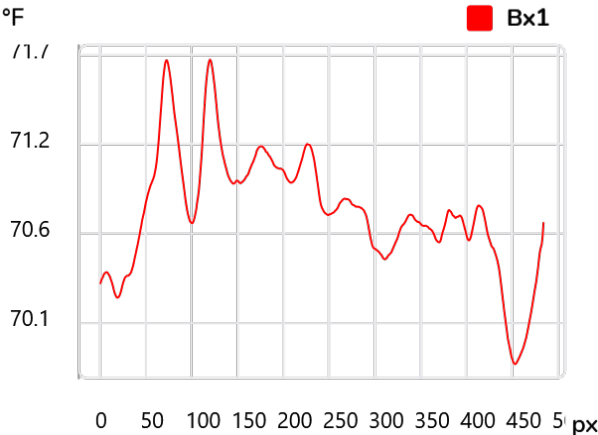
Thermogram 226 Created: 5/19/2026 12:45:18 PM

Equipment name : Large Shipping 400

Issue No Issue - Normal operation

Recommended Action No action recommended at this time

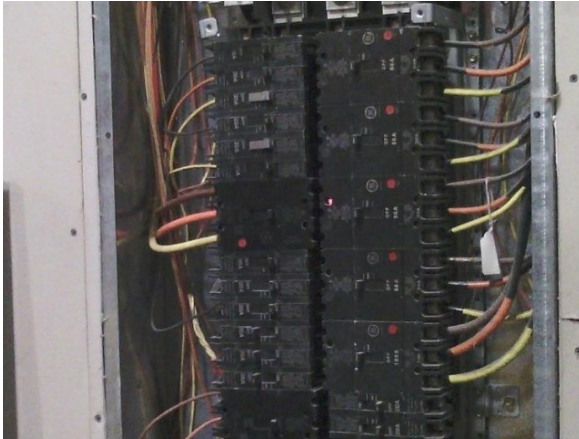
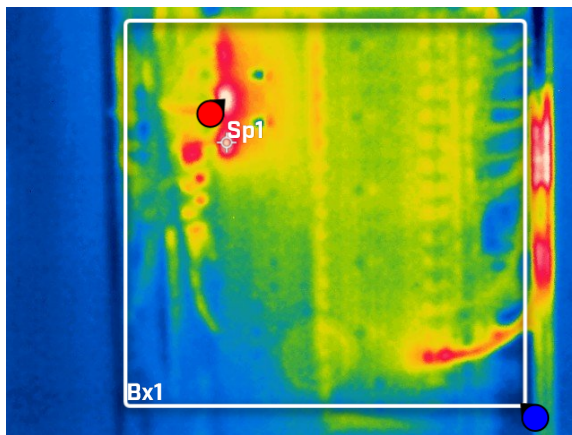
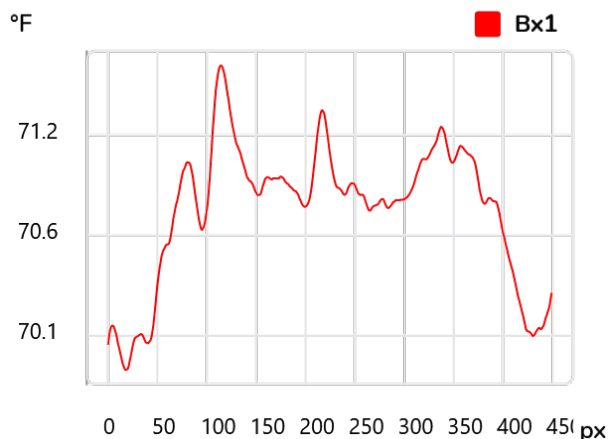
Thermogram 227 Created: 5/19/2026 12:46:32 PM

Equipment name : Large Shipping 400

**Recommended Action** No action recommended at this time

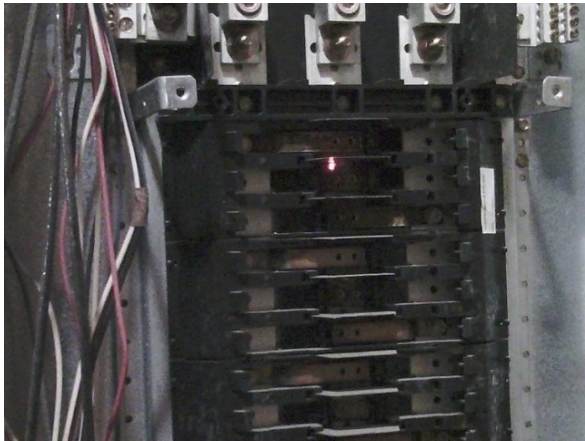
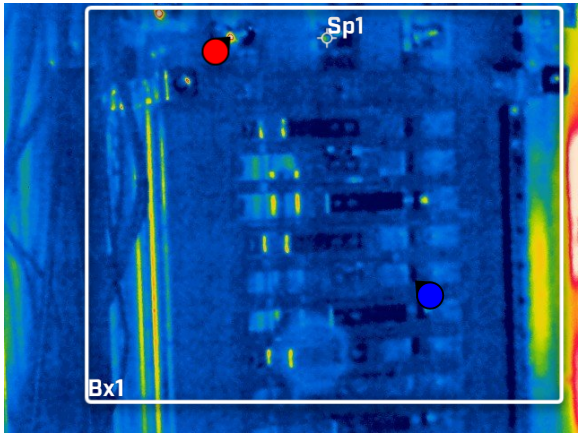
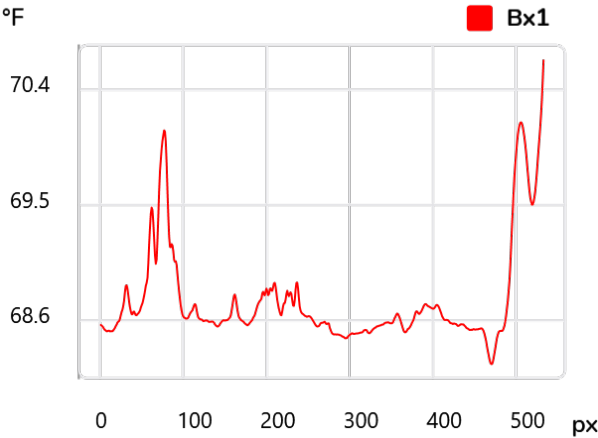
Thermogram 228 Created: 5/19/2026 1:17:59 PM

Equipment name : Large Shipping 400  
Device name : 1047  
Measurement Point : LZ-3B  
Status OK

Issue No Issue - Normal operation  
Recommended Action No action recommended at this time  
Comment No additional comments.  
Priority None

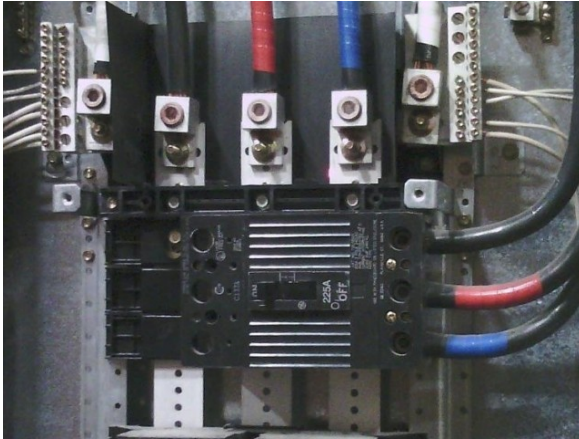
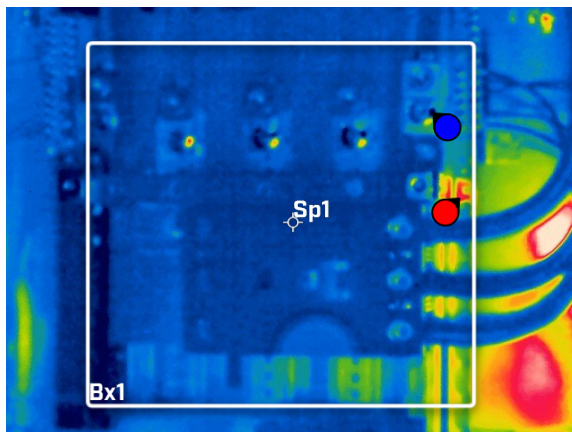
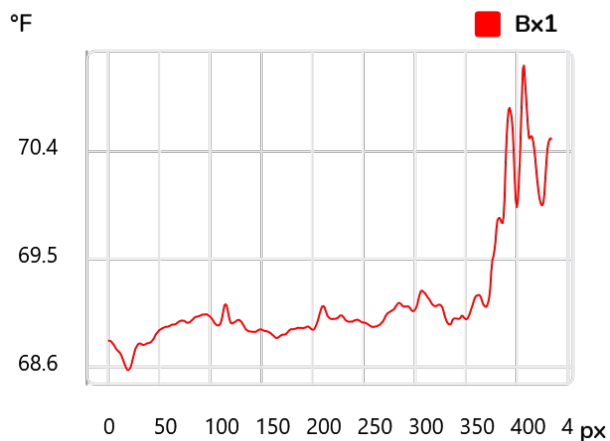
Thermogram 229 Created: 5/19/2026 1:03:19 PM

Equipment name : Large Shipping 400

Issue No Issue - Normal operation

Recommended Action No action recommended at this time

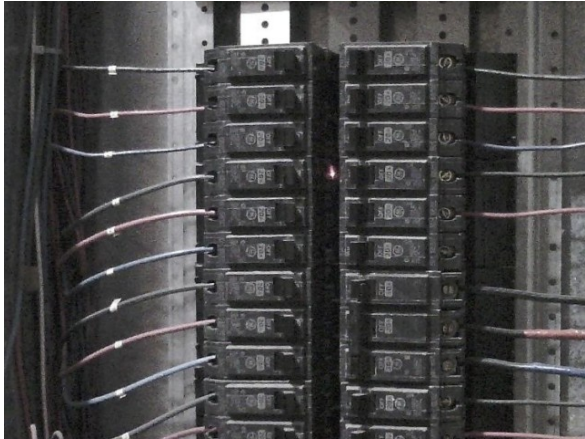
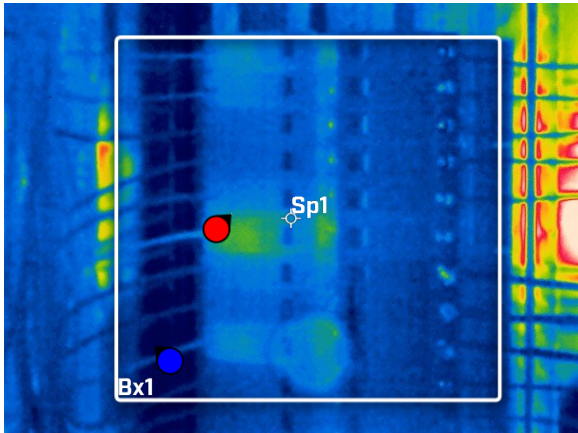
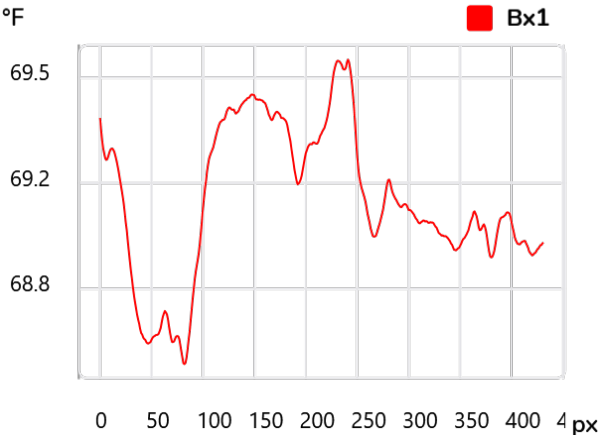
Thermogram 230 Created: 5/19/2026 1:04:08 PM

Equipment name : Large Shipping 400  
Device name : 1048  
Measurement Point : LZ-3A  
Status OK

Issue No Issue - Normal operation  
Recommended Action No action recommended at this time  
Comment No additional comments.  
Priority None

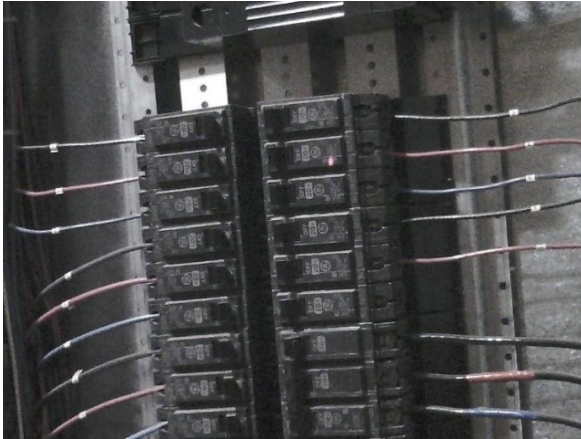
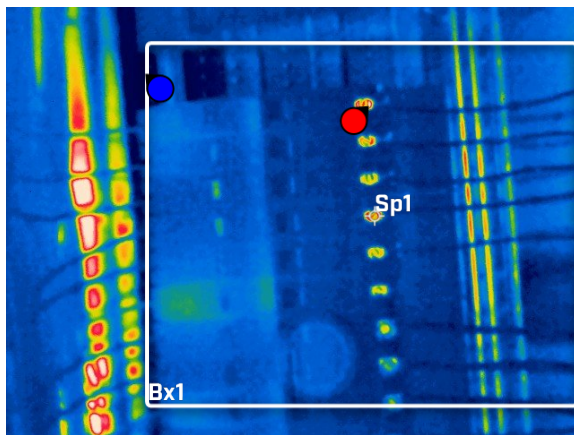
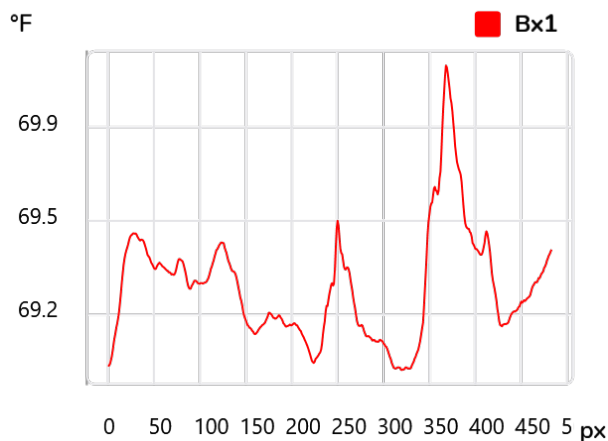
Thermogram 231 Created: 5/19/2026 1:05:13 PM

Equipment name : Large Shipping 400

Recommended Action No action recommended at this time

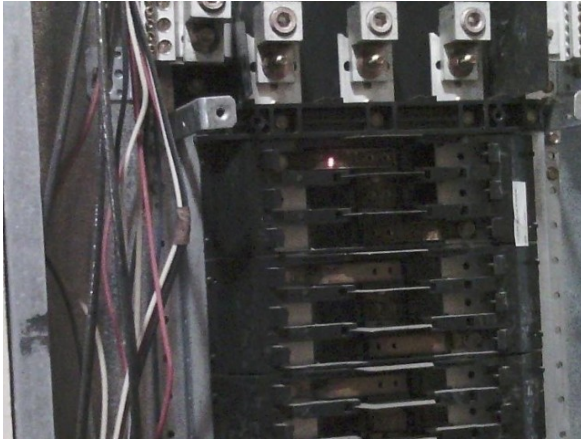
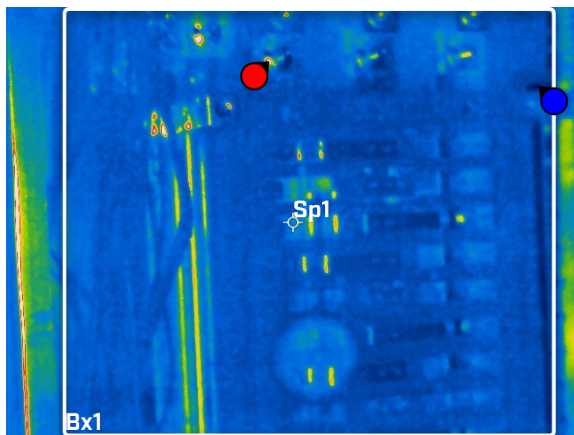
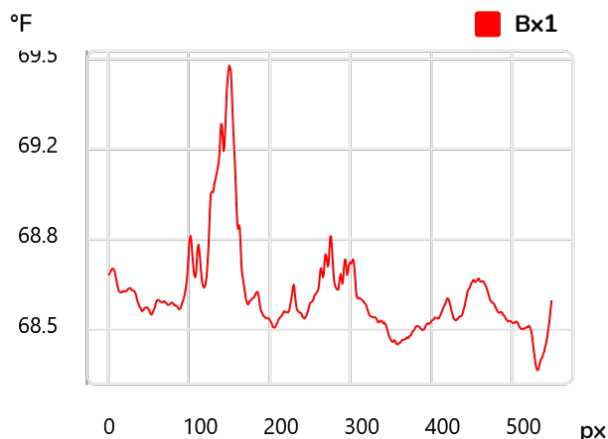
Thermogram 232 Created: 5/19/2026 1:15:55 PM

Equipment name : Large Shipping 400

**Issue** No Issue - Normal operation

**Recommended Action** No action recommended at this time

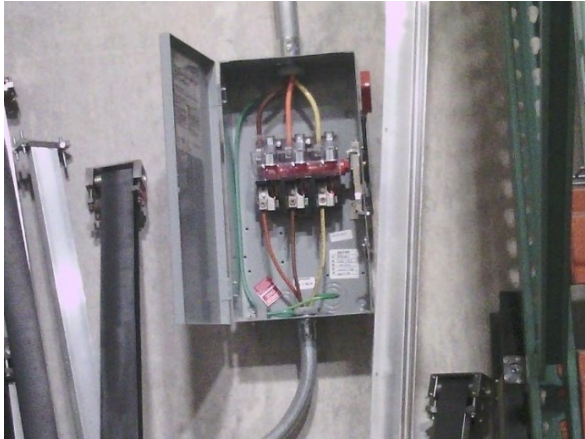
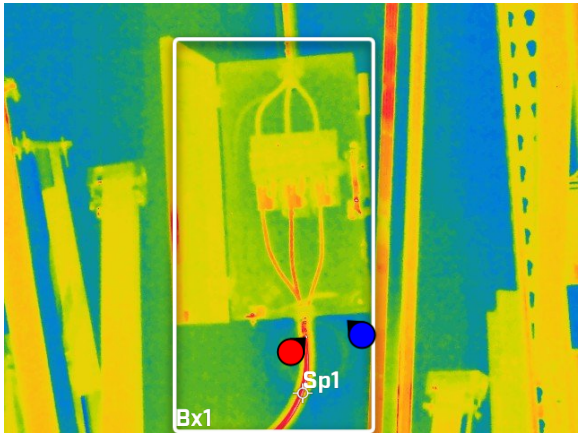
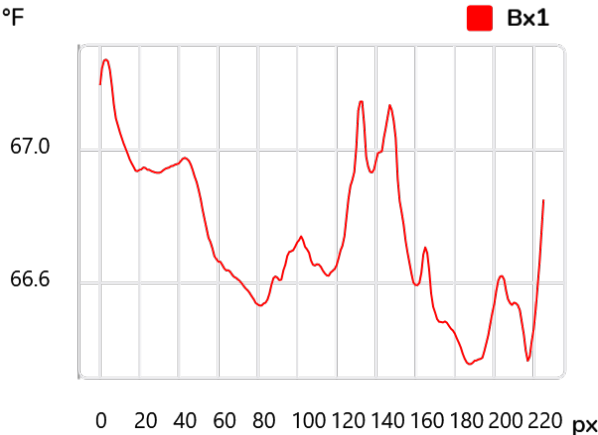
Thermogram 233 Created: 5/20/2026 12:25:16 PM

Equipment name : Large Shipping 400

Issue No Issue - Normal operation

Recommended Action No action recommended at this time

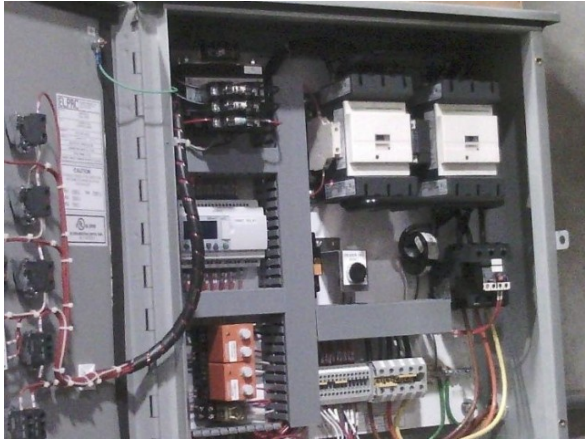
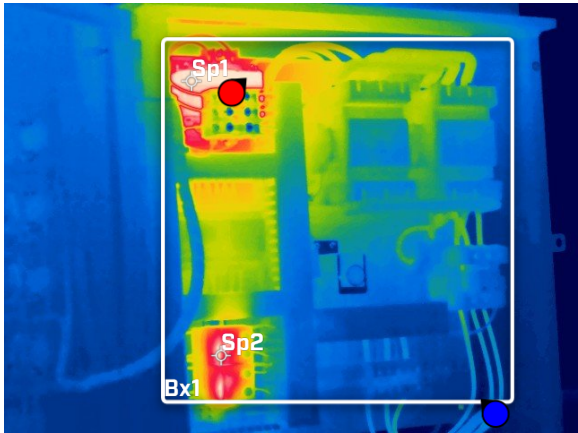
**Thermogram** 234 Created: 5/20/2026 12:26:10 PM

**Equipment name :** Large Shipping 400

**Status** OK

**Recommended Action** No action recommended at this time

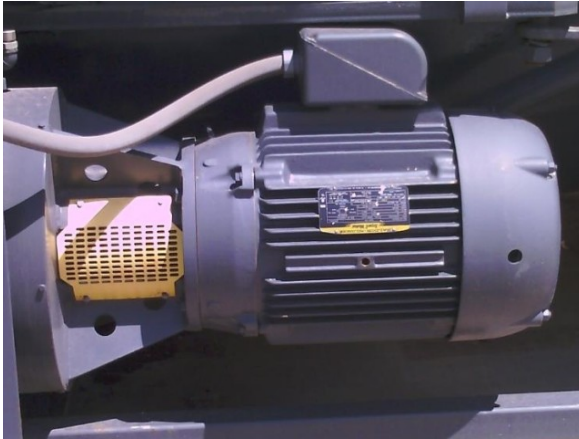
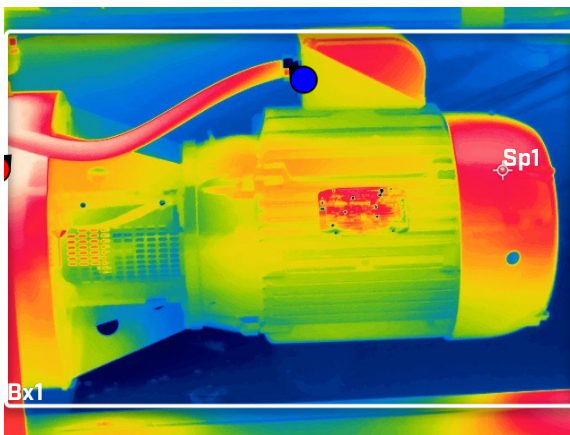
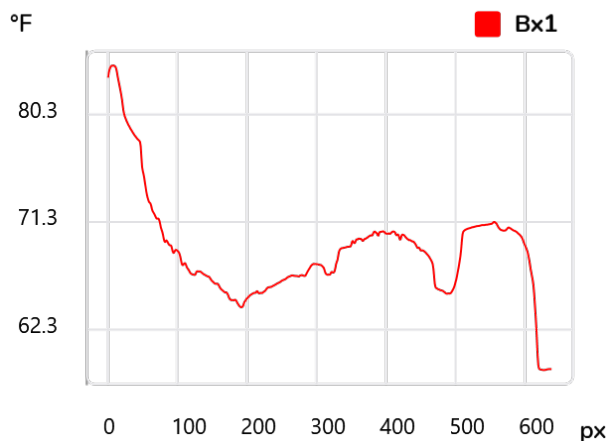
Thermogram 235 Created: 5/20/2026 12:31:54 PM

Equipment name : Large Shipping 400

Device name : 1049

**Recommended Action** No action recommended at this time

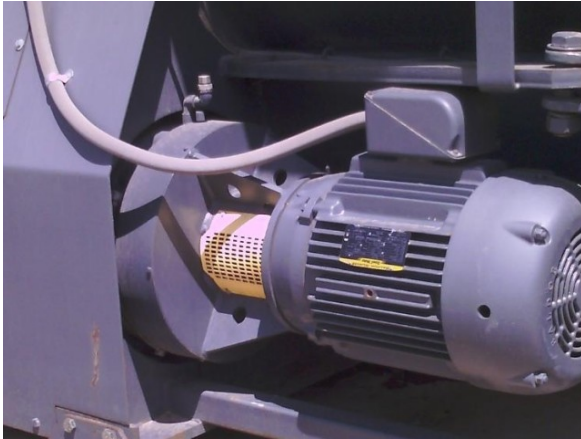
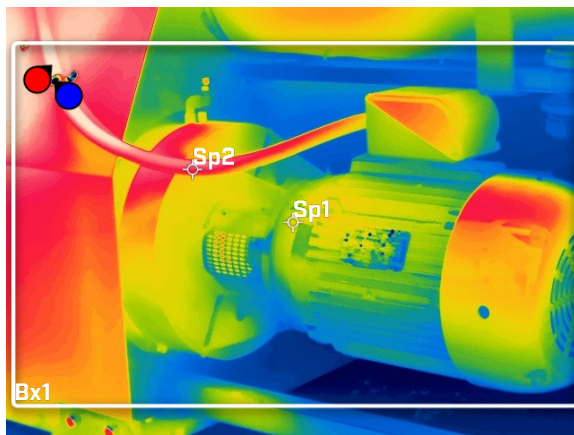
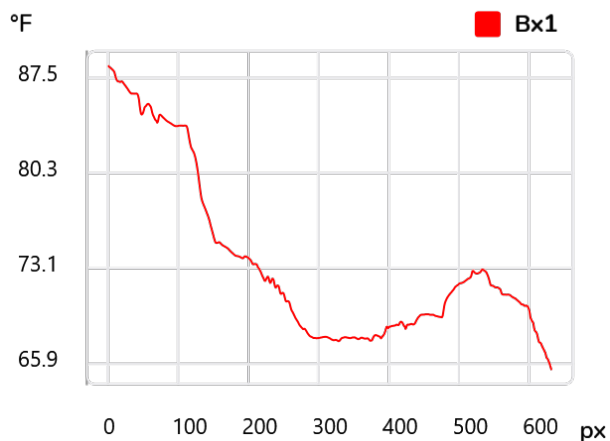
Thermogram 236 Created: 5/20/2026 12:32:18 PM

Equipment name : Large Shipping 400

Device name : 1049

Issue No Issue - Normal operation

Recommended Action No action recommended at this time

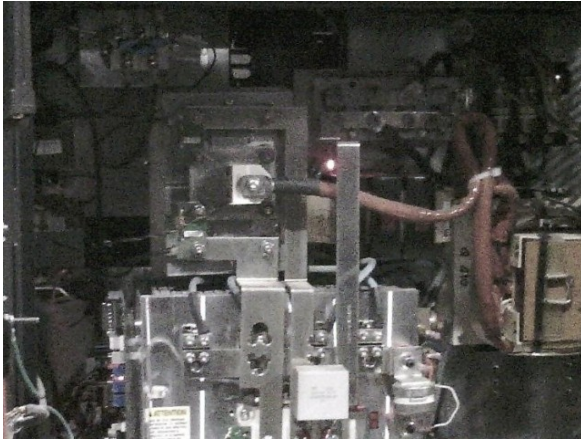
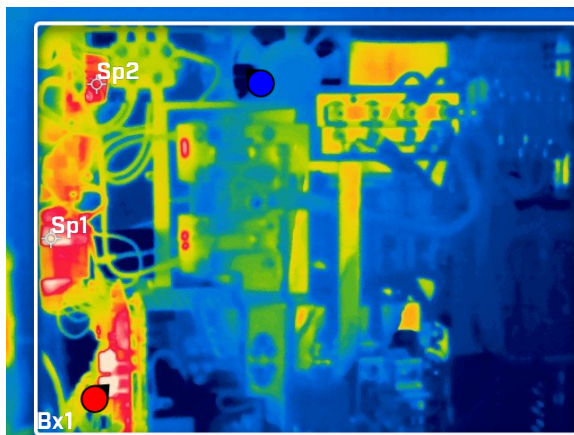
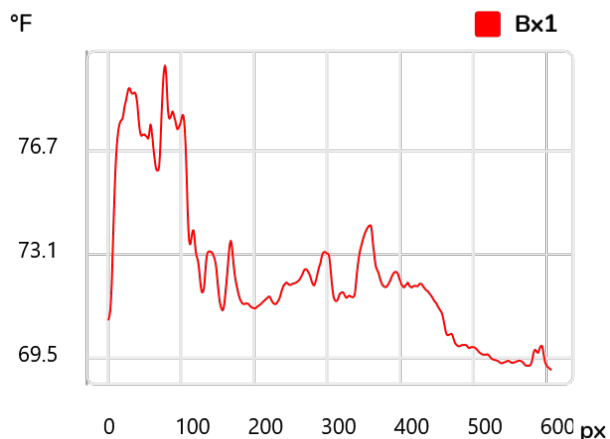
Thermogram 237 Created: 5/20/2026 12:39:58 PM

Equipment name : Large Shipping 400

Device name : 1049

**Recommended Action** No action recommended at this time

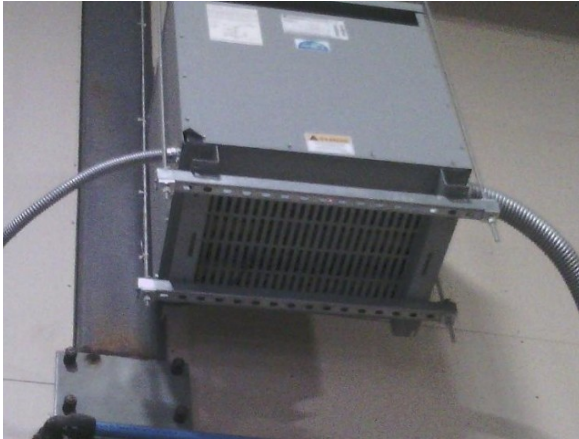
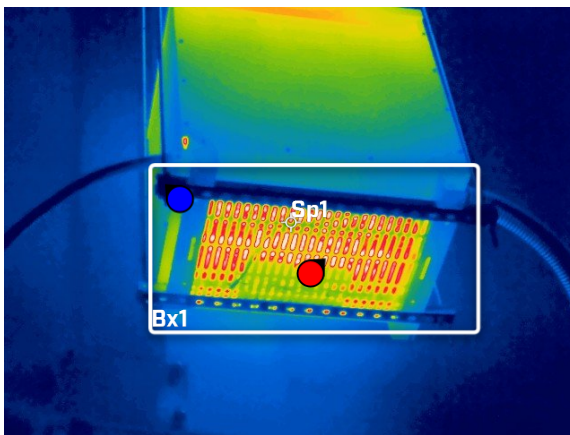
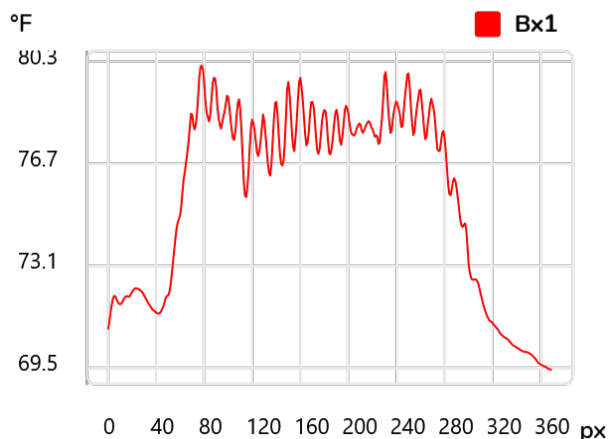
Thermogram 238 Created: 5/21/2026 10:29:06 AM

Equipment name : TZ-3  
Device name : Transformer  
Measurement Point : TZ-3  
Status OK

**Issue** No Issue - Normal operation

**Recommended Action** No action recommended at this time

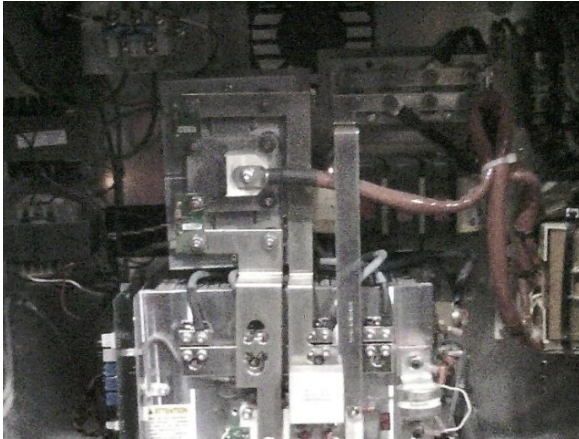
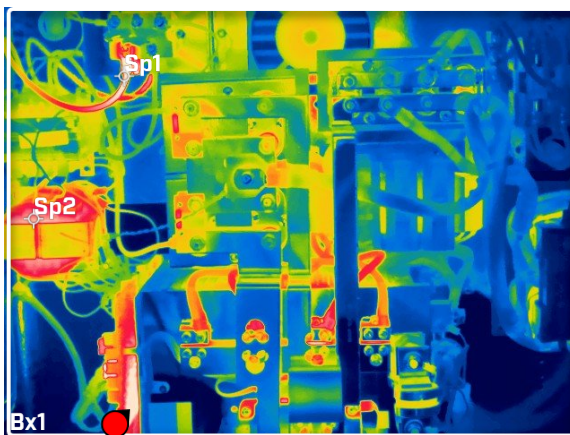
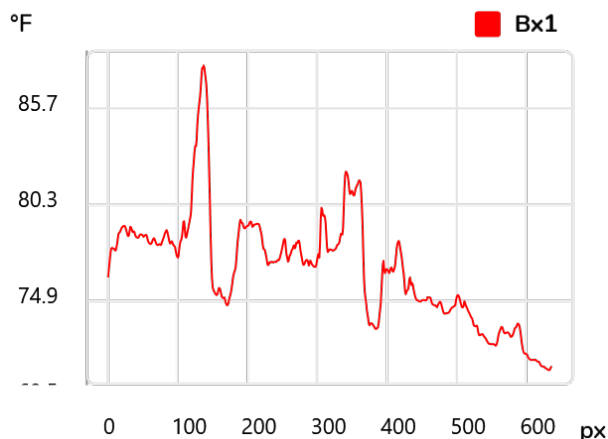
Thermogram 239 Created: 5/20/2026 12:42:43 PM

Equipment name : Small Parts Shipping 401

Device name : 1051

Measurement Point : GNB GTC-96ST1  
Forklift Charger

Recommended Action No action recommended at this time

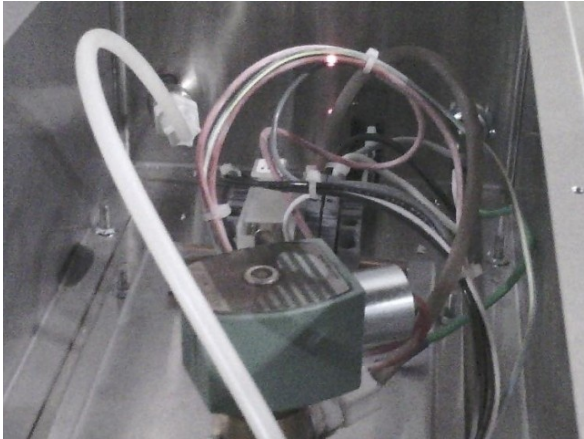
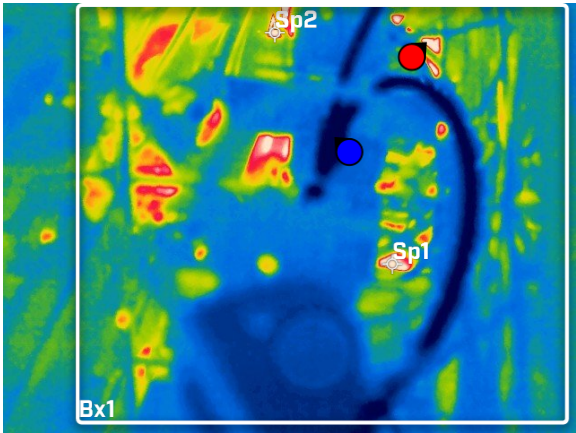
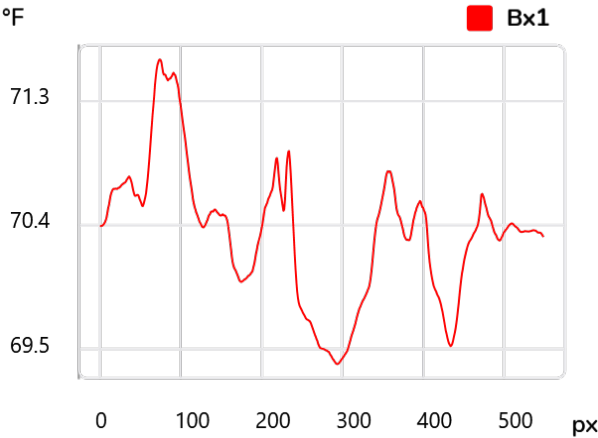
Thermogram 240 Created: 5/20/2026 1:22:21 PM

Equipment name : Small Parts Shipping 401

Device name : 1054

Measurement Point : Clean Air Humidor

Issue No Issue - Normal operation

Recommended Action No action recommended at this time

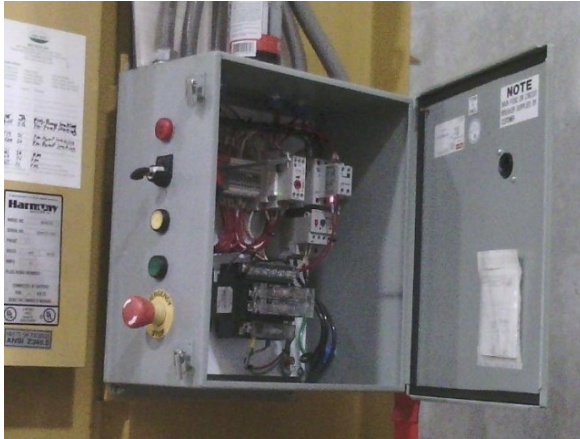
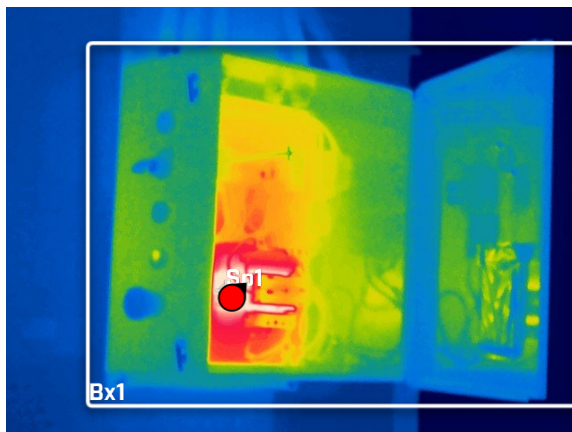
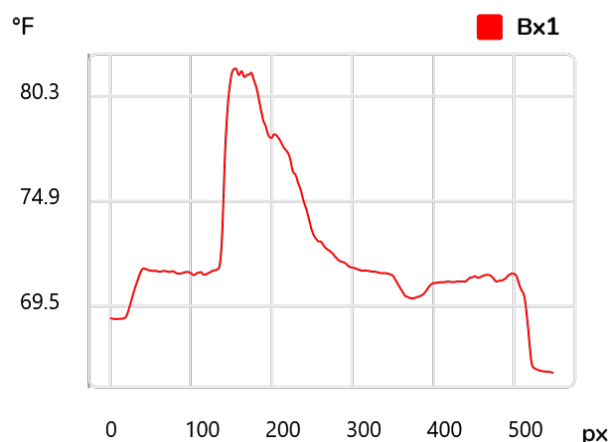
Thermogram 242 Created: 5/20/2026 12:56:21 PM

Equipment name : Small Parts Shipping 401

Device name : 1055

Issue No Issue - Normal operation

Recommended Action No action recommended at this time

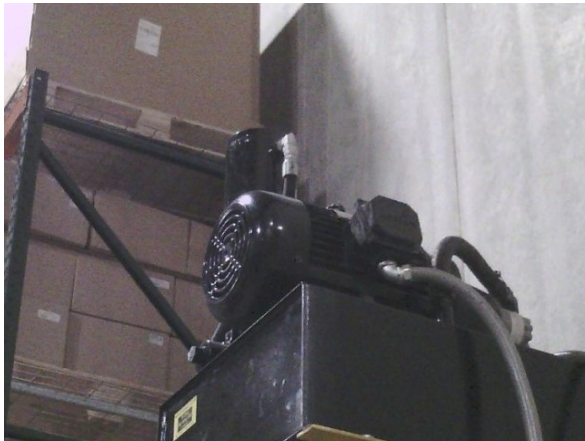
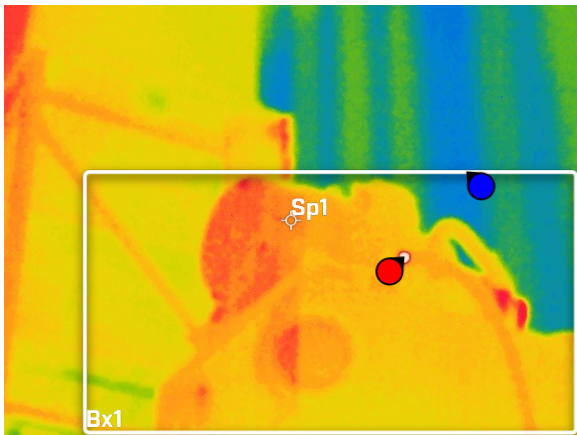
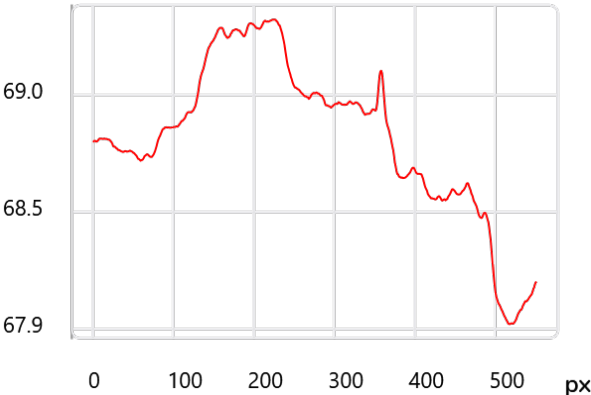
## Thermogram 243

Equipment name : Small Parts Shipping 401

Device name : 1055

Recommended Action No action recommended at this time

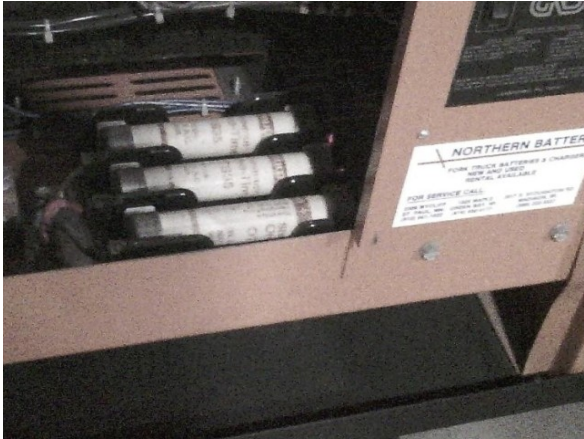
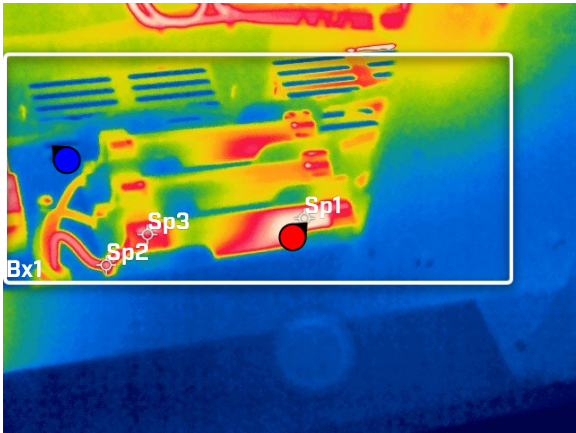
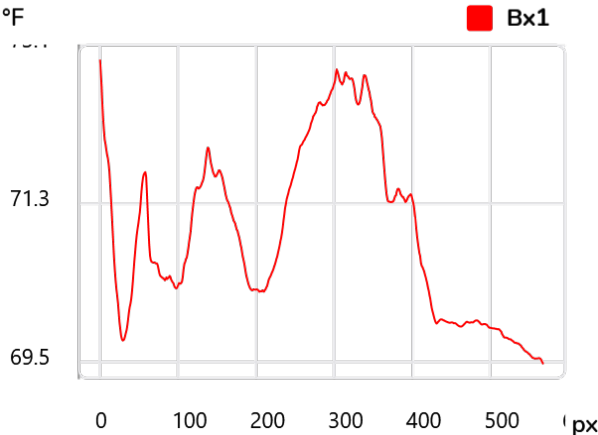
Thermogram 244 Created: 5/20/2026 1:08:22 PM

Equipment name : Receiving 501  
Device name : 1056  
Measurement Point : Douglas Forklift Charger  
Status OK

Issue No Issue - Normal operation  
Recommended Action No action recommended at this time  
Comment No additional comments.  
Priority None

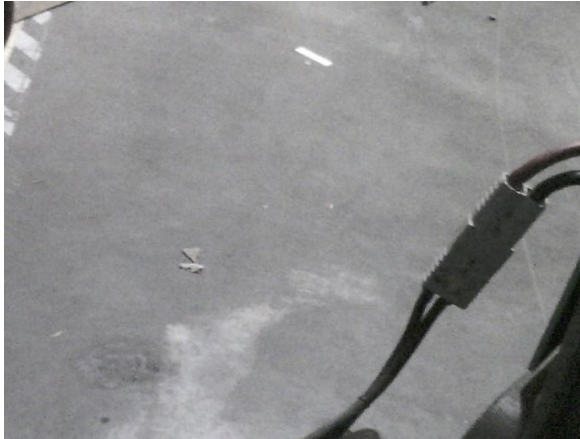
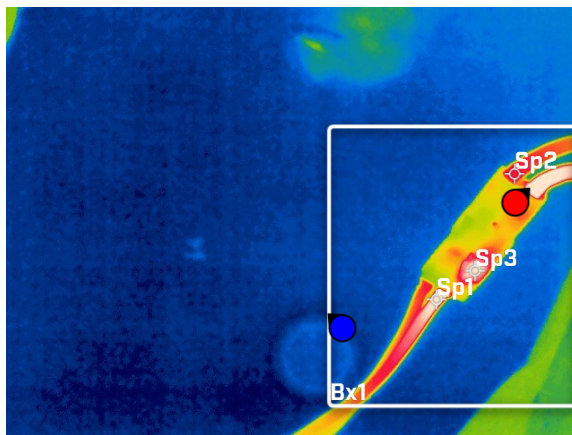
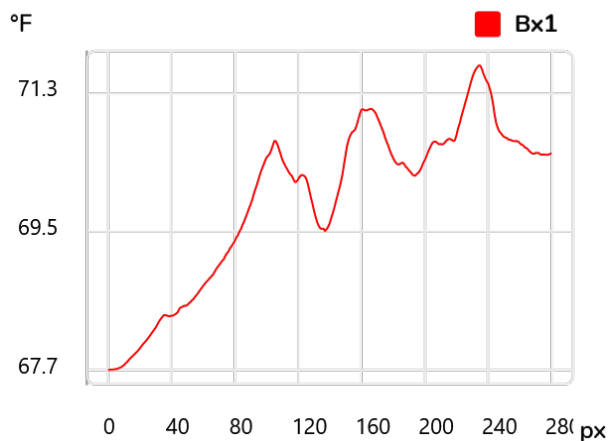
## Thermogram 245

Equipment name : Receiving 501  
Device name : 1056  
Measurement Point : Douglas Forklift Charger  
Status OK

Recommended Action No action recommended at this time

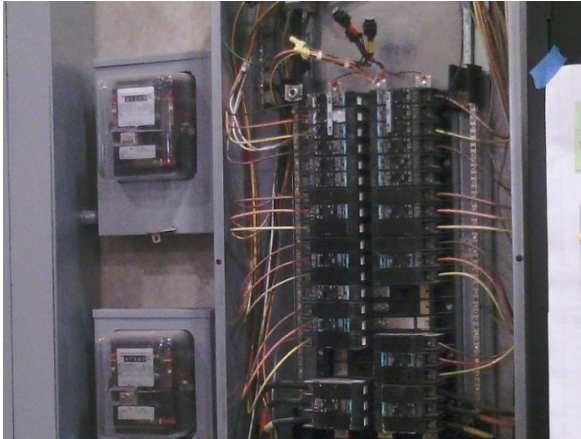
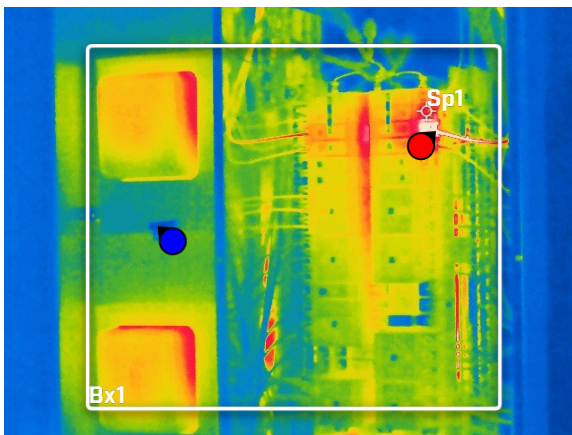
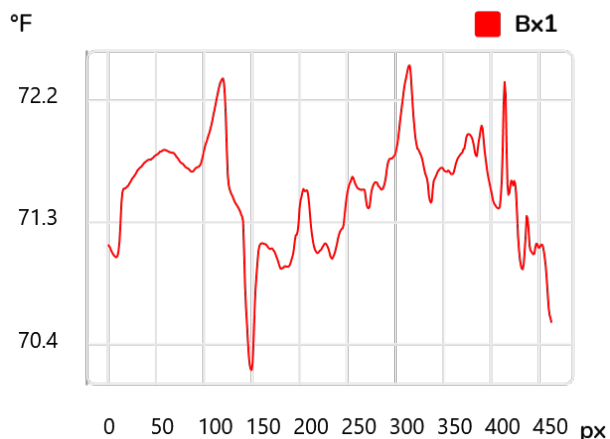
Thermogram 246 Created: 5/19/2026 1:57:19 PM

Equipment name : Receiving 501  
Device name : 1057  
Measurement Point : HP-4  
Status Note

Max 81.2 °F  
Min 69.7 °F  
Area 3.833 ft²  
Sp1 73.7 °F

Issue Dirty/corroded connection(s)  
Recommended Action Perform amp draw  
Comment Check connection and amp draw.  
Priority 2-Intermediate/Investigate

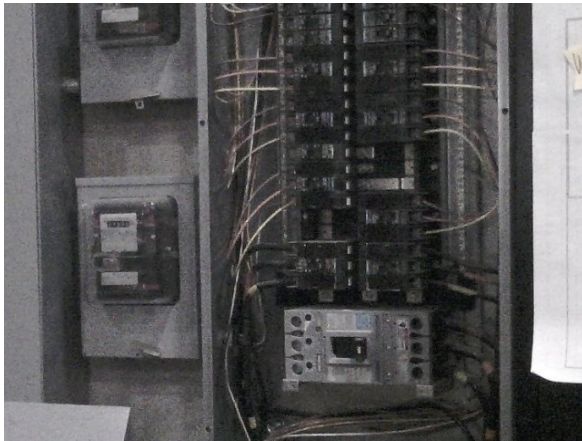
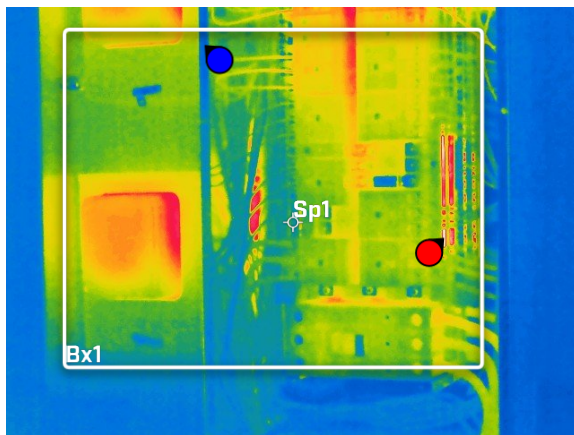
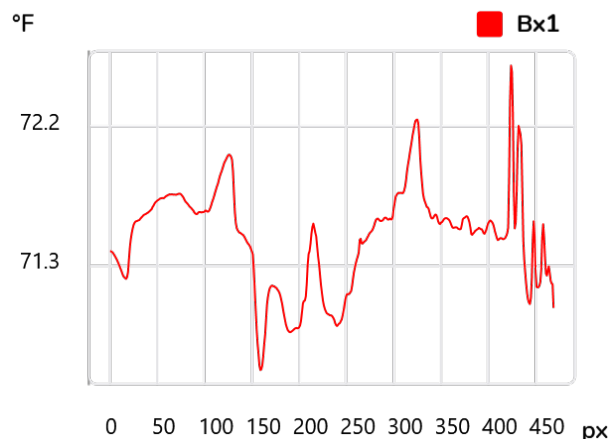
Thermogram 247 Created: 5/19/2026 2:04:02 PM

Equipment name : Receiving 501  
Device name : 1057  
Measurement Point : HP-4  
Status Note

Max 77.9 °F  
Min 70.2 °F  
Area 3.570 ft²  
Sp1 70.7 °F

Issue Dirty/corroded connection(s)  
Recommended Action Perform amp draw  
Comment Check connection and amp draw.  
Priority 2-Intermediate/Investigate

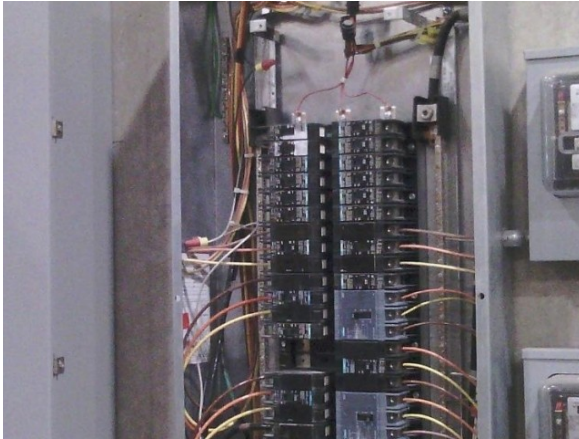
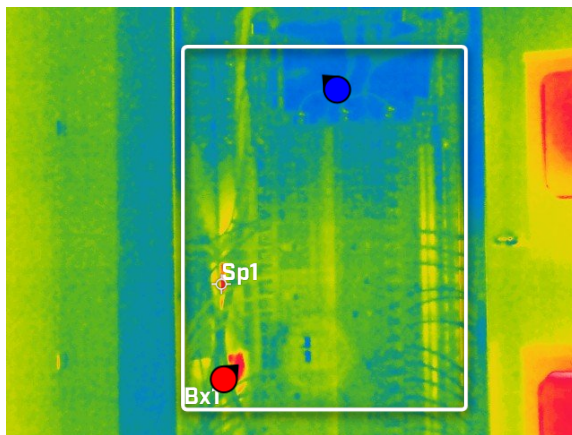
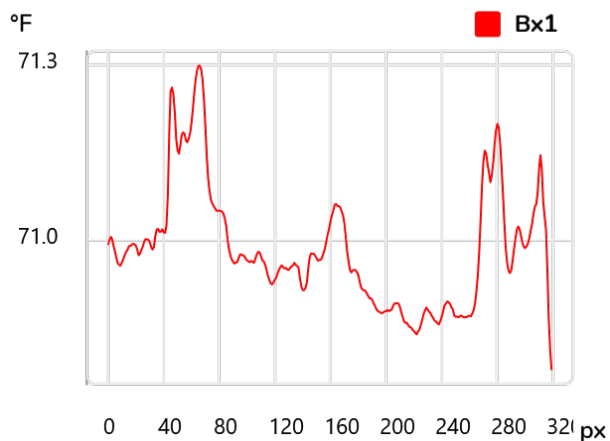
Equipment name : Receiving 501  
Device name : 1058  
Measurement Point : HP-3  
Status OK

| <b>Sp1</b> | 73.6 °F |

**Recommended Action** No action recommended at this time

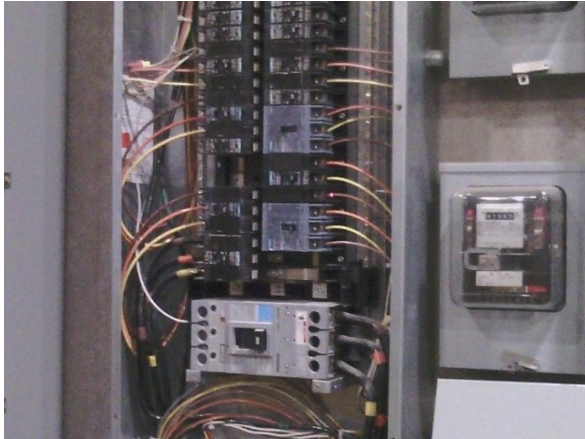
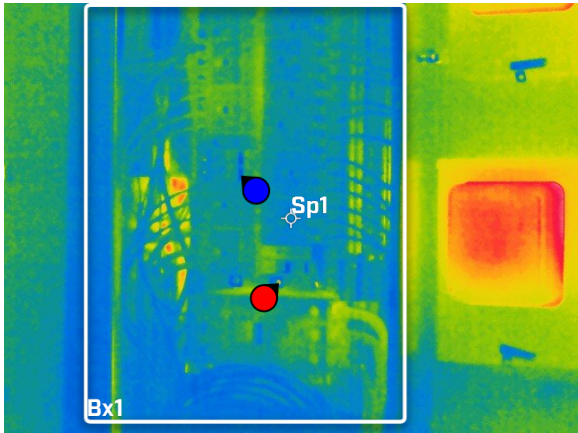
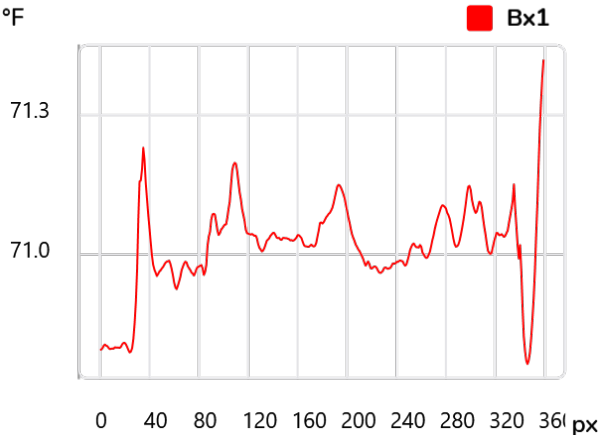
Equipment name : Receiving 501  
Device name : 1058  
Measurement Point : HP-3  
Status OK

| Sp1 | 70.9 °F |

Issue No Issue - Normal operation  
Recommended Action No action recommended at this time  
Comment No additional comments.  
Priority None

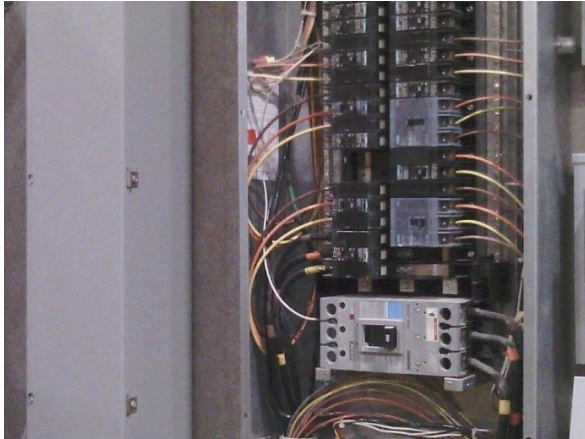
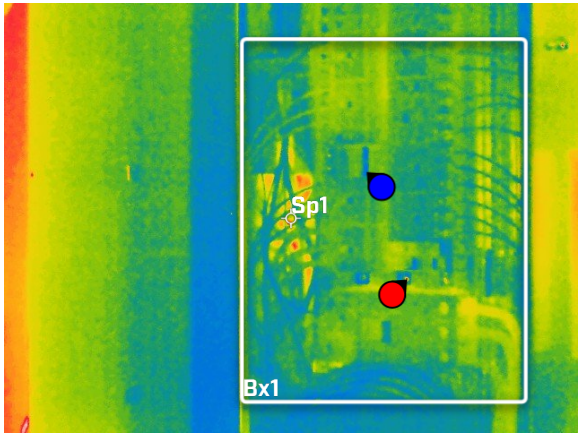
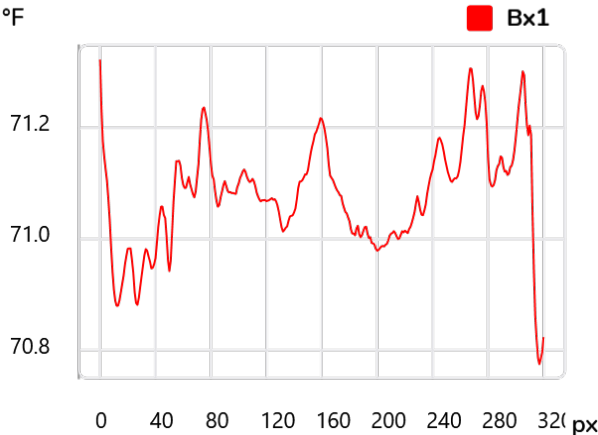
Equipment name : Receiving 501  
Device name : 1058  
Measurement Point : HP-3  
Status OK

| <b>Sp1</b> | 72.0 °F |

**Issue** No Issue - Normal operation  
**Recommended Action** No action recommended at this time  
**Comment** No additional comments.  
**Priority** None

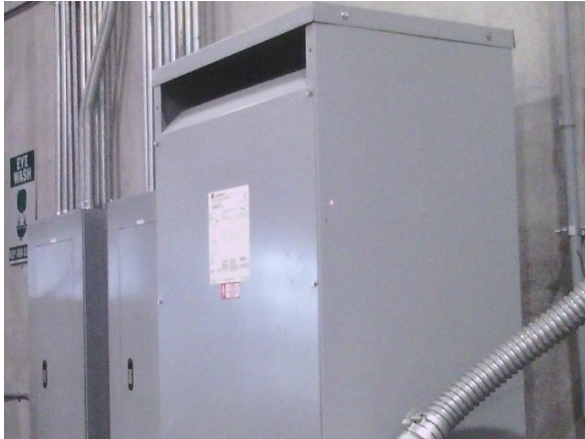
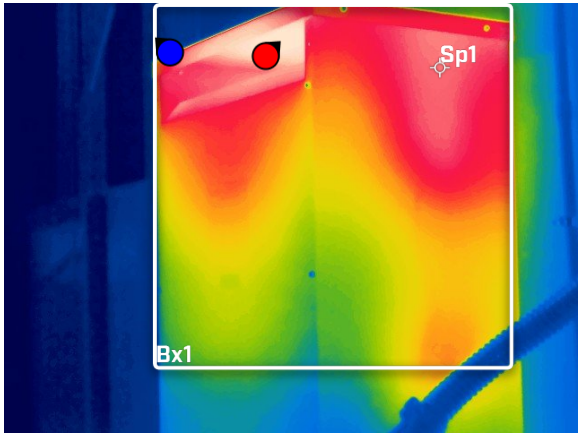
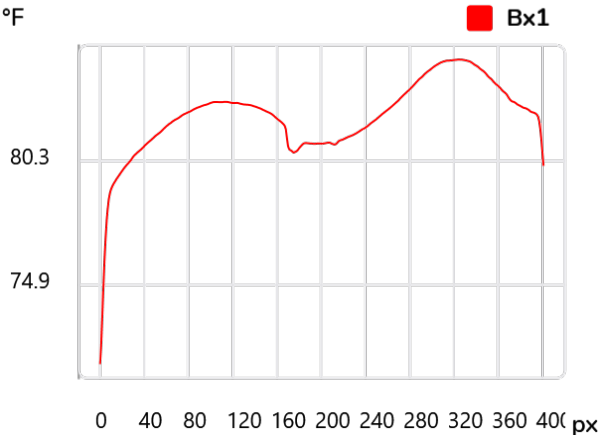
Equipment name : Receiving 501  
Device name : 1059  
Measurement Point : V48M28T75S  
Transformer (TOP)

| <b>Sp1</b> | 87.7 °F |

**Issue** No Issue - Normal operation  
**Recommended Action** No action recommended at this time  
**Comment** No additional comments.  
**Priority** None

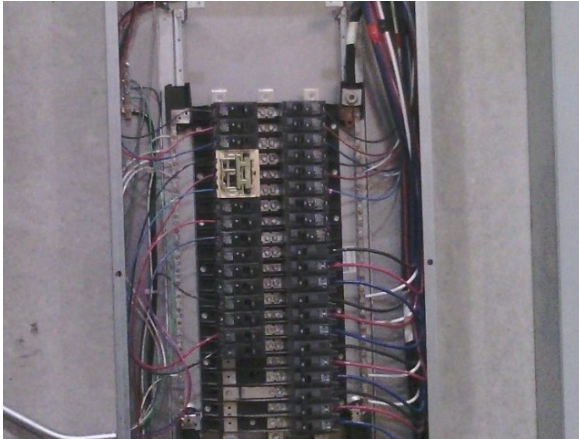
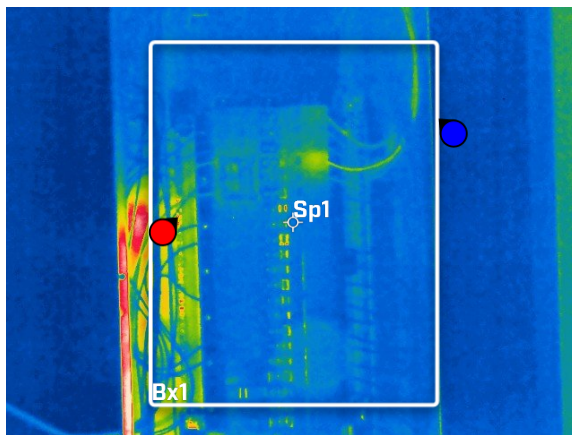
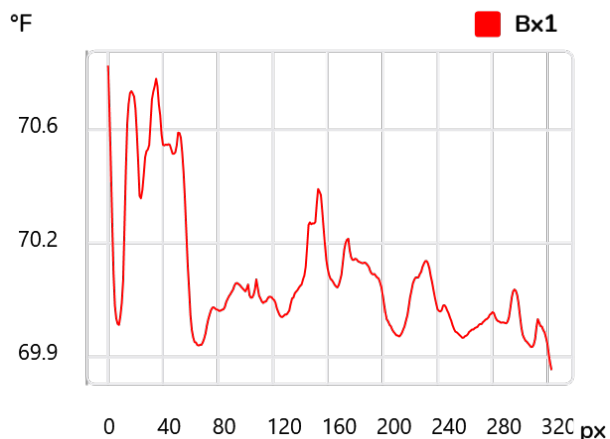
Equipment name : Receiving 501  
Device name : 1061  
Measurement Point : LP-1  
Status OK

| <b>Sp1</b> | 70.1 °F |

**Recommended Action** No action recommended at this time

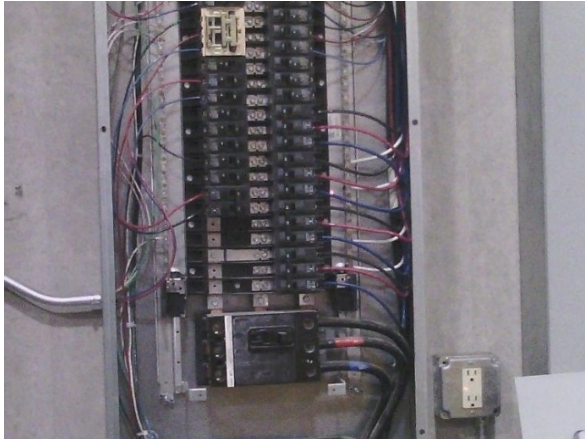
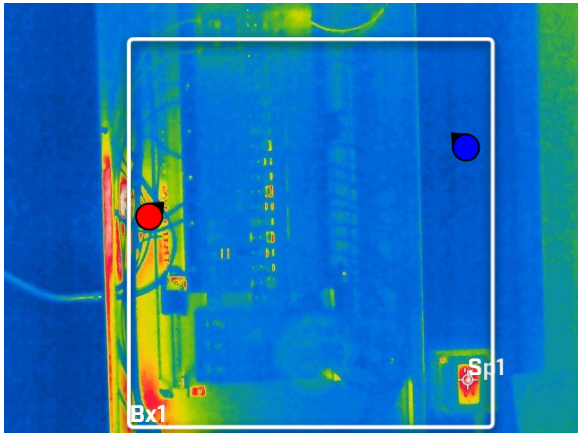
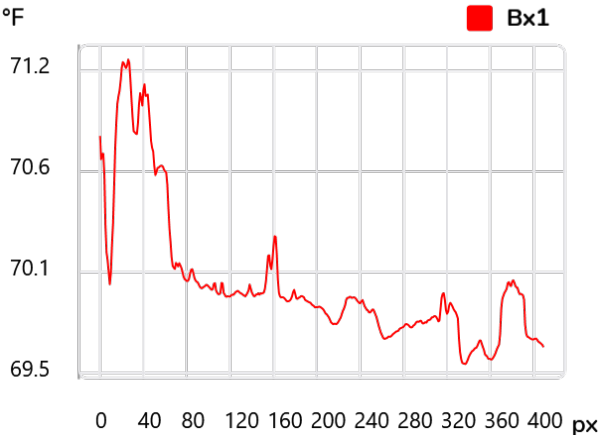
Equipment name : Receiving 501  
Device name : 1061  
Measurement Point : LP-1  
Status OK

| <b>Sp1</b> | 75.7 °F |

**Issue** No Issue - Normal operation  
**Recommended Action** No action recommended at this time  
**Comment** No additional comments.  
**Priority** None

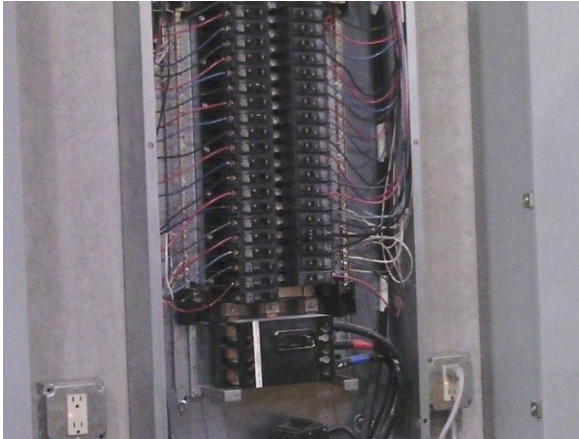
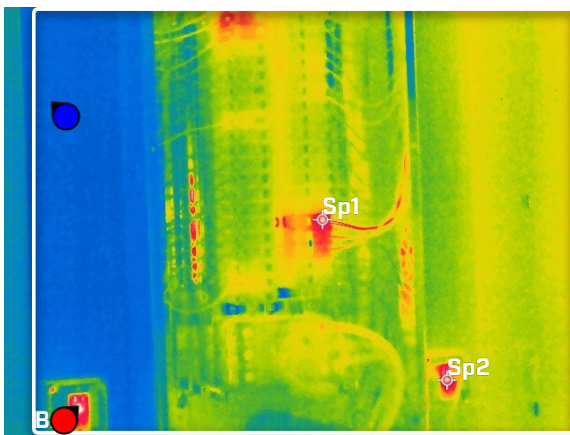
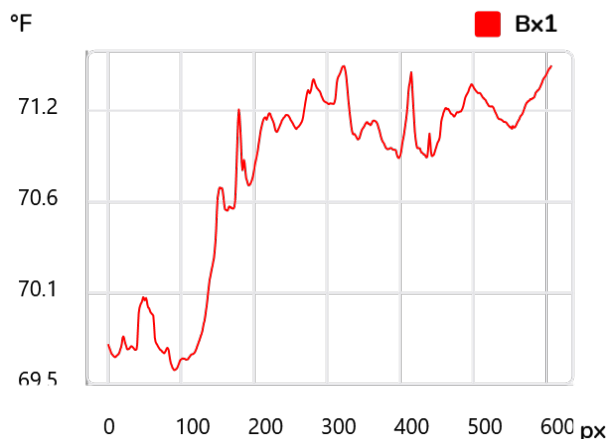
Equipment name : Receiving 501  
Device name : 1062  
Measurement Point : LP-2  
Status OK

| <b>Sp2</b> | 74.7 °F |

**Recommended Action** No action recommended at this time
