# THERMAL ELECTRICAL INSPECTION

## SAMPLE REPORT

RETROFIT  
ELECTRIC

# Retrofit Electric - Thermal Electrical Inspection

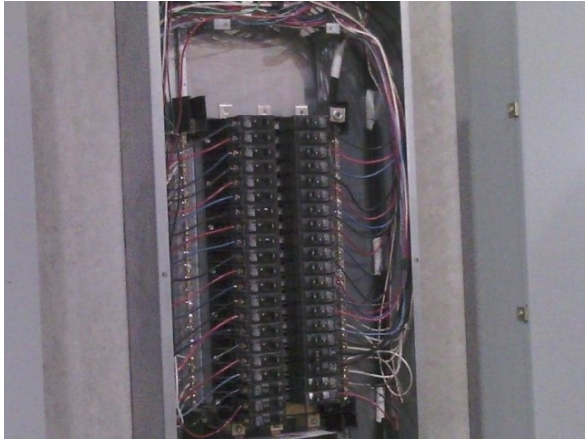
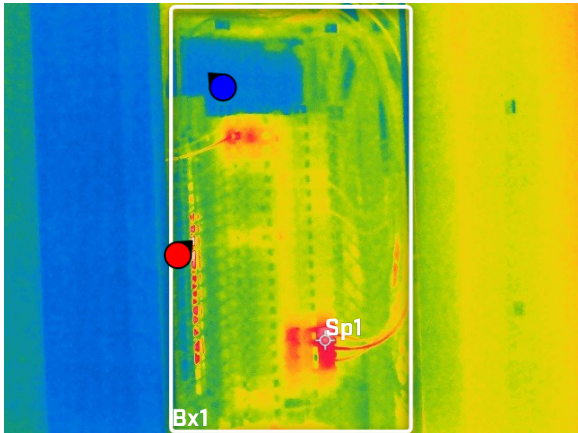
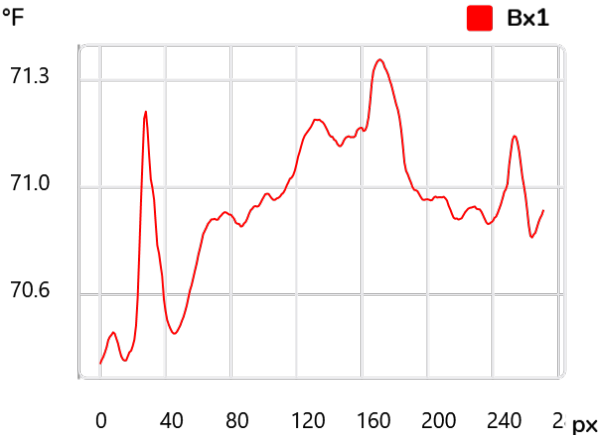
Equipment name : Receiving 501  
Device name : 1062  
Measurement Point : LP-2  
Status OK

| <b>Sp1</b> | 74.0 °F |

**Issue** No Issue - Normal operation  
**Recommended Action** No action recommended at this time  
**Comment** No additional comments.  
**Priority** None

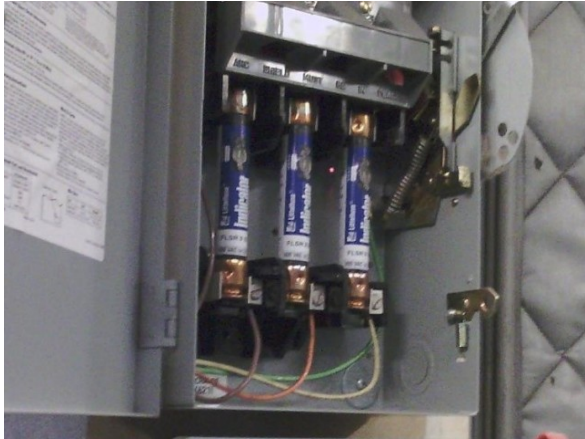
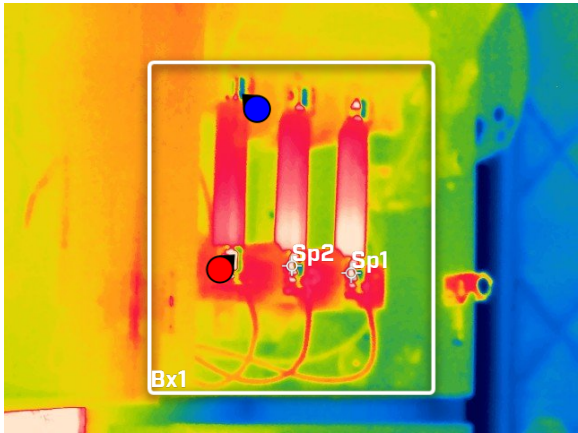
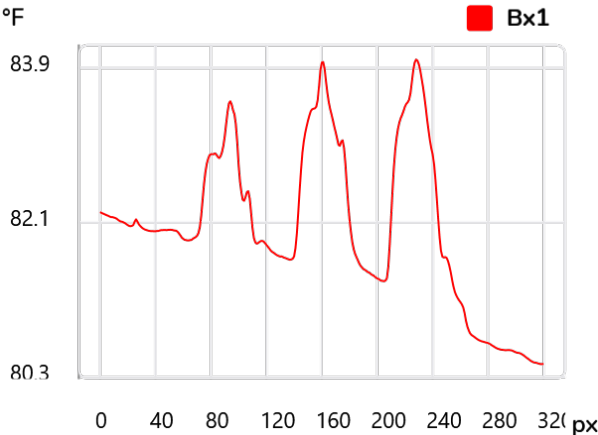
Equipment name : Receiving 501  
Device name : 1063  
Measurement Point : LV-4  
Status OK

| Value | |
|---|---|
| Sp2 | 90.9 °F |

Issue No Issue - Normal operation  
Recommended Action No action recommended at this time  
Comment No additional comments.  
Priority None

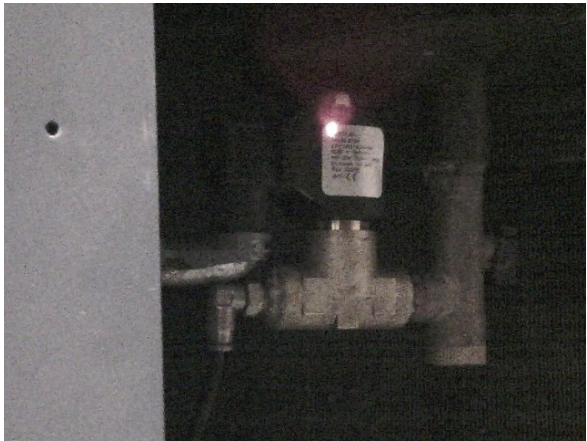
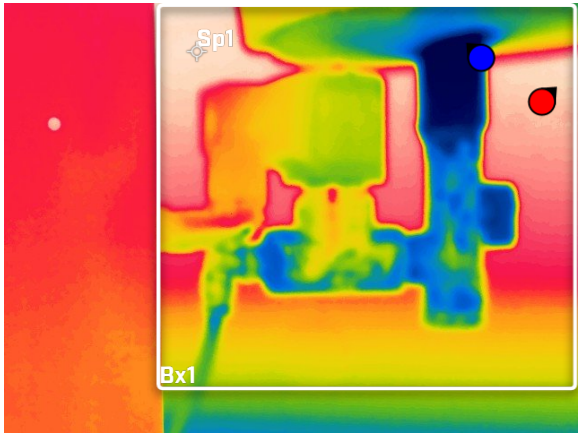
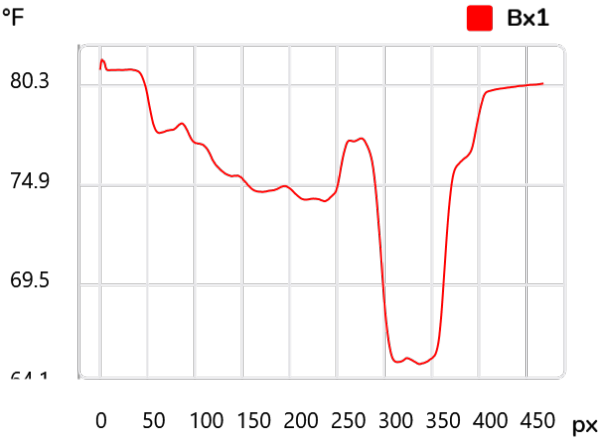
Equipment name : Receiving 501  
Device name : 1063  
Measurement Point : LV-4  
Status OK

| Sp1 | 85.8 °F |

Issue No Issue - Normal operation  
Recommended Action No action recommended at this time  
Comment No additional comments.  
Priority None

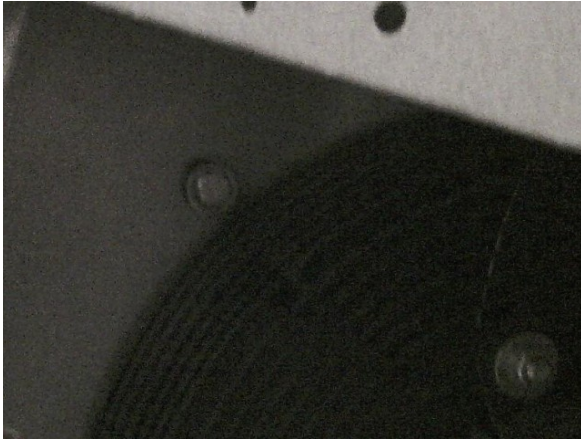
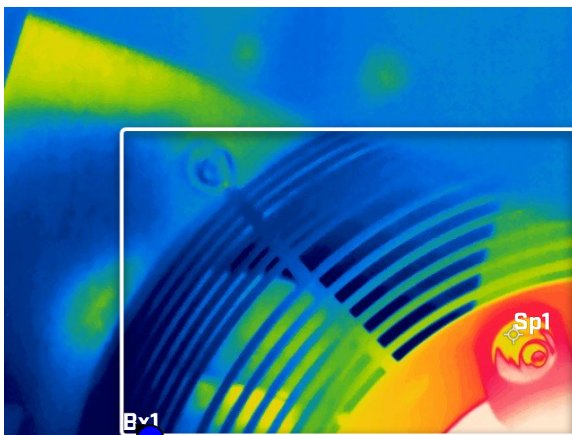
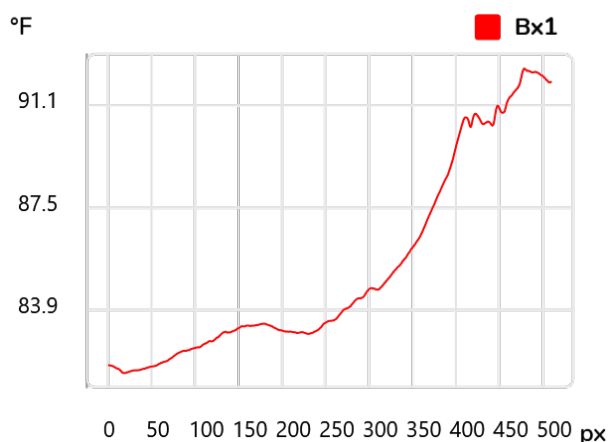
Equipment name : Receiving 501  
Device name : 1063  
Measurement Point : LV-4  
Status OK

| <b>Sp1</b> | 88.8 °F |

**Recommended Action** No action recommended at this time

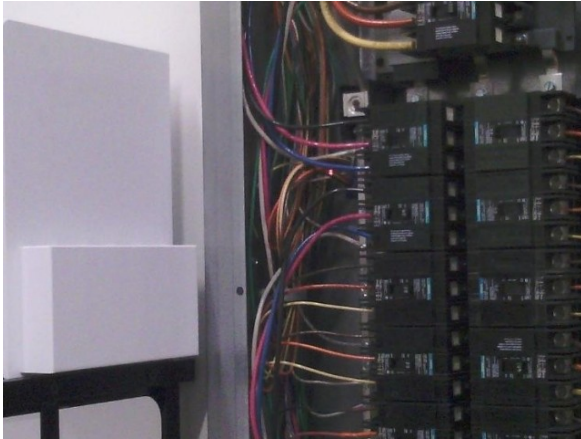
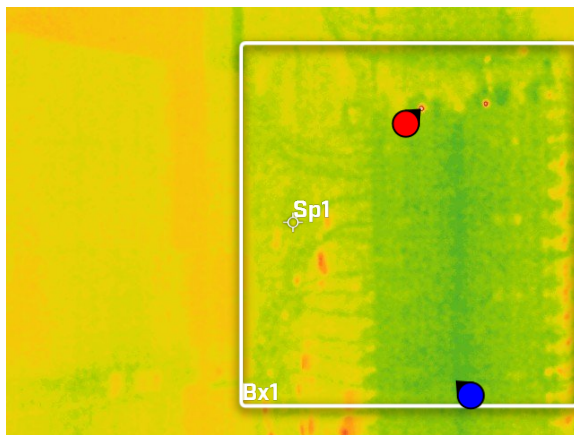
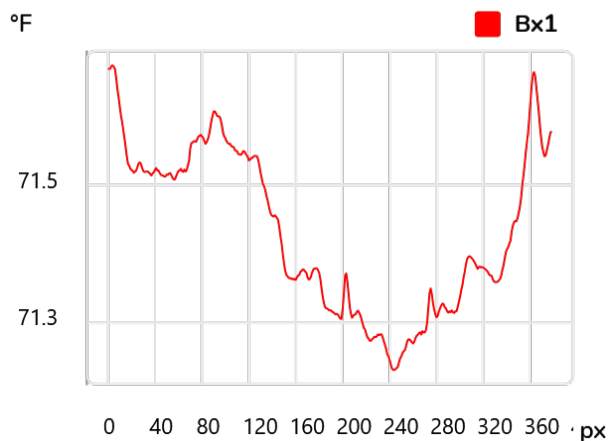
Equipment name : Engineering Lab 625

| <b>Sp1</b> | 71.5 °F |

**Recommended Action** No action recommended at this time

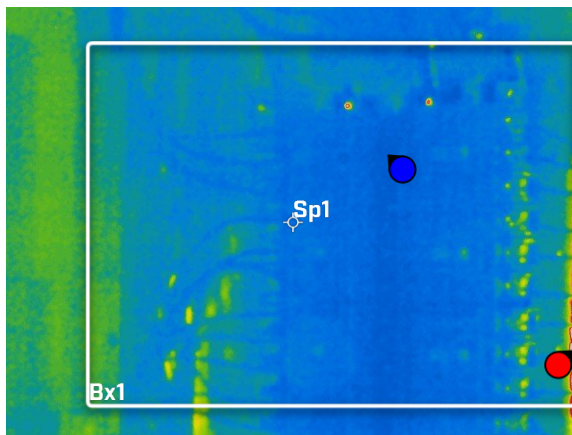
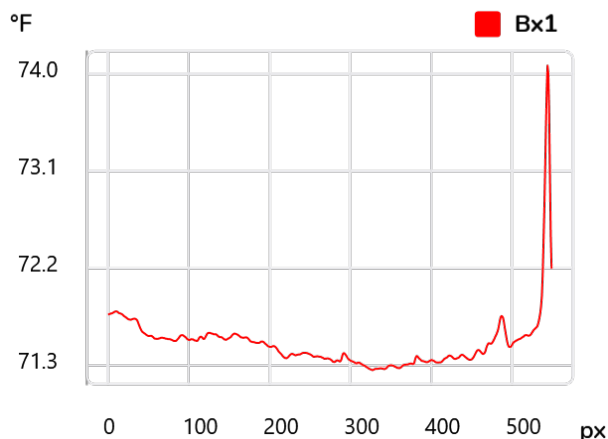
Thermogram 261 Created: 5/20/2026 10:11:35 AM

**Issue** No Issue - Normal operation

**Recommended Action** No action recommended at this time

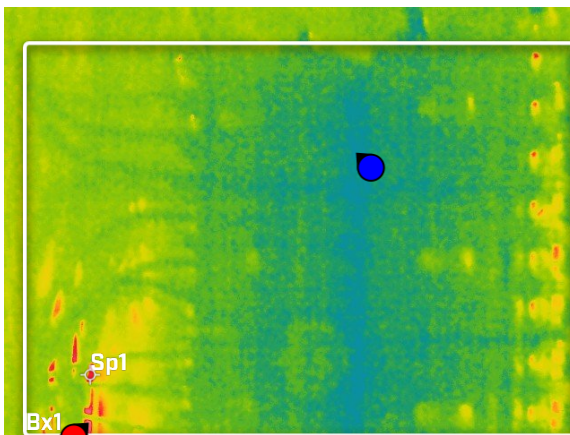
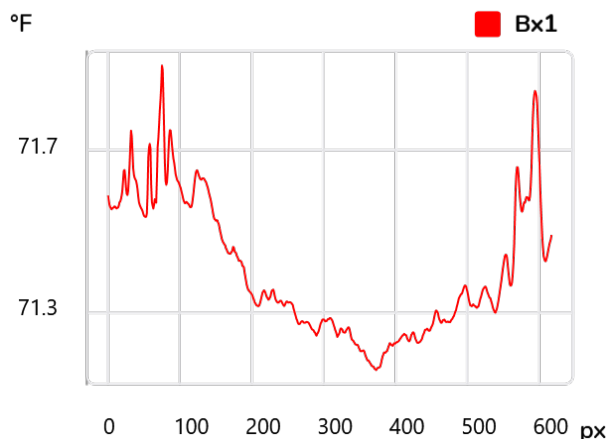
Thermogram 262 Created: 5/20/2026 10:12:12 AM

Issue No Issue - Normal operation

Recommended Action No action recommended at this time
